Clinical Workshop

A Defect in a Self-administration Anesthesia System

C. G. BALL, M.D.,* AND F. A. BERRY, JR., M.D.†

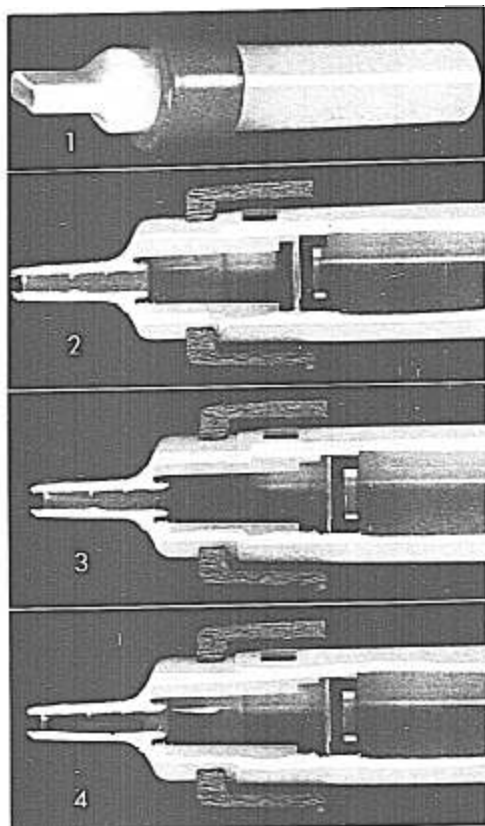
In several of the unused mouthpieces the retaining ring was located about 2 mm distal to its normal position. In addition, some of the plastic disks were not perfectly round, being slightly smaller in one diameter than another. The internal diameter of the narrow part of the mouthpiece is only slightly smaller than the largest diameter of the disk. When the mouthpiece is warmed in the mouth and then compressed by the teeth, this inner diameter is increased slightly, and this may be sufficient to allow the disk to slip out of the mouthpiece entirely.

When the retaining ring is seated in the tube properly, the plastic disk cannot be dislodged from its point of action. However, during use, and particularly after cleaning, sterilization and reuse, the retaining ring, which is not immovably fixed in position, may shift slightly, providing enough room for the disk to find its way into the patient end of the mouthpiece and into the patient.

While the mouthpiece was originally designed to be disposable, it can be reused with proper sterilization, and the temptation to do so is difficult to resist. In many of the mouthpieces that had been used previously and then sterilized with Cidex,§ the retaining ring had migrated several centimeters and the plastic disk had migrated proximally (figs. 3 and 4) or was missing entirely.

Since most of the patients using this device are hyperventilating, the possibility of aspirating the disk into the trachea is obvious. The risk of aspiration may be increased if airway

FIG. 3. The retaining ring has slipped distally, allowing the disk to migrate towards the mouth.

FIG. 4. Further progression of the disk through the mouthpiece.

Because of the serious nature of this defect, we feel that the design of the mouthpiece should be modified to prevent the disk from being displaced in any way by making the retaining ring immovable. In addition, it should be impossible for the disk, even if displaced, to travel out of the mouthpiece into the patient's mouth. This correction could perhaps

be accomplished by incorporating a plastic septum in the mouthpiece proximal to the plastic disk.

We have reported these findings to the manufacturer, who has been most receptive to correcting the problem. A product recall has been issued, and corrective measures are being taken. However, we feel that all anesthesia and delivery room personnel who may have occasion to use this apparatus should be aware of this unexpected and potentially serious complication.
