Electrocution in the Operating Room

This report of an electric-shock injury to a patient and her physician is presented to alert others to the possibility of a similar occurrence.^{1,2} To our best knowledge, these circumstances have not been previously reported, and analysis of these events suggests certain precautions.

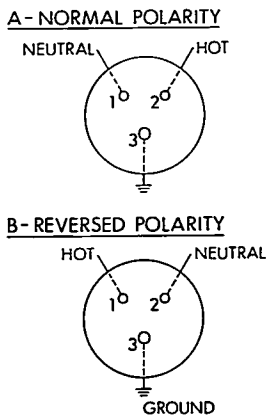
The EKG monitor and the power receptacles in the operating room were inspected. Figure 1A shows the proper wiring for a power plug and figure 1B shows the actual wiring of the plug. The chassis ground is connected to the "neutral" prong (no. 1) rather than the "ground" prong (no. 3). Figure 2A shows the usual wiring for a wall receptacle, and this was how the first receptacle was wired. Figure 2B shows the reversed-polarity wiring of the second receptacle.

FIG. 2. Wiring of power receptacles. Positions 1, 2, and 3 correspond to those in figures 1 and 3. A, first receptacle—normal polarity; B, second receptacle—note reversed polarity of positions 1 and 2.

Because the improperly wired EKG monitor had been in use for some time without a shock reported, we thought that the receptacle with reversed polarity must have been the only one so wired in the operating rooms. The building code for this city has no requirements for standardized-polarity wiring in hospitals, and at the time this hospital was built there was no requirement for separate ground conductors; conduits were used instead. We tested all receptacles and found that 20 per cent of those in the operating rooms had reversed polarity, which probably had been present for the 15 years since the hospital was built. This has since been corrected.
