Anesthesiology  
47:72-74, 1977

## Electrosurgical Burns at Skin Temperature Probes

ARTHUR J. L. SCHNEIDER, M.D.,\* HOWARD P. APPLE, PH.D.,† RAYMOND T. BRAUN, B.E.E.‡

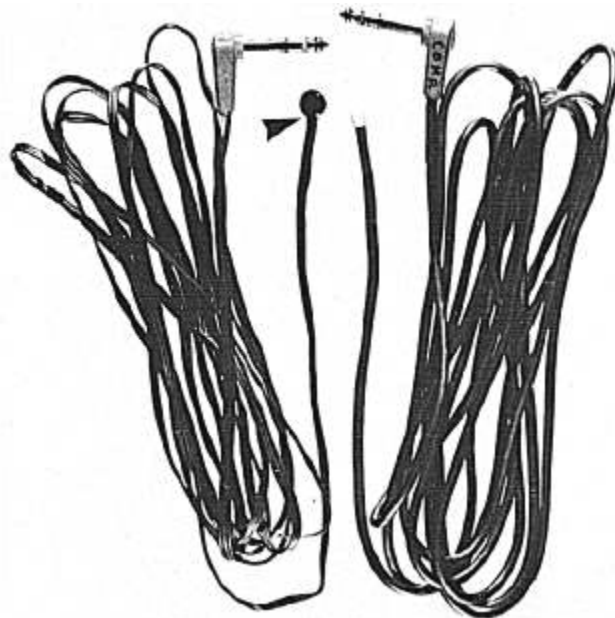
FIG. 1. Yellow Springs type 709 (left) and type 701 (right) temperature probes. Arcing, under conditions described in the text, occurred at the point indicated by the arrow on the left probe. The metal surface of the terminal button of the type 709 probe is turned away from the camera.

temperature probe was found to have sustained damage to the insulation of the three-conductor wire where the wire entered the metal-capped terminal button of the probe (see fig. 1). The Datascope 865-C was tested for leakage currents and circuit isolation with and without a temperature probe connected. Without a temperature probe the isolation was within normal ranges, but when the temperature probe was connected the isolation was reduced by a factor of 30. The Datascope was returned to the manufacturer for calibration and repair. The nickel-cadmium batteries, the voltage regulators, and the pulse sensor were found to have been destroyed. It is very probable that the current from the Bovie unit first broke down the temperature probe insulation and then damaged the Datascope. The CSV Bovie proved to be in working order except that the capacitor, which is attached between the distal end of the double-wired return electrode cable and the return plate itself, was mechanically damaged. This damage is thought to have resulted in high impedance in the normal return

point where the cable enters the terminal button of the probe. The resistance of the probe, measured as described above, was then found to be 100 megohms. Two additional probes were taped to the surfaces of beefsteaks with the metal surface down and the electro-surgical machine was used to cut the beef at a point about four inches from the probes. Similar Bovie settings were used; the ground plate was not used. Again, an obvious arcing took place at the junction and the insulation damage could be seen. Resistance of these probes was subsequently measured to be .024 and 4.5 megohms.

The decreased resistance found in one type 409 probe that had been in clinical service for an unknown period of time suggests that reesterilization, handling, and mechanical abuse may weaken the insulation.

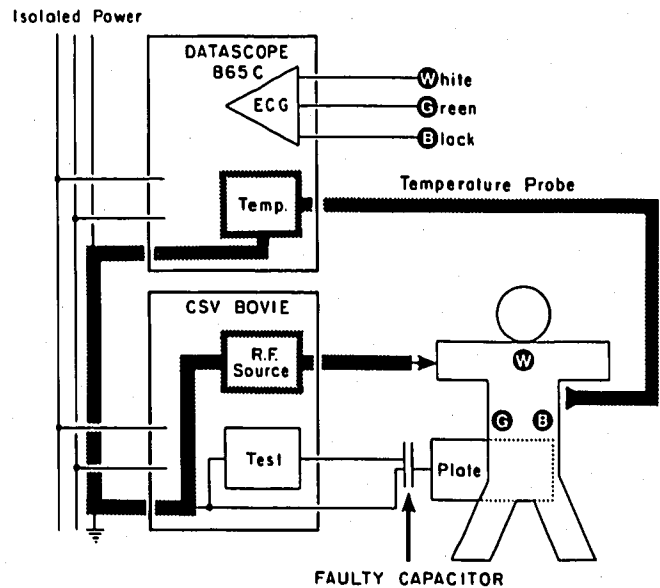
In our case, the capacitor failed in such a way (opened) that the safety circuit was maintained but the integrity of the central grounded conductor was destroyed. The safety current could pass from one conductor of the cable to the other but a high impedance was provided in the grounding path for the coagulating current of the electro-surgical machine. The temperature probe provided an alternate path to ground for the radiofrequency current.

FIG. 2. Diagram of conditions under which skin burns occurred. Because of the faulty (open) capacitor, radiofrequency current passed from the CSV Bovie through the temperature probe and Datascope. The current loop thought to be responsible for the burns is shown with a stippled overlay. White, green and black electrocardiogram leads were connected to the patient as indicated.

We tested 30 such capacitors that had been in clinical use and found that ten of them were open. All external capacitors were discarded. At our request internal modifications were carried out on the appropriate CSV Bovies, those with serial numbers below 11,000, by the manufacturer's representative so that internal capacitors could be installed.

The temperature circuits of most physiologic monitors are not isolated. Presumably, isolated input circuitry would have prevented this problem. We believe that additional modification of physiologic monitors is necessary and that isolated inputs for signals other than electrocardiogram should be seriously considered. Battery operation of this equipment does not seem to be the answer to the problem because of the possibility of accidental chassis grounding and high power consumption
