Anesthesiology
49:302, 1978

Vaporizer Leak

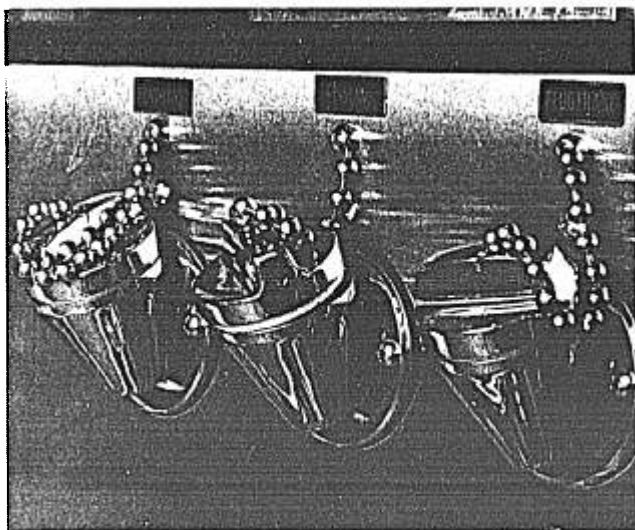
FIG. 1. Ohio DM 5000 vaporizer filler plugs.

vaporizer plugs have machine-screw threads. When the plugs are not securely tightened, a large part, if not all, of the fresh gas flow will escape via this leak. Despite awareness of this possibility, it was recently discovered that a leak of fresh gas from a seemingly tight vaporizer filler plug was present. On first inspection, the cause of the leak was not readily apparent. On close inspection from the side (Fig. 1) it was found that the middle vaporizer plug was cross-threaded and hence not seated. Users of this machine should be aware that the vaporizer filler plugs must be not only tight but also correctly threaded.
