Anesthesiology
75:714, 1991

Another Potential Complication of a Pulmonary Artery Catheter Insertion

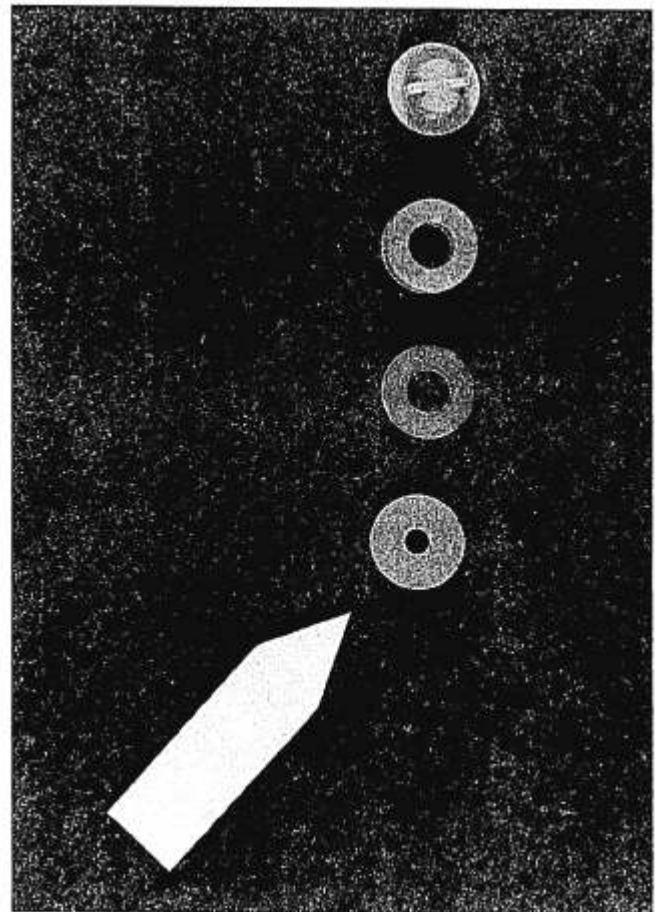
To the Editor:—We would like to report a case of a washer of a Tuohy-Borst valve (Baxter Healthcare Corp., Santa Ana, CA) dislodged into the sheath inserted in the right internal jugular vein. When the pulmonary artery (PA) catheter was inserted, persistent resistance to its further advance was encountered. Neither loosening the Tuohy-Borst cap nor reinsertion of the dilator was helpful. The wire was reinserted; the sheath was removed; and a new sheath was inserted without difficulty, followed by reinsertion of the PA catheter with ease. When the defective sheath was examined, the Tuohy-Borst valve was noticed to contain four pieces, as shown in figure 1. The distal rubber washer (fig. 1, arrow) had migrated to within 5 cm from the tip of the sheath, impeding insertion of the dilator. While examining the defective sheath outside the patient, further insertions of the dilator through the valve displaced this distal washer from the sheath *via* the tip. The washer is made of soft rubber, which explains how it was able to traverse the sheath. X-ray of the pieces in the figure revealed that only the third large washer is radiopaque.

FIG. 1. The Tuohy-Borst valve assembly. The arrow indicates the distal rubber washer.

In Reply:—The returned product was evaluated by our Quality Assurance Laboratory, and it was confirmed that the catheter seal had been pushed out of the Tuohy-Borst adaptor.

When difficulty is encountered during insertion of a PA catheter is not alleviated by loosening the Tuohy-Borst cap, we recommend immediate replacement of the sheath in order to avoid embolization of a potentially dislodged component of a Tuohy-Borst valve.

This specific problem has resulted in several corrective actions in the manufacturing process (*i.e.*, siliconization). In addition, the Tuohy-Borst duckbill valve and seals are being redesigned to prevent them from being pushed through the introducer.
