## Backup Failure of an Adjunct Battery in an Evita 4<sup>®</sup> Ventilator

*To the Editor:*—Electrical power failure in the hospital presents a severe challenge to intensive care unit patients.<sup>1</sup> We recently experienced electrical backup failure in an Evita 4<sup>®</sup> ventilator (Dräger Medizin-technik, Lübeck, Germany), which was caused by the internal erosion of a connecting cable of an adjunct battery Dryfit A512<sup>®</sup> (Sonnenschein, Budingen, Germany) to the ventilator.

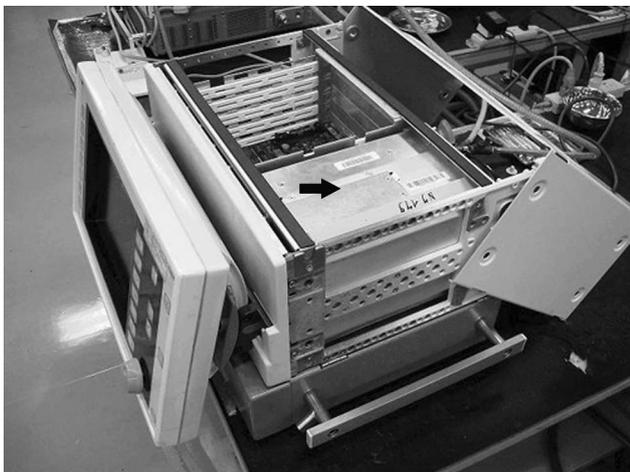
The AC and DC power modules of the ventilator were 8 yr old. The ventilator functioned steadily with an external power supply. Because the Evita 4<sup>®</sup> is normally configured to function for 10 min with backup from a fully charged battery in case of a power cut, the battery assembly was suspected to be responsible for the problem. The ventilator was sent to the manufacturers for close inspection to identify the source of the power backup failure. Dräger Germany found that the cable connector to an adjunct battery was eroded by leaked battery solution. Inside the moist electronic unit, the minor erosion had degraded the connecting cable over time and increased the electrical resistance, leading to the malconduction to the ventilator system and power failure even though the adjunct battery was properly charged

**Fig. 1.** The AC and DC power modules (*arrow*) are set in the electrical power unit of an Evita 4<sup>®</sup> ventilator (Dräger Medizin-technik, Lübeck, Germany).

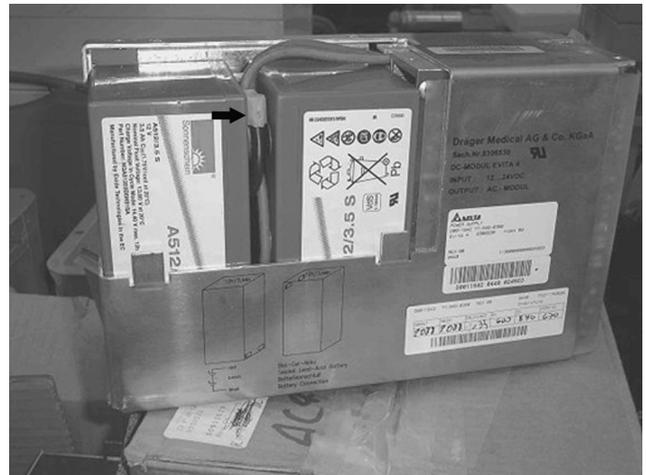
**Fig. 2.** A pair of the same type of batteries as the failed battery is placed in the adjunct battery assembly of the DC power module. The *arrow* indicates the cable connector to a battery.

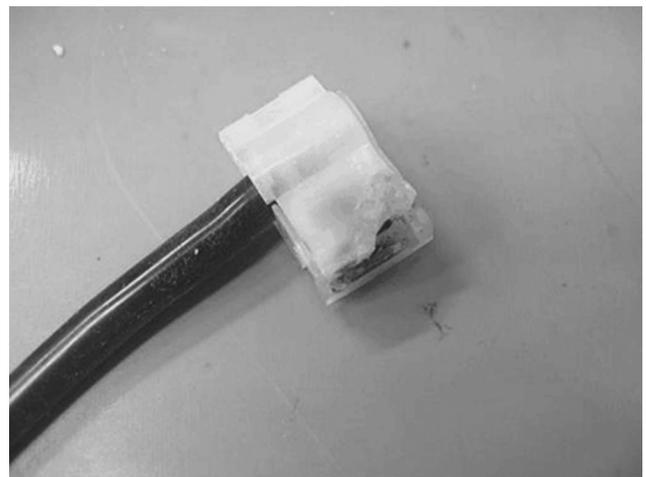
(figs. 1-3). Close examination of the manufacturer's database for batteries of approximately 10,000 serial numbers showed that the erosion occurred rarely. The current case was formally registered in the manufacturer's incident list. The manufacturer replaced the emergency power unit of the ventilator with a Panasonic lead-acid battery (Mastushita Battery Industrial, Osaka, Japan). Dräger Japan explained that all Evita 4<sup>®</sup> ventilators used in Japan would be inspected eventually, and batteries would be replaced, because there was a risk of leakage with the current battery unit.

**Fig. 3.** The eroded cable connector that caused the malconduction trouble.

ment of the battery assembly by trained technicians are mandatory. Moreover, we have to be aware that without reliable power supply, life-supporting machines such as ventilators would be lethal.<sup>2</sup>
