## A Case of Accidental Hypotension Caused by Drug Leakage through the Rubber Piston in a Prefilled Inovan Injection 0.3% Syringe

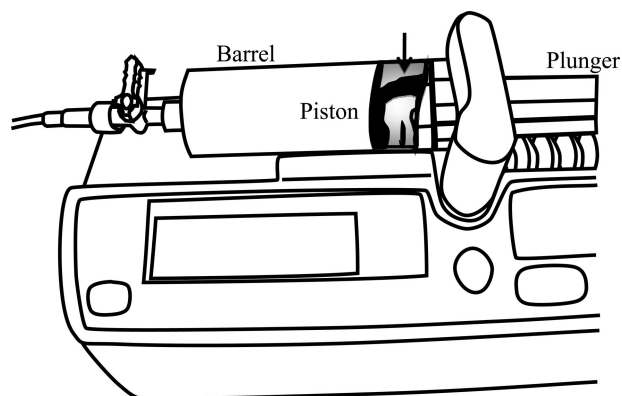
We sent the relevant syringe-infusion line assembly to the manufacturer for detailed inspection to identify the source of drug leakage and air influx, which appeared to occur at the piston that was fitted to the syringe barrel. We asked the manufacturer about the test results of the plunger/piston assembly that has been approved as medical equipment. The engineers responded as follows: They put the prefilled syringe in question to the liquid leakage test for syringe piston under compression in accordance with the International Organization for Standardization 7886-1: 1993-10-01.<sup>2</sup> There was no leakage in the rubber piston. Airtightness was maintained in the syringe, the extension tube, and the three-way stopcock. Next they examined situations that might produce drug leakage and how the leakage occurred during use of the prefilled syringe. The examination revealed the following: When the operator pushed the plunger into the rubber piston without turning it, there were some cases where the male screw thread molded at the top end of the plunger could not engage entirely the female screw thread molded on the inside wall of the rubber piston. Under this condition, the cylindrical rubber wall of the piston gradually became partially contorted as pressure was applied to the plunger after continuous infusion was started. This situation led to dislodging of the rubber piston, leaving a gap between the outside wall of the rubber piston and the inside wall of the barrel, and resulting in drug leakage as air entered through the gap (fig. 1). Consequently, the plunger/piston misassembly was proven to be the cause of erratic drug delivery, resulting in the abrupt onset of hypotension. The manufacturer had received the same incidental reports from several hospitals regarding the drug leakage from prefilled Inovan injection 0.3% syringes. They already had knowledge of the problem;

Fig. 1. Schematic representation of the situation in which a force applied to the plunger contorts the rubber piston when a prefilled syringe is used with a syringe pump. The gap (arrow) breaks the seal between the barrel of the syringe and the rubber piston, resulting in drug leakage as air entered through the gap. This plunger/piston misassembly caused an incident during drug administration.

We recommended that manufacturers provide a preassembled prefilled syringe with an integrated plunger/piston unit. However, the engineers indicated the following drawbacks of a preassembled prefilled syringe with an integrated plunger/piston: 1) Pressure may be exerted on the plunger during a fall or transportation of the syringe; 2) when the top film is peeled only partially during removal of the syringe, the finger grip may be caught by the film, resulting in tilting of the plunger with respect to the axial line of the barrel, which may cause plunger/piston misassembly; 3) the length of the whole unit becomes longer, posing problems in storage, transportation, and handling; 4) the manufacturers should apply to the Ministry of Health, Labor, and Welfare for changing a part of the original design, and approval will take more than 1 yr; and 5) the syringe pump structure may have to be modified to accommodate the newly arranged syringes. Based on these issues, Kyowa Hakko Kirin and Terumo are issuing appropriate warnings that the operator should not push the plunger into the rubber piston but should instead turn the plunger to engage the screw threads during assembly. They are also planning to modify the fundamental configuration of the plunger/piston assembly. We strongly recommend that the International Organization for Standardization, marketing companies, and manufacturers work together to supply prefilled syringes, particularly syringes with an integrated
