A Case of Accidental Hypotension Caused by Drug Leakage through the Rubber Piston in a Prefilled Inovan Injection 0.3% Syringe

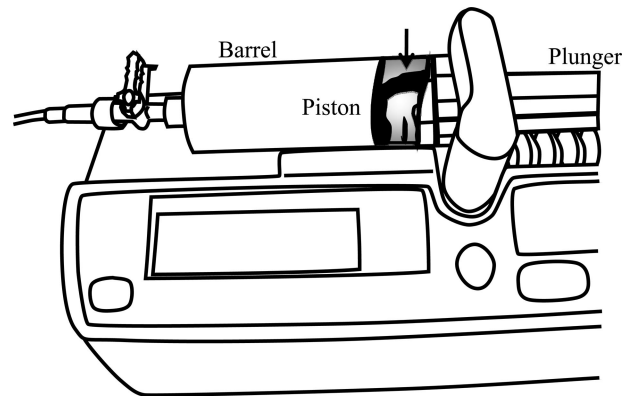
We sent the relevant syringe-infusion line assembly to the manufacturer for detailed inspection to identify the source of drug leakage and air influx, which appeared to occur at the piston that was fitted to the syringe barrel. We asked the manufacturer about the test results of the plunger/piston assembly that has been approved as medical equipment. The engineers responded as follows: They put the prefilled syringe in question to the liquid leakage test for syringe piston under compression in accordance with the International Organization for Standardization 7886-1: 1993-10-01.² There was no leakage in the rubber piston. Airtightness was maintained in the syringe, the extension tube, and the three-way stopcock. Next they examined situations that might produce drug leakage and how the leakage occurred during use of the prefilled syringe. The examination revealed the following: When the operator pushed the plunger into the rubber piston without turning it, there were some cases where the male screw thread molded at the top end of the plunger could not engage entirely the female screw thread molded on the inside wall of the rubber piston. Under this condition, the cylindrical rubber wall of the piston gradually became partially contorted as pressure was applied to the plunger after continuous infusion was started. This situation led to dislodging of the rubber piston, leaving a gap between the outside wall of the rubber piston and the inside wall of the barrel, and resulting in drug leakage as air entered through the gap (fig. 1). Consequently, the plunger/piston misassembly was proven to be the cause of erratic drug delivery, resulting in the abrupt onset of hypotension. The manufacturer had received the same incidental reports from several hospitals regarding the drug leakage from prefilled Inovan injection 0.3% syringes. They already had knowledge of the problem;

Fig. 1. Schematic representation of the situation in which a force applied to the plunger contorts the rubber piston when a prefilled syringe is used with a syringe pump. The gap (arrow) breaks the seal between the barrel of the syringe and the rubber piston, resulting in drug leakage as air entered through the gap. This plunger/piston misassembly caused an incident during drug administration.

We recommended that manufacturers provide a preassembled prefilled syringe with an integrated plunger/piston unit. However, the engineers indicated the following drawbacks of a preassembled prefilled syringe with an integrated plunger/piston: 1) Pressure may be exerted on the plunger during a fall or transportation of the syringe; 2) when the top film is peeled only partially during removal of the syringe, the finger grip may be caught by the film, resulting in tilting of the plunger with respect to the axial line of the barrel, which may cause plunger/piston misassembly; 3) the length of the whole unit becomes longer, posing problems in storage, transportation, and handling; 4) the manufacturers should apply to the Ministry of Health, Labor, and Welfare for changing a part of the original design, and approval will take more than 1 yr; and 5) the syringe pump structure may have to be modified to accommodate the newly arranged syringes. Based on these issues, Kyowa Hakko Kirin and Terumo are issuing appropriate warnings that the operator should not push the plunger into the rubber piston but should instead turn the plunger to engage the screw threads during assembly. They are also planning to modify the fundamental configuration of the plunger/piston assembly. We strongly recommend that the International Organization for Standardization, marketing companies, and manufacturers work together to supply prefilled syringes, particularly syringes with an integrated
