A Case of Accidental Hypotension Caused by Drug Leakage through the Rubber Piston in a Prefilled Inovan Injection 0.3% Syringe

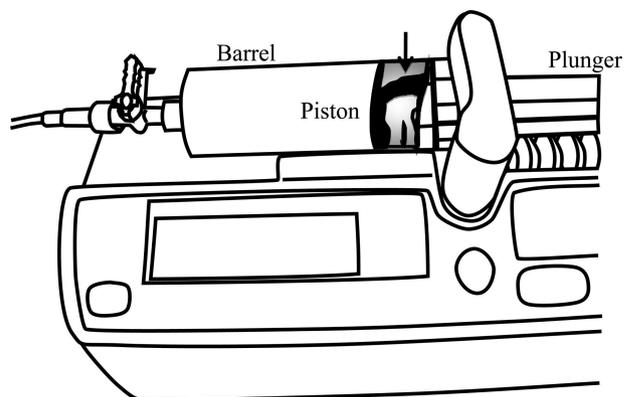
We sent the relevant syringe-infusion line assembly to the manufacturer for detailed inspection to identify the source of drug leakage and air influx, which appeared to occur at the piston that was fitted to the syringe barrel. We asked the manufacturer about the test results of the plunger/piston assembly that has been approved as medical equipment. The engineers responded as follows: They put the prefilled syringe in question to the liquid leakage test for syringe piston under compression in accordance with the International Organization for Standardization 7886-1: 1993-10-01.² There was no leakage in the rubber piston. Airtightness was maintained in the syringe, the extension tube, and the three-way stopcock. Next they examined situations that might produce drug leakage and how the leakage occurred during use of the prefilled syringe. The examination revealed the following: When the operator pushed the plunger into the rubber piston without turning it, there were some cases where the male screw thread molded at the top end of the plunger could not engage entirely the female screw thread molded on the inside wall of the rubber piston. Under this condition, the cylindrical rubber wall of the piston gradually became partially contorted as pressure was applied to the plunger after continuous infusion was started. This situation led to dislodging of the rubber piston, leaving a gap between the outside wall of the rubber piston and the inside wall of the barrel, and resulting in drug leakage as air entered through the gap (fig. 1). Consequently, the plunger/piston misassembly was proven to be the cause of erratic drug delivery, resulting in the abrupt onset of hypotension. The manufacturer had received the same incidental reports from several hospitals regarding the drug leakage from prefilled Inovan injection 0.3% syringes. They already had knowledge of the problem;

Fig. 1. Schematic representation of the situation in which a force applied to the plunger contorts the rubber piston when a prefilled syringe is used with a syringe pump. The gap (arrow) breaks the seal between the barrel of the syringe and the rubber piston, resulting in drug leakage as air entered through the gap. This plunger/piston misassembly caused an incident during drug administration.

We recommended that manufacturers provide a preassembled prefilled syringe with an integrated plunger/piston unit. However, the engineers indicated the following drawbacks of a preassembled prefilled syringe with an integrated plunger/piston: 1) Pressure may be exerted on the plunger during a fall or transportation of the syringe; 2) when the top film is peeled only partially during removal of the syringe, the finger grip may be caught by the film, resulting in tilting of the plunger with respect to the axial line of the barrel, which may cause plunger/piston misassembly; 3) the length of the whole unit becomes longer, posing problems in storage, transportation, and handling; 4) the manufacturers should apply to the Ministry of Health, Labor, and Welfare for changing a part of the original design, and approval will take more than 1 yr; and 5) the syringe pump structure may have to be modified to accommodate the newly arranged syringes. Based on these issues, Kyowa Hakko Kirin and Terumo are issuing appropriate warnings that the operator should not push the plunger into the rubber piston but should instead turn the plunger to engage the screw threads during assembly. They are also planning to modify the fundamental configuration of the plunger/piston assembly. We strongly recommend that the International Organization for Standardization, marketing companies, and manufacturers work together to supply prefilled syringes, particularly syringes with an integrated

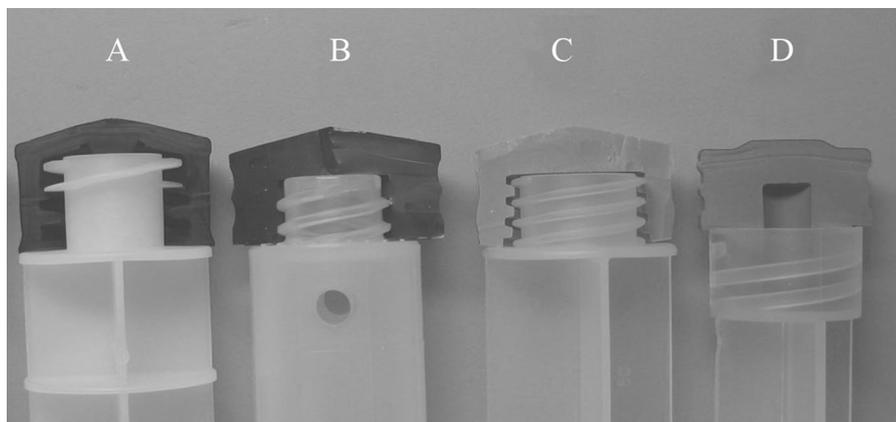
The cause of the present error in intravenous drug administration was probably attributable to the design of the piston/plunger assembly that varies between manufacturers. However, we have no precise information about their designs. We selected four different commercially available prefilled syringes and compared the configurations of their plunger/piston assemblies. In the case of the Inovan 0.3% injection syringe, only the uppermost part of the plunger head was molded with a small number of male threads, and the cylindrical wall of the rubber piston is thin. Under these conditions, the syringe is highly susceptible to contortion of the rubber piston during use and formation of a gap between the piston and the barrel. In contrast, in the cases of the Iopamiron Injection 300 syringe (iopamidol; marketed and manufactured by Bayer Healthcare, Bayer Schering Pharma, Osaka, Japan) and Nitrol injection for continuous infusion 25-mg syringe (isosorbide dinitrate; marketed by Eisai Co., Ltd., Tokyo, Japan; manufactured by Nipro Pharma Corp., Osaka, Japan), a deep portion of the plunger head is molded with male threads and the inside wall of the piston fits closely with the plunger head, leaving a narrow gap between the two.

Fig. 2. The design of the plunger/piston assemblies in four prefilled syringes. The plunger head fits into the rubber piston that is sagittally sectioned. (A) Prefilled Inovan 0.3% injection syringe (Terumo Corp., Tokyo, Japan). (B) Iopamiron Injection 300 syringe (Bayer Healthcare, Bayer Schering Pharma, Osaka, Japan). (C) Nitrol injection for continuous infusion 25-mg syringe (Nipro Pharma Corporation, Osaka, Japan). (D) 1% Diprivan injection kit (AstraZeneca United Kingdom, Alderley Park, United Kingdom).

In the case of the 1% Diprivan injection kit (propofol; manufactured by AstraZeneca United Kingdom, Alderley Park, United Kingdom, imported and marketed by AstraZeneca K.K. Pharmaceuticals, Osaka, Japan), the piston has the thickest rubber wall among the four products and contortion hardly occurs, and the male screw threads of the piston engage with the female screw threads molded on the top portion of the plunger (fig. 2). A piston with a thick rubber wall is less likely to contort during use. However, the engineers of Kyowa Hakko Kirin and Terumo indicate that the thick wall may affect internal syringe compliance, influence the force needed to operate the plunger *via* a syringe pump, and may be associated with irregular drug delivery.⁴
