# Failure to Ventilate with the Dräger Apollo® Anesthesia Workstation

Gillian Hilton, M.B.Ch.B., M.R.C.S., F.C.A.R.C.S.I., F.R.C.A.,\*  
 Vanessa Moll, M.D.,† Andrew A. Zumaran, C.B.E.T.,‡ Richard A. Jaffe, M.D., Ph.D.,§  
 John G. Brock-Utne, M.D., Ph.D.§

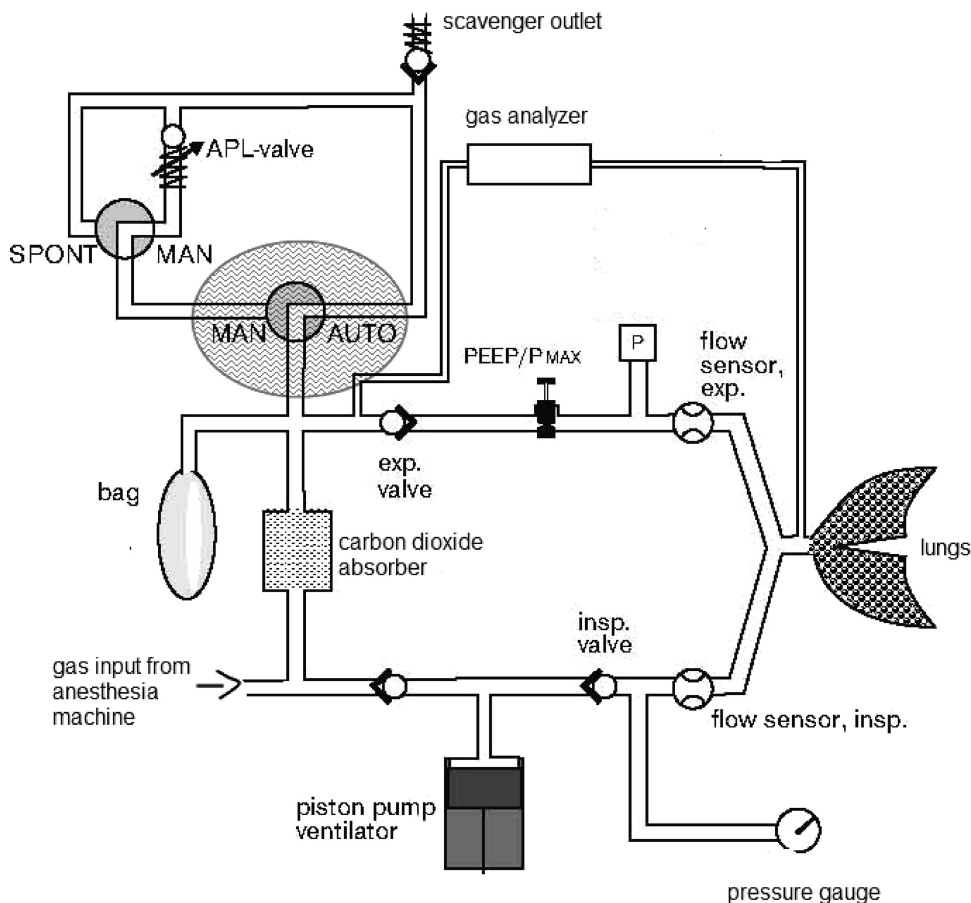
Could a fault with the electronically controlled Man-Auto valve (see fig. 1, shaded area) have caused it to stick in the bypass direction, thereby diverting inspiratory gas flow directly to the scavenging system? Although we believe that this is the most likely explanation, it could not be confirmed. The machine's error log was sent to Dräger

in Germany. Dräger stated they could not find any errors that could explain the failure-to-ventilate problem. They did not specifically mention what the error log might detect in relation to this specific type of problem. Dräger recommended replacing the inspiratory and expiratory flow sensor harness assemblies as well as the analog board and the expiratory sensor in case the problems were related to malfunction of any of the associated components.
