# Analyses of Landscape Design and Maintenance Requirements in Urban Parking Lots<sup>1</sup>

Christina A. Pfeiffer, John A. Wott, and James R. Clark<sup>2</sup>  
Center for Urban Horticulture, GF-15  
University of Washington  
Seattle, WA 98195

Four Seattle-area transit parking lots were used as case studies in assessing the relationship between design and construction practices and future landscape management. Soil compaction and inadequate irrigation appeared to have the greatest impact on plant survival and vigor. Other problems identified included inappropriate plant selection, out-dated and vague construction specifications, and conflicts between planting bed design and pedestrian traffic patterns. The combination of such factors decreased the effectiveness of the plantings and increased maintenance efforts in urban parking lots. Long-term maintenance problems may be avoided with plant selection/specification review and maintenance requirement/cost projections during the design stage.

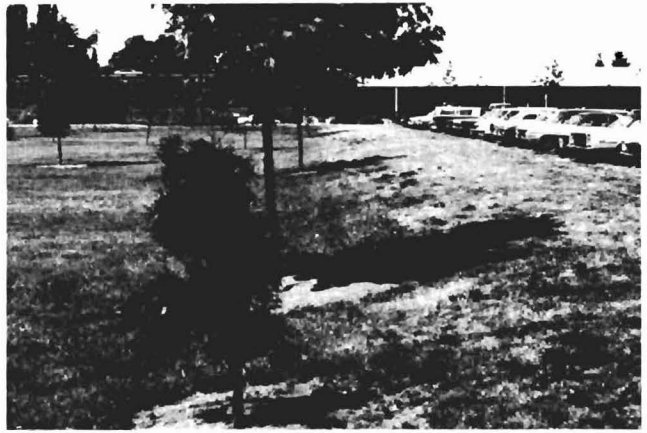
Fig. 2. Soil compaction along a parking lot perimeter. The boundary where grading ended is evident along the light-colored strip adjacent to the parked cars. Eighteen *Thuja plicata* were planted in this strip four years earlier.

Adherence to soil specifications was also variable. Where there should have been a uniform condition, layers of clay were interspersed in the parking island topsoil.

Soil conditions at construction sites have been identified as a major limitation to plant establishment (1, 14, 22, 29, 30, 31). The construction procedures for these parking lots were very destructive to soil structure. Specifications required the subgrade for pavement to be compacted to 95% standard density (37). This translates to a total pore space of 5% and where grading overlapped into planting areas, it had serious consequences for plant establishment. In a perimeter bed at one site, all 18 *Thuja plicata* Donn, Western red-cedar, had died (Fig. 2). Ideally, soils for planting beds should have a pore space of 45 to 50%, with a bulk density of no greater than 1.3 to 1.4 gr/cm (81 to 87 lbs/ft) (29, 31). Correction of soil compaction and interface problems, and the replacement of the missing plants after construction is far more costly than proper soil management during the original construction.

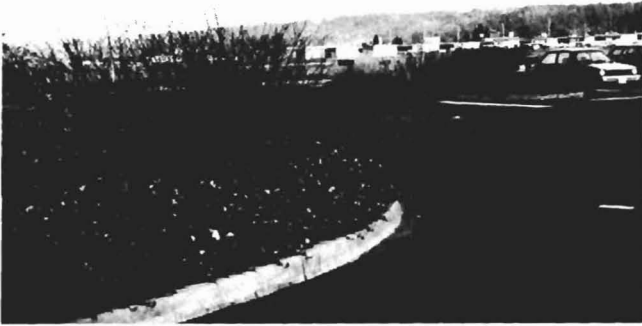
Other species were well-adapted to the site, but were not located appropriately. For example, *Hedera helix* L. 'Baltica', *Photinia x fraseri* Dress, and either *Cornus alba* 'Sibirica' Loud. or *Cornus sericea* 'Flaviramea' Rehd. were planted together in parking island planters (Fig. 3). *Hedera helix* 'Baltica' requires at least three

Fig. 3. Example of a densely planted parking island bed. The tall heights of *Photinia x fraseri* and *Cornus alba* 'Sibirica' contribute to visibility problems for pedestrians and vehicles. In addition, all the species used require frequent pruning to control their size.

edgings per year in the Pacific northwest, making it a high maintenance choice for island planters and narrow beds. Performance standards for these sites indicated that for safety and visibility, shrubs located within 9 m (30 ft) of an intersection were to be no taller than 0.76 m (2.5 ft) at maturity (27). *Photinia x fraseri* and the two *Cornus* are vigorous plants with rapid growth to over 3.2 m (10 ft) tall and required frequent pruning to maintain the low height. In addition, the *Photinia* were showing trunk dieback from frequent shearing. These shrubs would have been more appropriately used in perimeter beds where their height and spread would be more in scale with the planting space.

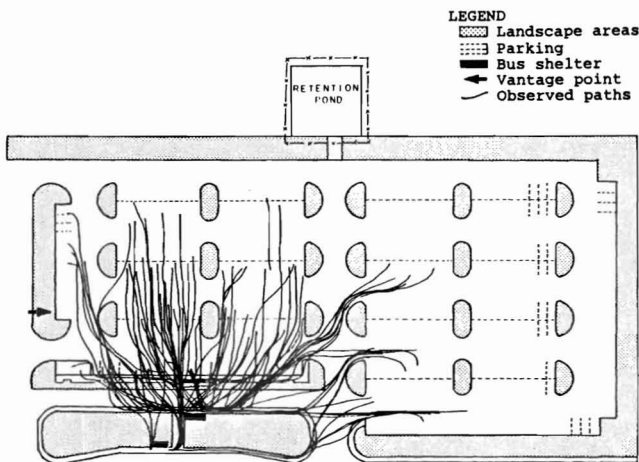
**Human factors.** Pedestrian paths were in radial patterns focusing on the bus shelter area (Fig. 4). Parking spots were filled as a function of nearest distance to the bus stop. People who arrived early tended to follow the paved walkways. However, once a bus arrived, the pace

Fig. 4. Observed pedestrian paths from the parking area to the bus shelter. These paths represent the typical activity of commuters on a normal business day. The pedestrian paths observed for all the lots in this study conformed to a radial pattern as shown for this site.

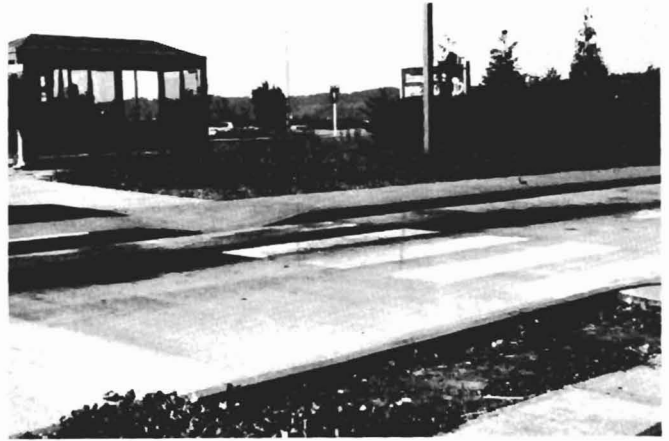
Fig. 5. Physical damage to the planting bed adjacent to the bus shelter directly corresponded to the observed traffic patterns shown in Figure 4. People using the parking lots tended to follow the provided sidewalks until a bus arrived at the stop. Then, they walked directly through any planting beds which intersected direct access to the bus.

quicken to the most direct path, often across a landscape bed. Paths and mechanical damage to planting beds near the bus shelter directly corresponded to the observed pedestrian traffic (Fig. 5). Pedestrian traffic was concentrated near the shelter areas. Designs which provided ample access and walking space around the shelters had less landscape damage and were visually more effective.

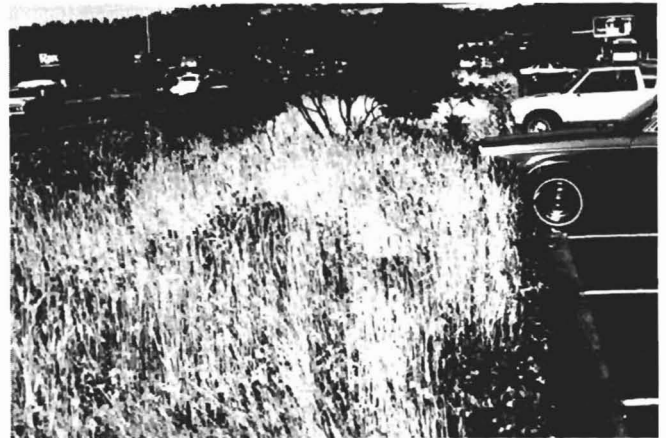
Fig. 6. Dense weed growth in a landscape bed may have contributed to the high mortality of *Rhus glabra* planted there. This problem was likely a combined result of landscape specifications which indicated that herbicides were not to be used, coupled with an inadequate maintenance program after installation.

**Maintenance.** Inadequate maintenance schedules during initial years after installation contributed to many of the plant vigor and mortality problems (Fig. 6). Litter counts indicated that litter clean up would be a required component of the maintenance schedules. Most of the litter items appeared to come from surrounding businesses and fast food chains. Other litter sources resulted
