## A simple approach to assessing copper pitting corrosion tendencies and developing control strategies

Darren A. Lytle, Daniel Williams and Colin White

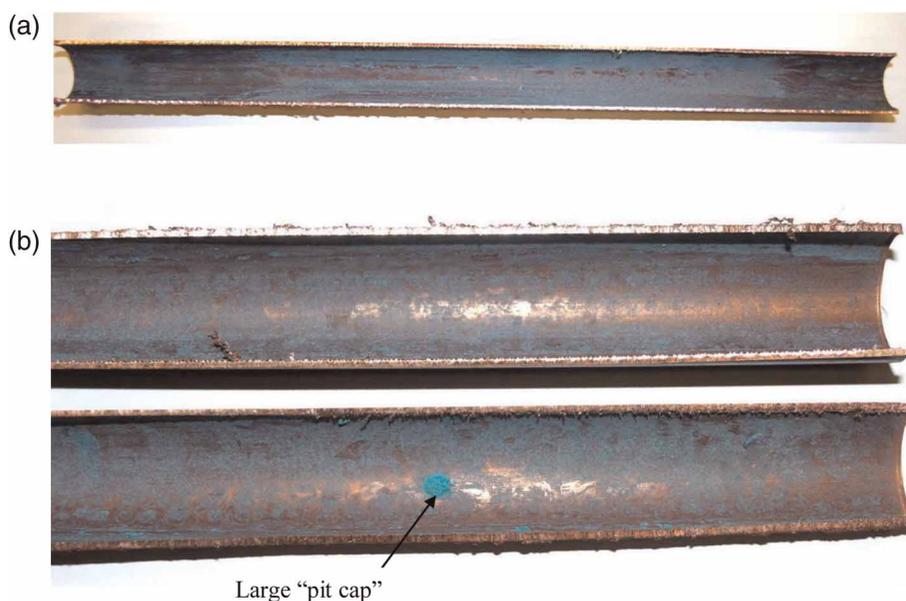
The pipe sections (101 days) were photographed then longitudinally cut while still wet with a band saw. The experience of the investigators has shown that the tendency to dislodge corrosion by-products on the interior surface of pipes during cutting is greatly reduced if pipes are cut before they are permitted to dry. The appearance of the internal surface of pipe sections showed obvious differences between the pipe exposed to phosphate (Figure 3(a)) and the

untreated pipe section (Figure 3(b)). Phosphate-exposed pipe had large patches of relatively uniformly deposited blue-green colored solids on the surface which were not as evident when the pipe was wet. The deposits were also fairly smooth and uniform in thickness. There were no obvious signs of raised, isolated mounds of corrosion by-products that resembled a pit cap or indicated localized pitting corrosion.

Figure 3 | Interior surface of copper pipes removed after 101 days: (a) pipe exposed to an ortho- and poly-phosphate blended chemical, and (b) untreated (no phosphate) pipe.

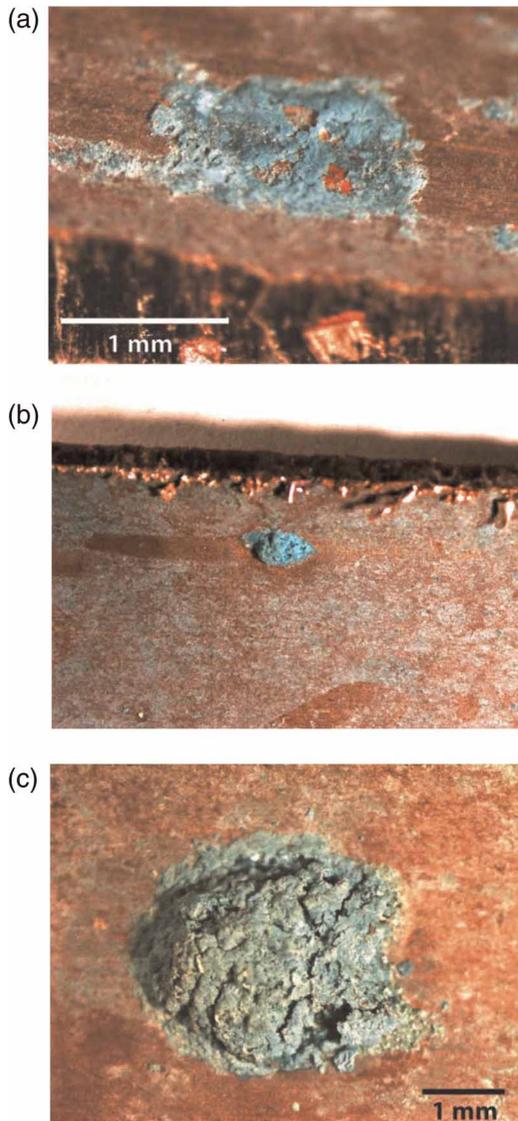
Imperfections and other areas of interest identified on the untreated pipe section surface (Figure 4) were cross-sectioned for detailed analysis. Several small mounds and dense patches of blue/green corrosion by-products were noted. Of particular interest was the large corrosion by-product mound first identified at 72 days (Figures 3(b) and 4(c)). The mound was circular and dome-shaped, had a diameter of approximately 3 mm, was blue/green in color, and appeared to be partially covered with a cream-colored solid (Figure 4(c)). A cross-sectional stereomicroscopic image through the mound clearly revealed that localized corrosion in the form of a pit was taking place below the mound (Figure 5(a)) after 101 days. All of the features of classical pitting corrosion attack: the pit cap, thin membrane, and the pit were present (Lucey 1967). The pit cap was approximately 0.75 mm thick, consisted of blue/green solids, and was dome-shaped. SEM imaging of the

**Figure 4** | Stereomicrographs of (a–c) areas of interest on the interior surface of the untreated copper pipe that may indicate a site of pitting corrosion (after 101 days).

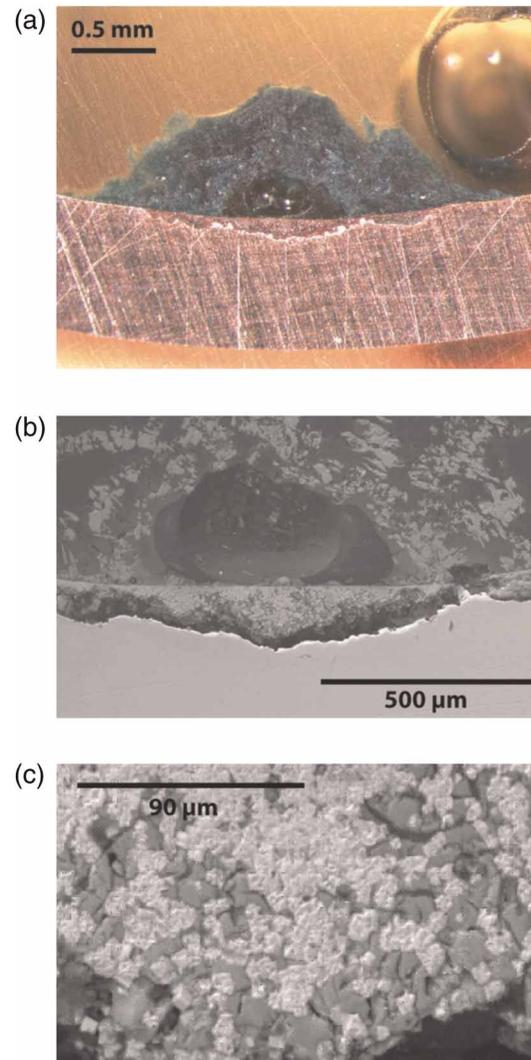
**Figure 5** | Large mound of corrosion deposits on surface of untreated copper pipe. Cross-section of copper deposits imaged by (a) stereomicroscope, (b) scanning electron microscope, and (c) scanning electron microscope, focusing on pit contents (after 101 days).

cross-section revealed finer details about the area of local corrosion attack (Figure 5(c)). A generally intact thin membrane having a thickness of approximately 0.01 mm of dark orange material (likely cuprite,  $\text{Cu}_2\text{O}$ ) separated the cap from the pit. The pit was approximately 0.150 mm deep or 20% of the copper wall thickness at the cross section (Figures 5(a) and (b)). The pit was partially full of somewhat defined dark orange crystals that appeared to be cubic in shape (Figure 5(c)), having a size of approximately  $6\ \mu\text{m}$  that were most likely cuprite crystals. There were also a

SEM imaging combined with EDS elemental mapping analysis of the cross-section of the large pit (Figure 5(b)) showed that the pit cap largely consisted of sulfur, oxygen, and copper (Figure S2, available online at <http://www.iwaponline.com/jws/061/079.pdf>). The thin membrane that separated the cap from the pit was copper rich. Chlorine (most likely a chloride compound or chloride ions) (supplemental Figure S3, available online at

<http://www.iwaponline.com/jws/061/079.pdf>) was concentrated at the base of the pit where active corrosion was occurring, indicating that it was a very important parameter with respect to pit propagation. Similar elemental mapping analysis was performed on a smaller pit on the same pipe section. The pit cap was approximately 0.8 mm wide at the base and was 0.32 mm thick, and the pit was only 50  $\mu\text{m}$  deep (Figure S3, <http://www.iwaponline.com/jws/061/079.pdf>). SEM and EDS mapping results of the pit and surrounding area showed the same features as the larger pit although the structure of the contents was not as well defined.

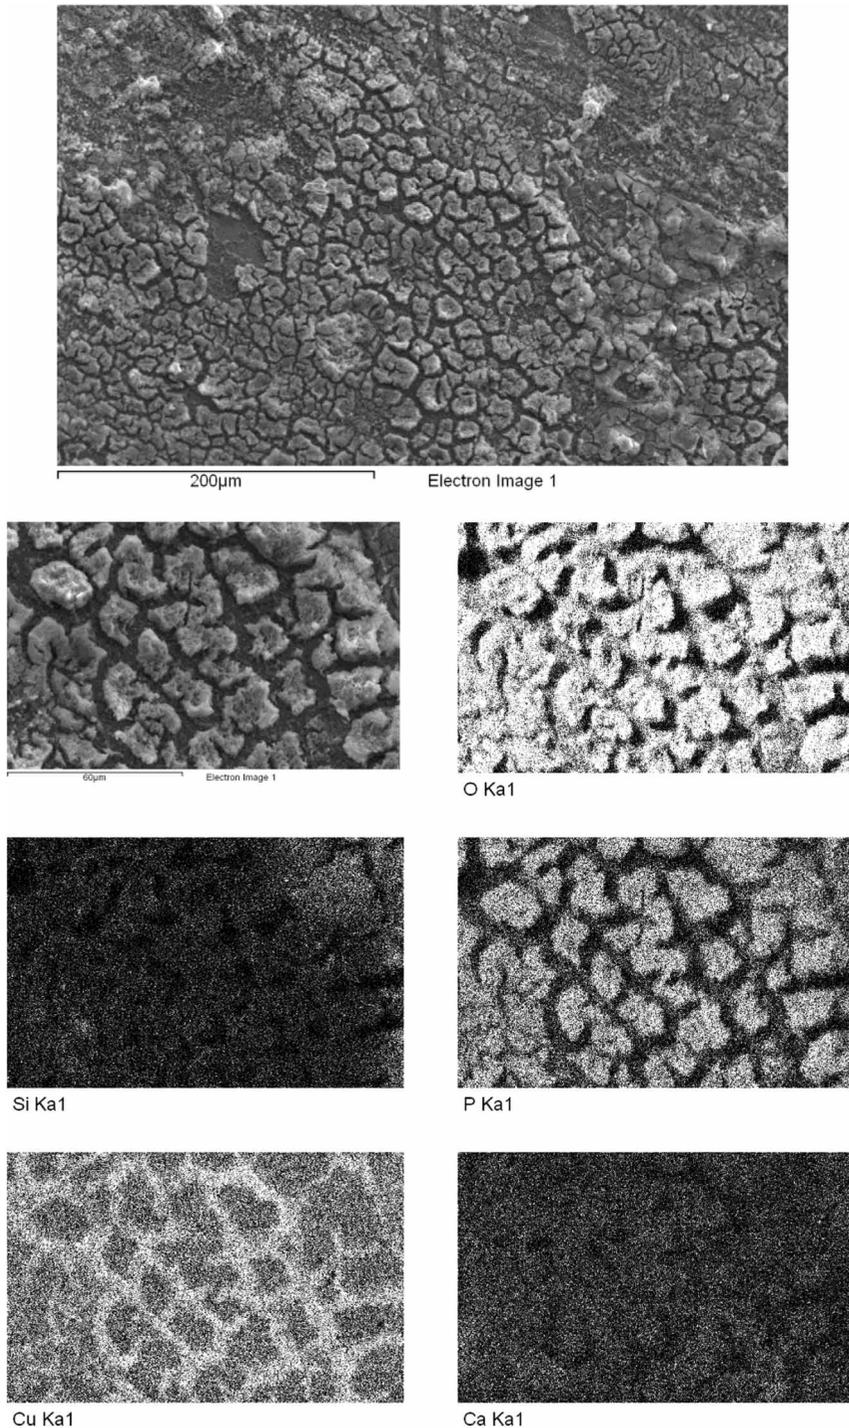
Phosphate treatment prevented obvious signs of pitting corrosion. Analysis of the pipe surface could provide insight as to the role of phosphate on copper corrosion and passivation. SEM images (Figure 6) of the surface of phosphate-treated pipe surfaces after 206 days showed that a relatively uniform layer of solids formed on the pipe surface. The solids appeared to be chipping away and showed signs of shrinkage, both of which were likely artifacts from drying. EDS analysis of the pipe surface showed that phosphorus was incorporated throughout the solid in a uniform distribution. The prevention of pitting corrosion of copper by phosphates in some conditions is in agreement with past works (Marshall & Edwards 2006; Lytle & Schock 2008; Lytle *et al.* 2010; Sarver *et al.* 2011b). Direct evidence of the benefit of a blended phosphate chemical on preventing copper pitting corrosion alone is important given the limited knowledge on the subject. Furthermore, the benefit of

**Figure 6** | Scanning electron microscopy image of pipe surface exposed to phosphate treatment and corresponding elemental mapping by EDS of oxygen, silicon, phosphorus, copper, and calcium (after 206 days).
