REAGGLOMERATION AS A CAUSE OF TREAD GROOVE CRACKING*

W. M. HESS AND K. A. BURGESS

COLUMBIAN CARBON COMPANY, PRINCETON, NEW JERSEY

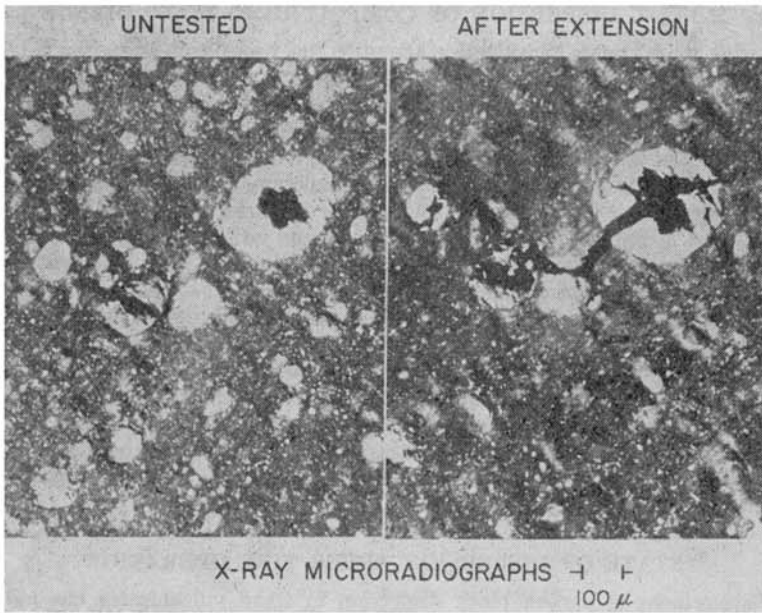
Recent experiments at the Columbian Laboratories⁷ have demonstrated that cracks in carbon-rubber vulcanizates can be initiated by dry agglomerates of black. This effect is illustrated in Figure 1, in which a stock with a poor dispersion is shown before and after repeated stretching to 50% elongation.

FIG. 1.—Crack initiation.

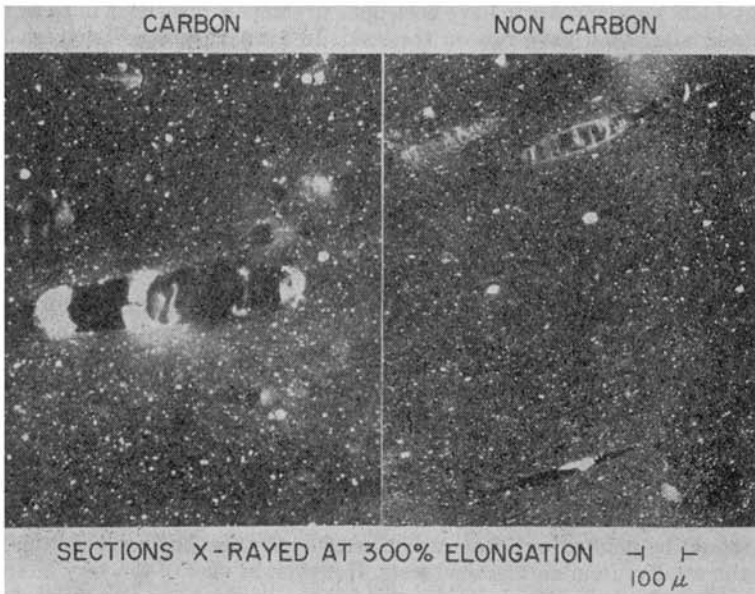
FIG. 2.—Pigment agglomeration in tire treads.

The relative weakness of dry pigment agglomerates is readily apparent through microradiographic examination of thin rubber sections under strain. This effect is illustrated in Figure 2 in which both carbon and non-carbon agglomerates have ruptured at an elongation of 300%. These as well as all other microradiographs shown in this paper are printed as negatives. Hence, all areas of relatively high x-ray absorption show up light in tone. Particularly dark regions around or within the pigment agglomerates represent actual breaks in the specimen.

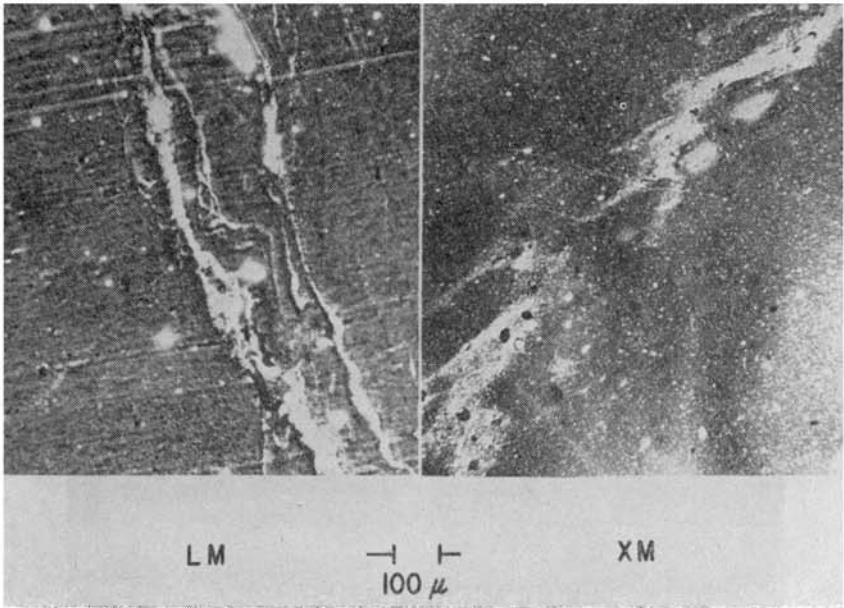
A less common type of dispersion defect is illustrated in Figure 3. Shown here is an oil extended SBR-black vulcanizate exhibiting a streaky, uneven blending of polymer and compounding ingredients. The transparency of the streaks under the light microscope indicates a black loading considerably lower than normal. However, by microradiography the streaky areas showed high x-ray absorption due to large concentrations of zinc oxide.

FIG. 3.—Uneven distribution, oil extended SBR.

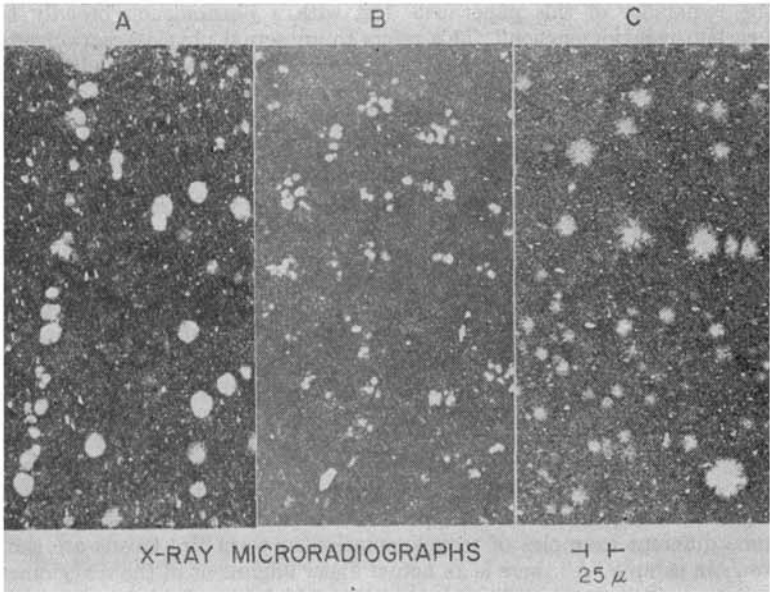
Some different examples of reagglomeration in worn tire treads are shown in Figure 7. In sample "A" there is an actual linear alignment of the reagglomeration areas. Sample "B" shows a clustering pattern which has also been observed quite frequently. It will be noted that the reagglomeration areas in both of these samples tend toward a spheroidal shape. This is the most common form in which they have been found. However, in some cases a more irregular, dendritic appearance has been observed as shown in sample "C". In many instances areas have been observed which show a very high absorption nucleus surrounded by a more diffuse layer. This type of configuration is illustrated in Figure 8. In line with the recent work of Walters and Keyte¹³ it appears that the dense nuclei in these areas are zinc oxide and that the more diffuse fringes represent the formation of zinc stearate.

FIG. 7.—Different examples of reagglomeration

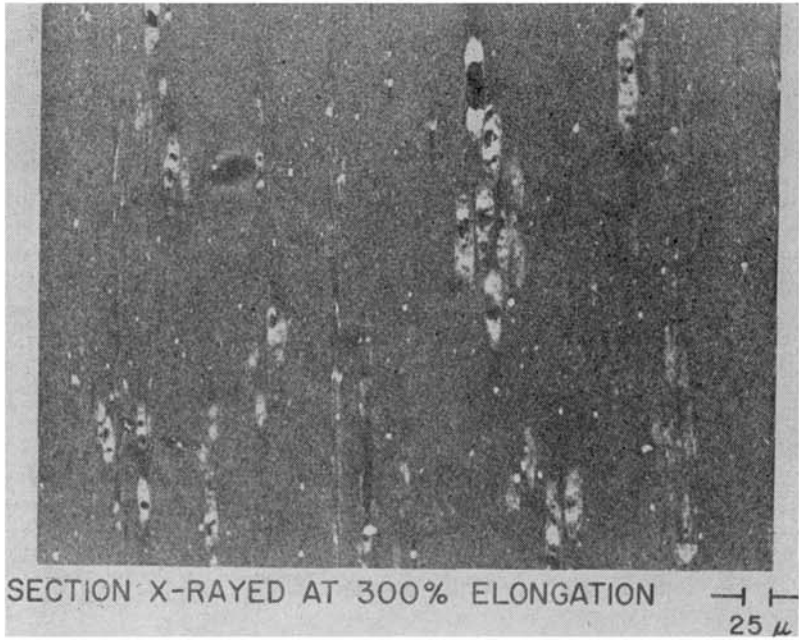
Up to this point nothing has been said regarding the possible effects of reagglomeration areas in a tread stock. Employing the technique of examining thin sections under strain by microradiography a tendency toward weakness in the reagglomeration areas has been observed. A section from an oil extended SBR tread is shown in Figure 11, at a strain of 300%. The weakness of the areas in this micro-radiograph is quite apparent. The tendency of the reagglomeration areas to break

open under strain appears to be related at least in part to their opacity to soft x-rays. The more dense areas appear to be the most brittle.

FIG. 11.—Reagglomeration areas under strain.

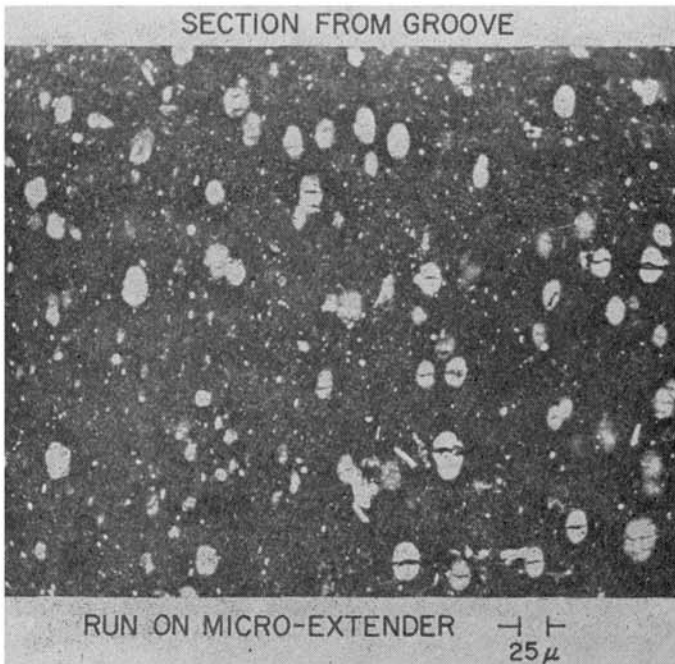
Figure 12 shows a section cut from the groove of a natural rubber truck tire which had been run for 19,000 miles. Severe reagglomeration was found throughout this tire. Repeated stretching of the section to 50% elongation produced the effect shown. Hairline cracks can be seen in most of the reagglomeration areas, again illustrating their relative weakness under stress. Longer stretching cycles on sections from this tread produced tears which tended to follow a path through many of the reagglomeration areas as shown in Figure 13. This is a particularly good illustration of the brittle nature of these regions. Some of them can be seen almost chunking out along the edges of the tear.

FIG. 12.—Badly cracked NR truck tire.

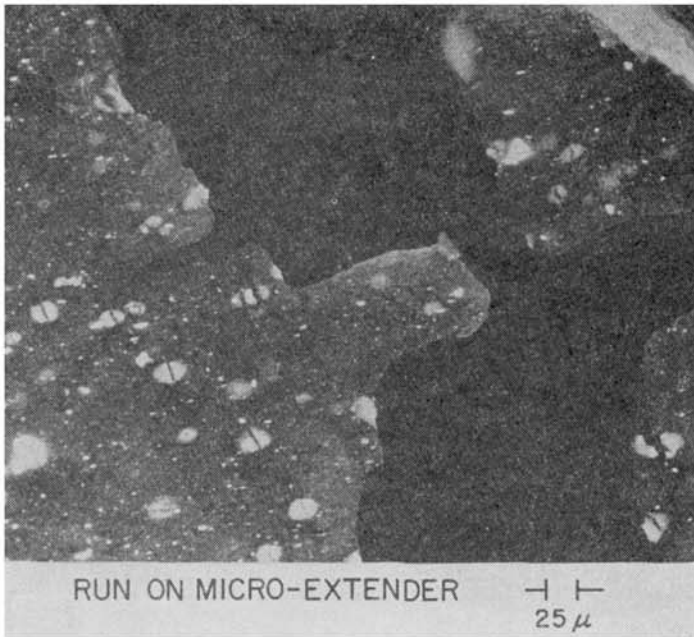
FIG. 13.—Badly cracked NR truck tire, showing tear in section from groove.

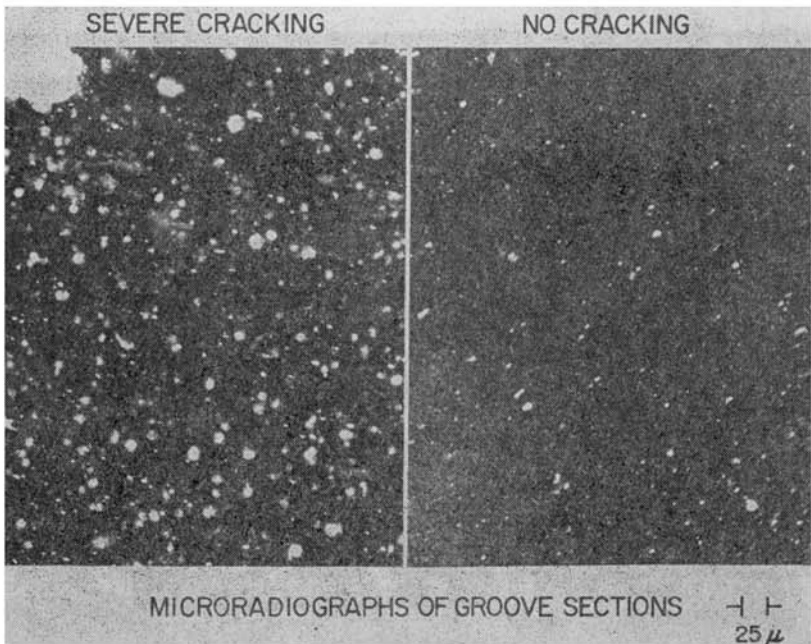
Treads exhibiting a high degree of non-carbon reagglomeration have shown poorer resistance to crack development than those in which reagglomeration had not taken place or was present to a lesser degree. Examples of good and poor crack resistance in natural rubber treads are shown in Figure 15. The badly cracked tread is the same one listed as sample "A" in Table 2. Microradiographs of sections from the grooves of these two tires are illustrated in Figure 16. Both tires had been run for approximately 20,000 miles.

FIG. 16.—Comparison of worn threads.

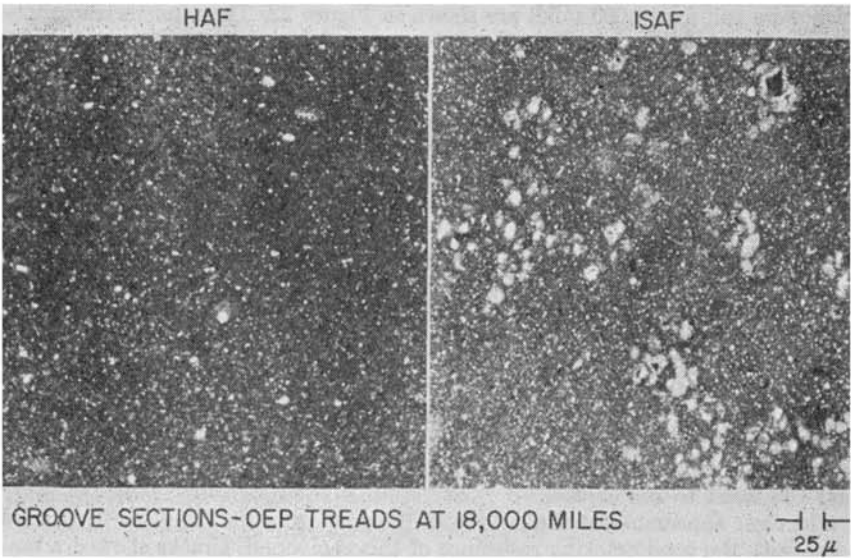
The type of carbon black also appears to play a part in the tendency for the other ingredients to reagglomerate during tire operation. The effect of carbon particle size in oil extended SBR is shown in Figure 21. Both of the laboratory mixed stocks shown here were run for a total of about 18,000 miles. The ISAF sample cracked; the HAF did not. These results appear to be in line with the lower running temperature of the coarser HAF type black.

FIG. 21.—Effect of carbon fineness.

Reagglomeration in oil extended SBR may be minimized by the use of larger particle size or higher structure carbon blacks and through improved dispersion of non-carbon ingredients.

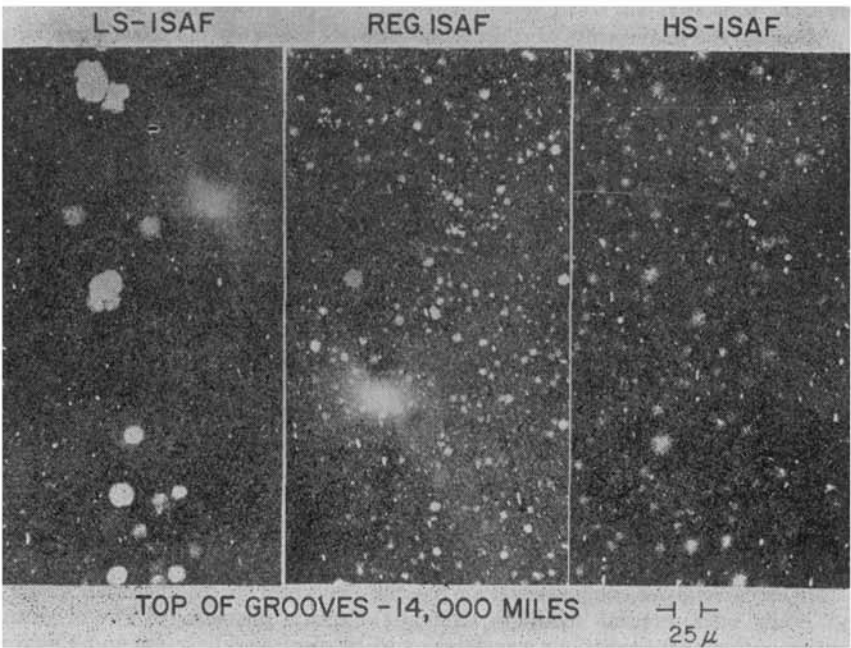
FIG. 22.—Comparison of ISAF carbons in OEP.

which were run for 14,000 miles are shown in Figure 22. These microradiographs show the top of the grooves. Very large, dense reagglomeration areas were observed at the top of the grooves in most of the LS-ISAF treads. Areas of this type, although fewer in number than those in the other two stocks, would be expected to be more damaging, particularly with respect to crack initiation. Another microradiograph of this same LS-ISAF tire is shown in Figure 23. Here the section was cut laterally near the top of a groove and shows a profile of the edges of an actual crack. Unfortunately, due to dirt picked up during tire operation detail along the crack edges is not too good.

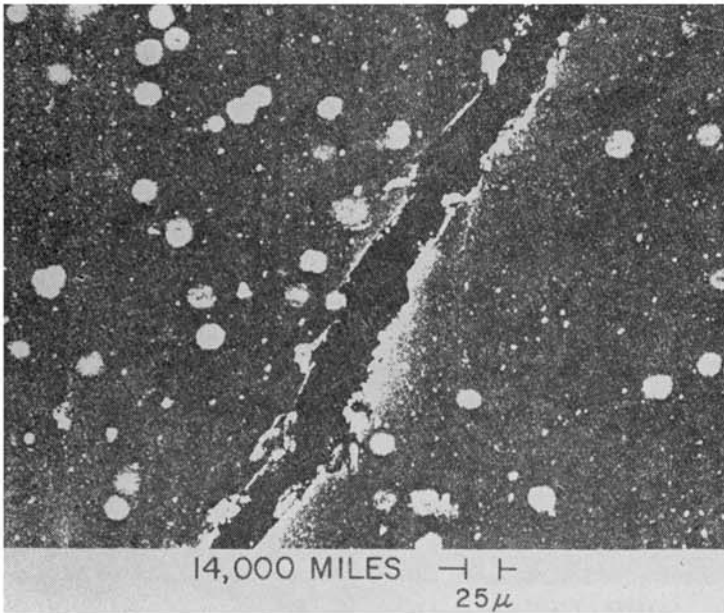
FIG. 23.—Actual crack in groove.

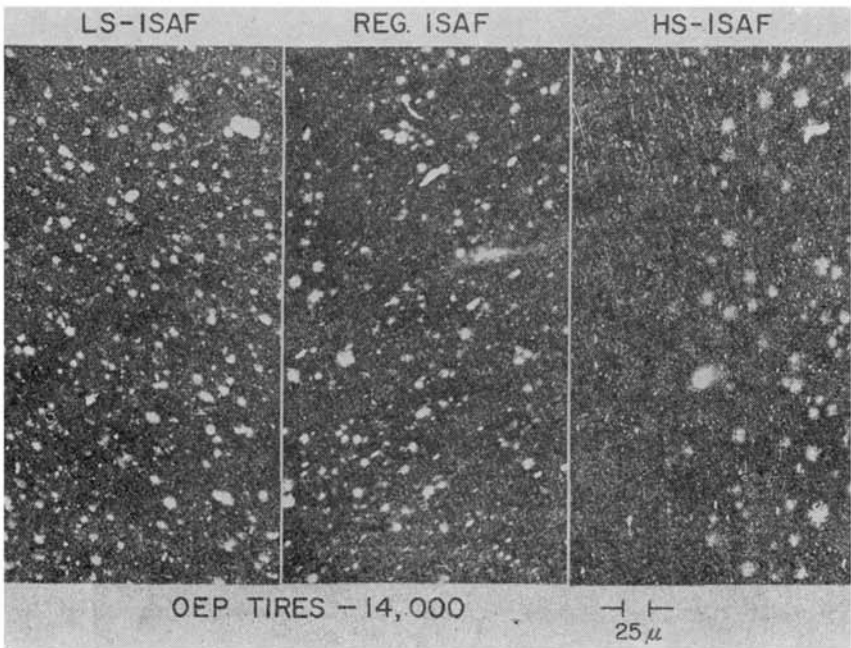
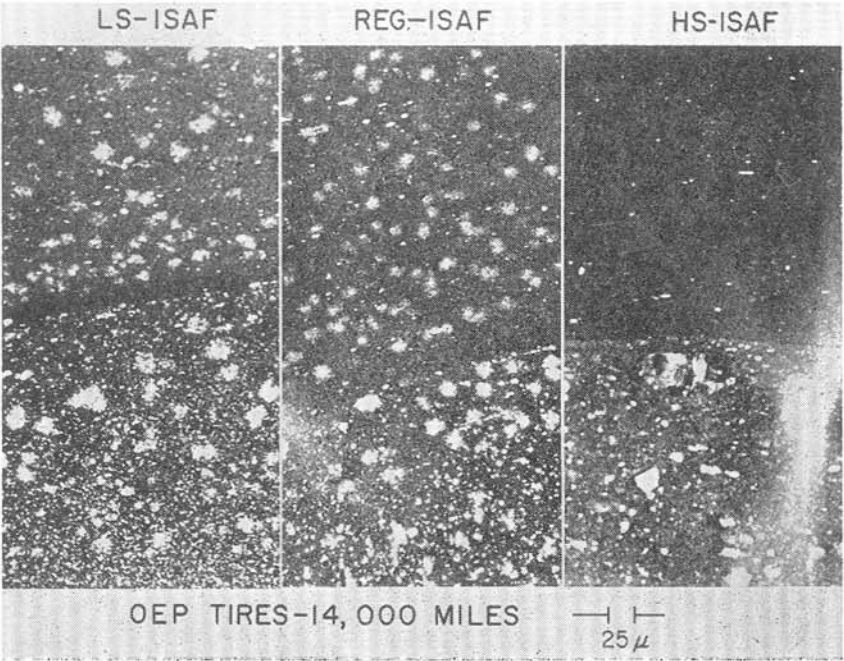
Figures 24 and 25 show at lower depths the same grooves which were illustrated in Figure 22. In these lower regions the reagglomeration areas were also more dense in appearance for the LS-ISAF. Significantly fewer areas were apparent at lower groove depths for the HS-ISAF. This is particularly noticeable in Figure 25 in which the tread-undertread interfaces are shown. At the bottom of the grooves the high structure black showed a tendency to be devoid of reagglomeration while the other two carbons showed areas down to and into the undertread. Of interest is the fact that there was always a fine strip above the undertread in which no reagglomeration occurred. This clear area may represent the cement used to bond the tread to the carcass.

The clear appearance at the bottom of the grooves in the HS-ISAF tires were in line with the good cracking resistance of this compound. Cracks showed a tendency to be deeper when reagglomeration occurred throughout the whole groove from top to bottom. Shown in Figure 26 is a groove section cut from an LS-ISAF tire which failed as a result of a bad crack and subsequent tread separation. The area shown in this microradiograph was at the base of the groove near the separation. Note the linear alignment of reagglomeration areas just above the undertread. The clear zone between tread and undertread is again also apparent.

FIG. 24.—Middle depth of tread grooves.

Fig. 25.—Bottom of tread grooves.

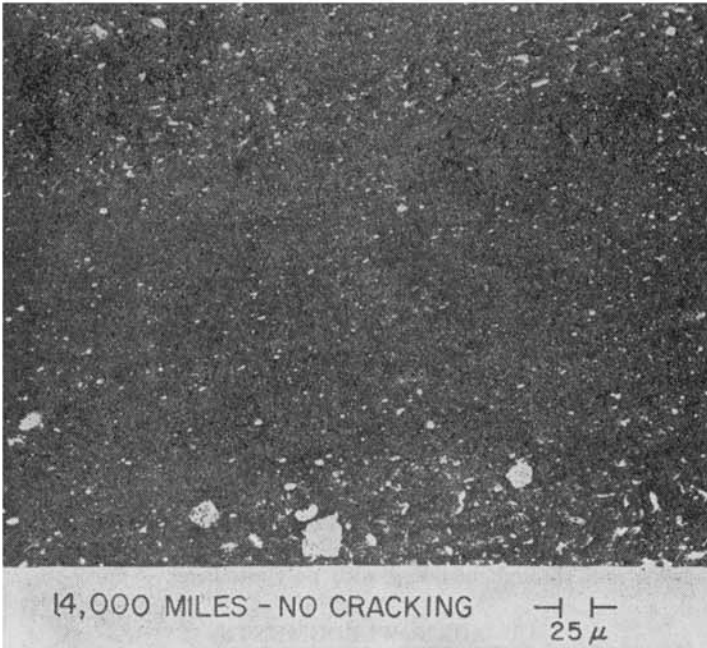
Although the final results of this program clearly indicated the poorest cracking resistance for the LS-ISAF carbon, one of the treads of this black failed to crack at all. Since all the tires were run under essentially the same conditions no explanation can be given for this result. However, the appearance of the grooves in this tire coincided with the cracking results in that they were devoid of reagglomeration as shown in Figure 27.

FIG. 27.—LS-ISAF in OEP—groove.

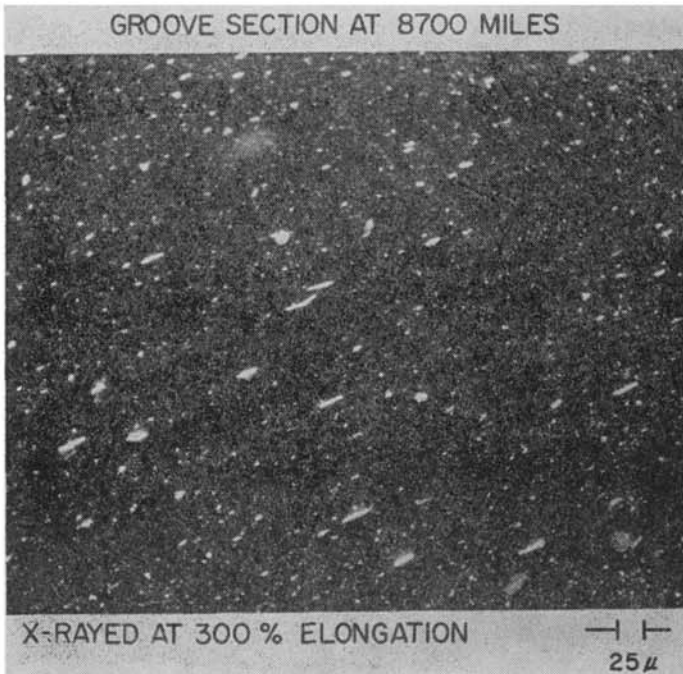
The blending of oil extended SBR with polybutadiene appears to reduce the cracking tendency associated with the use of ISAF tread carbons. Microscopical examination of 50-50 oil extended SBR/BR treads has indicated little or no reagglomeration. This is attributed to the better wetting characteristics of the polybutadiene polymer and possibly also to somewhat lower heat buildup. A section from the groove of a 50-50 OEP/BR tire run for 8700 miles is shown in Figure 28. There was no reagglomeration or cracking in this tire. The specimen was x-rayed at 300% elongation to illustrate the excellent wetting of all compounding ingredients.

FIG. 28.—ISAF in OEP-BR blend.

Conversely, reagglomeration can be reduced or eliminated by good dispersion of all compound ingredients, the use of higher structure or larger particle size carbon blacks, and through blending with polybutadiene.
