The effect of acid cleaning on a fine pore ceramic diffuser aeration system

C.-H. Hung and W.C. Boyle

Department of Civil and Environmental Engineering, University of Wisconsin-Madison, 1415 Engineering Drive, Madison, WI 53706, U.S.A.

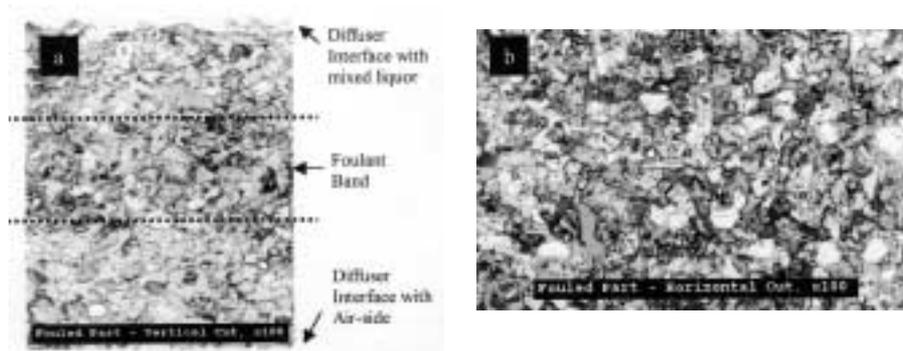
Thin sections of diffuser G2-R2-15 (DWP equaled 319 cm of water measured at 1.68 standard m³/hr of air (1 scfm)) were prepared for light microscopy observation. Figure 1 shows a complete diffuser section (vertical cut and a horizontal cut made 7 mm below the diffuser surface). The vertical-cut image shows a well preserved diffuser profile. A band of impurities (internal foulants) occupies the diffuser internal space between 5 mm to 10 mm below the top surface while the rest of the diffuser (above and below the band) is free of significant foulant. The clean area just below the diffuser surface has been the result of regular acid washing at the top of diffuser surface by the MMSD operators. The horizontal cut through the foulant band (Figure 1) clearly shows the void space decreased by internal foulants. Higher magnification thin section images reveal that ceramic diffusers are composed of two basic parts: AlO₂ granules and a clay matrix which holds the AlO₂ granules together. Impurities closely attach to the clay matrix instead of the AlO₂ granules. This suggests the possibility that internal foulant formation is the result of impurities from wastewater that first attach to the clay matrix and then grow toward the open voids.

Figure 1 Light microscopy diffuser thin section – a) vertical cut (left) and b) horizontal cut through fouled section

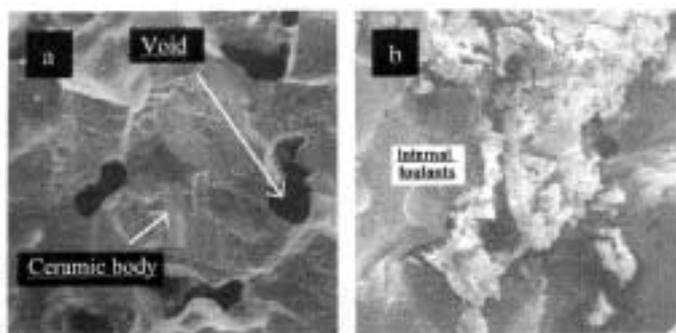
Figure 2 is a photomicrograph taken from a selected piece of diffuser G3-R4-1 (heavily fouled, its DWP equaled 733.5 centimetres of water measured at 0.67 standard m^3/hr of air (0.4 scfm)). Figure 2a was taken from the lower part of the diffuser, a section which is equally free of significant foulant. The lower part of diffuser has less chance to come into contact with wastewater, and, thus, has less chance for developing internal foulant. Figure 1a shows many open spaces in the ceramic diffuser. No impurities were found in diffuser internal structure. Figure 2b was taken from the upper portion (0.5 cm below the top surface) from the same diffuser G3-R4-1. This portion of the diffuser was in direct contact with the wastewater. Suspended solids from the wastewater, biofilms on the diffuser surface and within the pores, and wastewater permeating the diffuser all may contribute to the formation of internal foulant. In Figure 2b, the internal fouling marked by bright and flower-like materials, occupies the spaces between the dark-colored ceramic bodies. These internal foulants reduce the pore volume in the upper portion of diffuser profile creating a resistance to flow and resulting in increased head loss through the diffuser at a given airflow rate. After an extended operating period, some diffusers (those with higher foulant accumulations) will have lower airflow than others. This will lead to poor airflow distribution along the header and lower oxygen transfer rates. Furthermore, the lower airflows in a given diffuser will exacerbate the fouling process.

Figure 2 Diffuser profiles, non-fouled part of the diffuser (2a, left) and fouled part (1b, right)

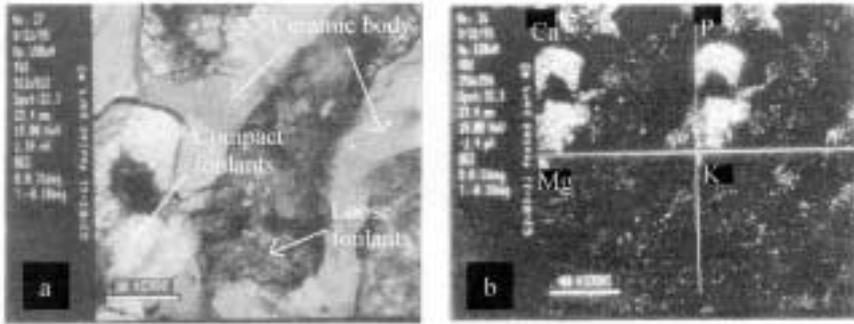
Figure 3a was taken from a fouled portion of diffuser G2-R3-11 (slightly fouled, its DWP equaled 42.7 centimetres of water measured at 1.68 standard m^3/hr of air (1 scfm)). The void spaces between the rigid ceramic bodies were occupied by foulants. The impurities appeared to accumulate along the internal diffuser void surface and gradually filled the active void. Foulant then moved towards the remaining voids in the channels. Four elements, including calcium (Ca), phosphorus (P), potassium (K), and magnesium (Mg) were measured for this diffuser section and are shown in Figure 3b which is an EDXA dot map. The locations of calcium and phosphorus are coincident and the Ca-P distribution matches the visual image of internal foulants (Figure 3a). This suggests that calcium and phosphorus may be the major components of the internal foulant in this diffuser. The molecular configuration of the Ca-P compound, however, is still unknown. Potassium and magnesium were spread throughout the diffuser profile. There were also no observed concentrations of elements including iron, sodium, and sulfur which are not shown in Figure 3b. Two types of internal foulants were observed as shown in Figure 3. The left-side portion exhibited brighter colors and a more compacted structure than the foulant at the right-side. Also from its dot map, the compacted structure portion exhibited a higher concentration of Ca-P compounds than the portion with the loose structure. EDXA revealed that the loose structure was mainly composed of unidentified material which showed no metal element response. Two hypotheses may be suggested for these formations: (1) The loose internal fouling

Figure 3 Internal foulant image from diffuser G2-R3-1, a) profile image (left) and b) EDXA dot map (right)

portion may be in the early stage of foulant formation. Its structure will become more compacted after a given operating period. (2) The compacted structure is composed mainly of Ca-P compounds and can be referred to as inorganic fouling. The loose portion, on the other hand, may be composed of organic material with some Ca-P compounds trapped within its structure.
