Assessment of galvanized steel pipes for water service in buildings by direct diagnosis method

Key words | corrosion rate, direct diagnosis, galvanized steel pipe, visual assessment

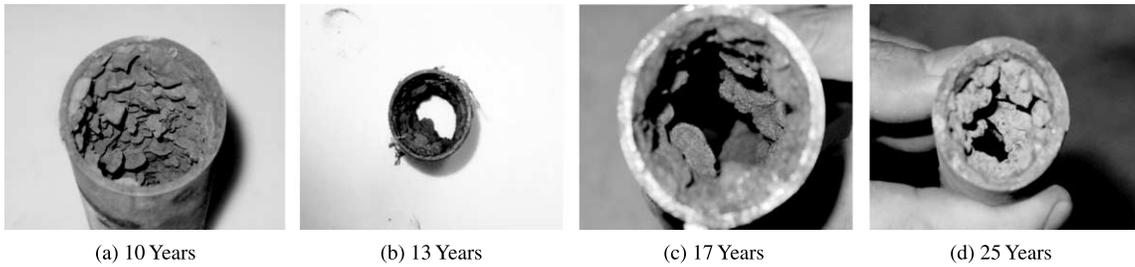
On the internal surfaces of the sampled pipes, the tubercle growth and the hydraulic cross sectional area reduction were observed. Although laying conditions were identical (e.g. sampled from same apartment), hydraulic cross sectional areas are different from each other according to age of pipe (Figure 1).

Figure 1 | Representative examples of water service pipes (galvanized steel pipes) according to age of pipe.

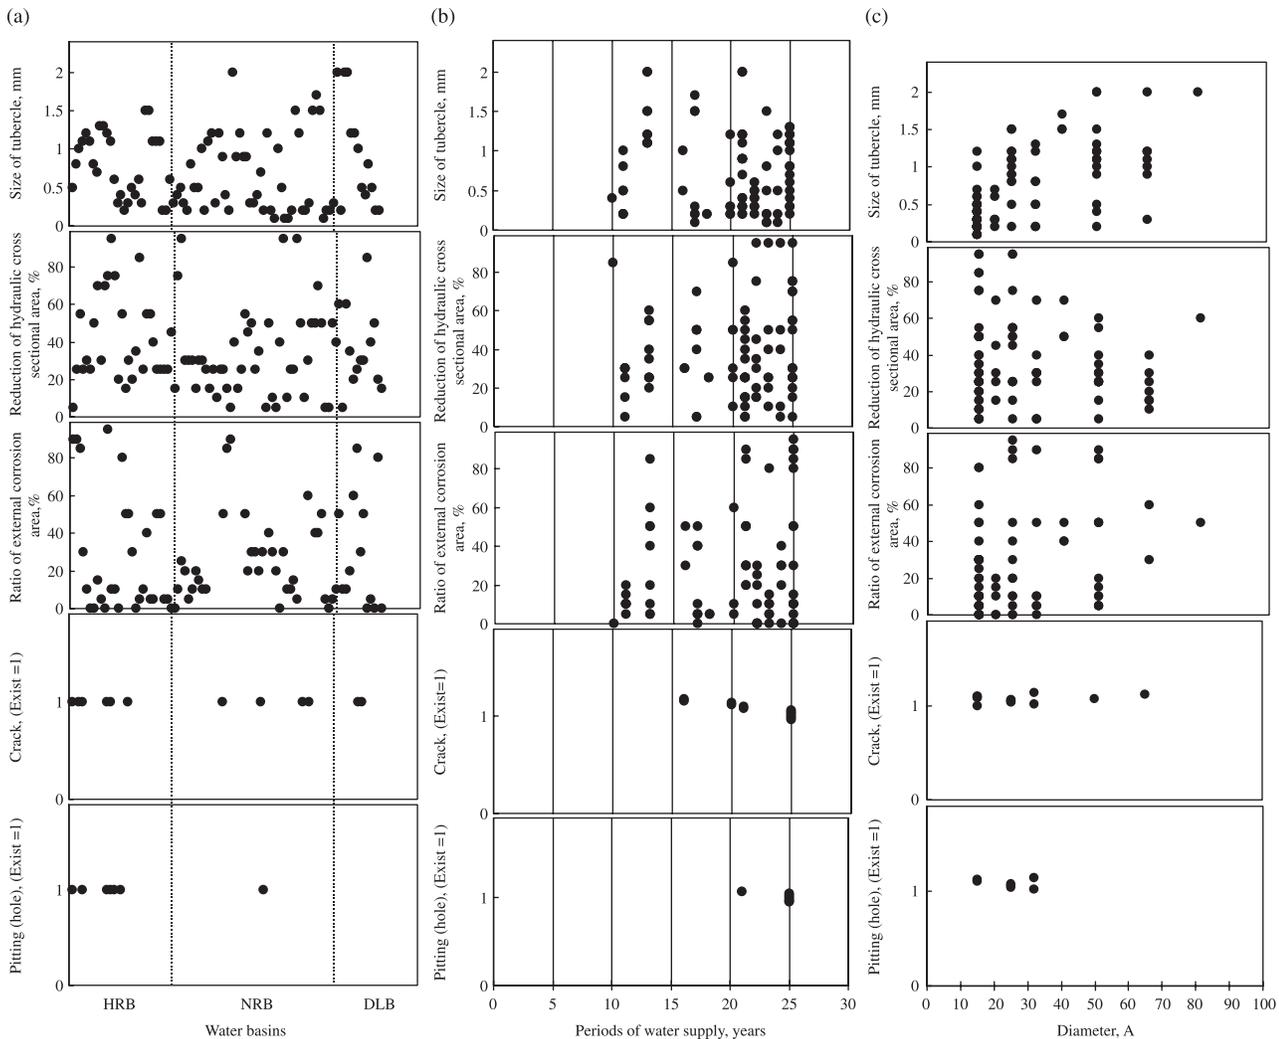
Figure 2 shows the results of visual assessments according to major water basins, age of pipe, and diameter. As shown in Figure 2(a), the size of tubercle in pipes sampled from three water basins was 0.1 ~ 20 mm, the reduction rate of hydraulic cross sectional area was 5 ~ 100%, and ratio of the external corrosion area on the sampled service pipes was 0 ~ 100%. There was little difference among main water basins. The number of horizontally cracked pipes was 6 on Han River Basin(HRB), 4 on Nakdong River Basin(NRB) and 2 on Dongbuk Lake Basin(DLB). Also, the number of sampled pipes that had pit corrosion (holes) were 6 on HRB, 1 on NRB and 0 on DLB, respectively.

As shown in Figure 2(b), the size of tubercle, the decline of hydraulic cross-sectional areas and the ratio of external corrosion areas on the pipes depending on the age of pipe do not show distinct trends. Because of the limited data set, it was very hard to conclude a concrete relationship between the age of pipe and other parameters. The number of horizontally cracked pipes was 4 in the case of pipes 16 ~ 20 years; 8 in the case of those over 21 years. Accordingly the relationship between the number of cracked pipes and the age of pipe is somehow proportional. From the view of pitting corrosion (hole), the number is 1 in the case of pipes 16 ~ 20 years, and 6 in the case of those

over 21 years. The number of pitting corrosion on the pipes (hole) tends to be proportional to the age of pipe.

As shown in Figure 2(c), as the diameter of the pipe increases, the size of tubercle increases. On the other hand,

as the diameter of the pipe decreases, the decline of hydraulic cross-sectional area becomes more serious, and the occurrence of cracked and pitting corrosion on the pipes becomes more frequent. Therefore it can be

Figure 2 | Visual assessment results on sampled GSPs (HRB: Han River Basin, NRB: Nakdong River Basin, DLB: Dongbuk Lake Basin, Diameter, A: (mm)).

concluded from visual assessment that the smaller the diameter of pipe, the more serious the deterioration.

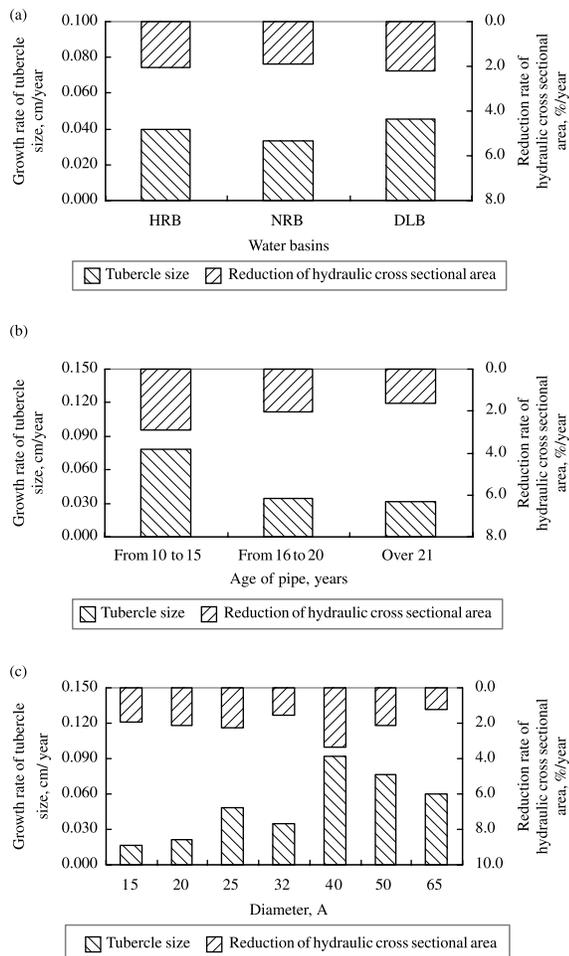
Taking into account the results of visual assessments, Figure 3 shows the growth rate of tubercle and the decline rate of hydraulic cross-sectional area based on water basins, the age of pipe and the diameter of pipe. As shown in Figure 3(a), the diameter of pipe affects seriously the decline rate of hydraulic cross-sectional area. However, there is little difference among water basins. Also, from Figure 3(b), it is observed that the growth rate of tubercle and the decline rate of hydraulic cross-sectional area in the case of pipes 10 ~ 15 years are higher than those of over 16 years. These results indicate that the growth rate of tubercle and the decline rate of hydraulic cross-sectional area are dependant on the age of pipe. Although both rates increase sharply in

the early period from starting water supply, as the age of a pipe increases, those rates decrease gradually.

Investigating the growth rate of tubercle and the decline rate of hydraulic cross-sectional area as can be seen in Figure 3(c), the growth rates of tubercle in the pipes of over 40 mm diameter are relatively higher than those in the pipes of less than 40 mm diameter, but the decline rates of hydraulic cross-sectional capacity in each pipe are alike, or even the decline rate in the pipes of over 40 mm diameter are lower. The results are due to a larger cross-section of pipe providing more sufficient space for the growth of tubercle. However, comparison between the cross-section area of pipe and the area occupied by tubercle, the latter is too small to affect total cross-section area.

Figure 3 | Growth rate of tubercle size and decline rate of hydraulic cross-sectional capacity.

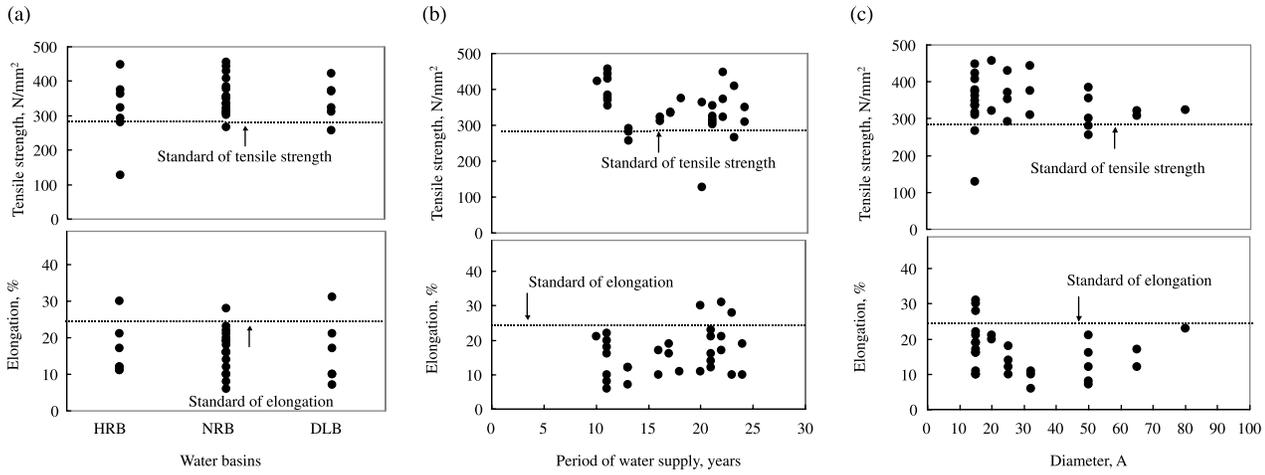
Figure 4 shows the analysis results of physical properties including tensile strength and elongation according to water basins, the age of pipe and the diameter of pipe. Actually, it is difficult to acquire sufficient information about the physical properties at the incipient stage. From the measurement of the tensile strength and elongation of sampled pipes, about 13.4% among total pipes meet the Korea Standard tensile strength requirements for water supply pipe (less than 294 N/mm²). Since over 90% cannot meet the Korea Standard elongation requirement, a lowering of strength accelerated by corrosion appears mostly.

Figure 4 | Results of physical properties analysis.

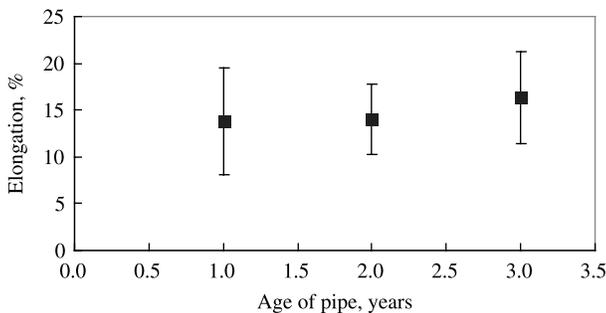
Accordingly, it can be thought that elongation is more affected by aging than any other physical properties. Referring to the average elongation values according to the age of pipe as seen in Figure 5, the average elongation value of a pipe whose

age is over 10 years is about 14 ~ 16%, and 36 ~ 40% less than the standard requirement.

Figure 5 | Average elongation value according to the age of pipe.

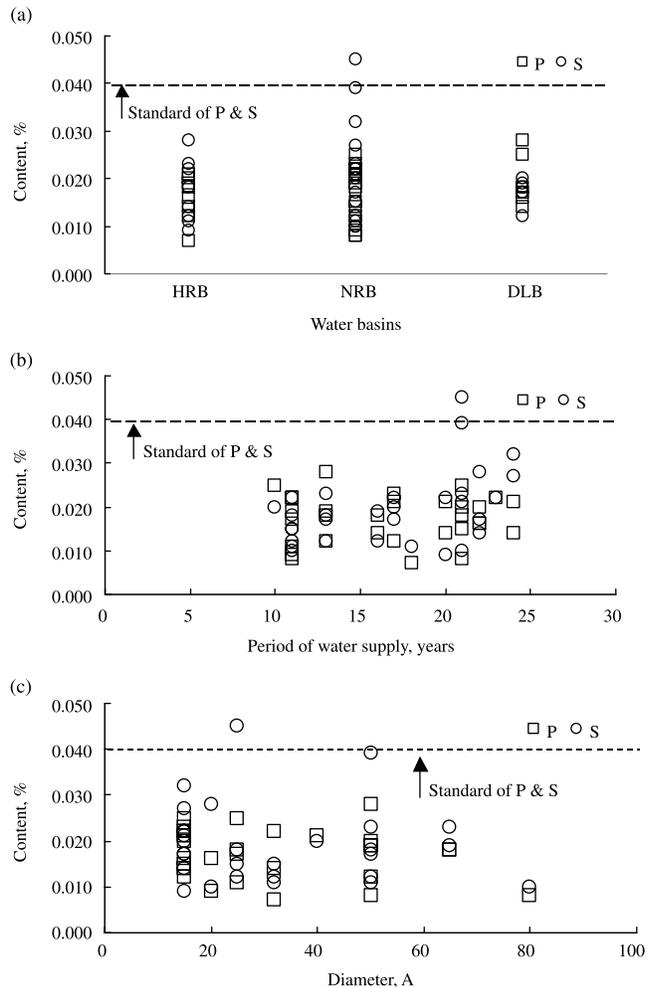
Figure 6 shows the analysis results of chemical compositions according to water basins, the age of pipe and the diameter. In the case of galvanized steel pipes there are only two standard items for chemical compositions regulated by Korean government, those are phosphorous (P) and sulfur (S). Both contained quantities should be less than 0.040%. From the analysis results in Figure 6, P and S quantities in most of sampled GSPs are measured to be less than the regulated value, 0.040%. Therefore it can be concluded that there is little effect of chemical composition on the deterioration of a water supply pipe.

Figure 6 | Results of chemical composition analysis.

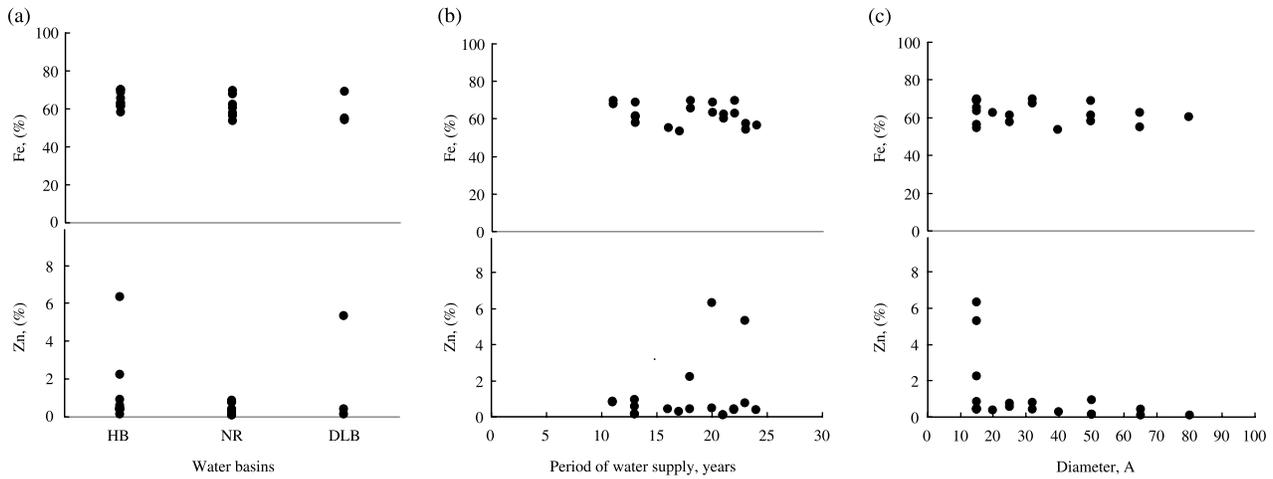
Figure 7 | Results of scale composition analysis.

sampled according to water basins, the age of pipe and the diameter. Even though other inorganic materials are eluted from the scale in addition to Fe and Zn, the amount of those is too small to consider. As shown in Figure 7, the contained quantity of Fe, which is the largest among the ingredients, is 54.3 ~ 69.8%. However, the contained quantities of Fe and Zn were not different according to water basins, the age of pipe and the diameter. In the case of Zn, the contained amount is 0.09 ~ 6.34%. In the aged and small sized pipe whose diameter is less than 15 mm, the contained amount of Zn tends to be higher than in other cases. In the case of pipes in which Zn amounts are high, the decline rate of

hydraulic cross-sectional capacity is generally lower than in the case in which Zn amount is low. Also, the occurrence frequency of crack and pitting in the former case is lower than in the latter case. These results indicate that the state of galvanization on the internal wall is significantly related to the degree of aging the pipe.

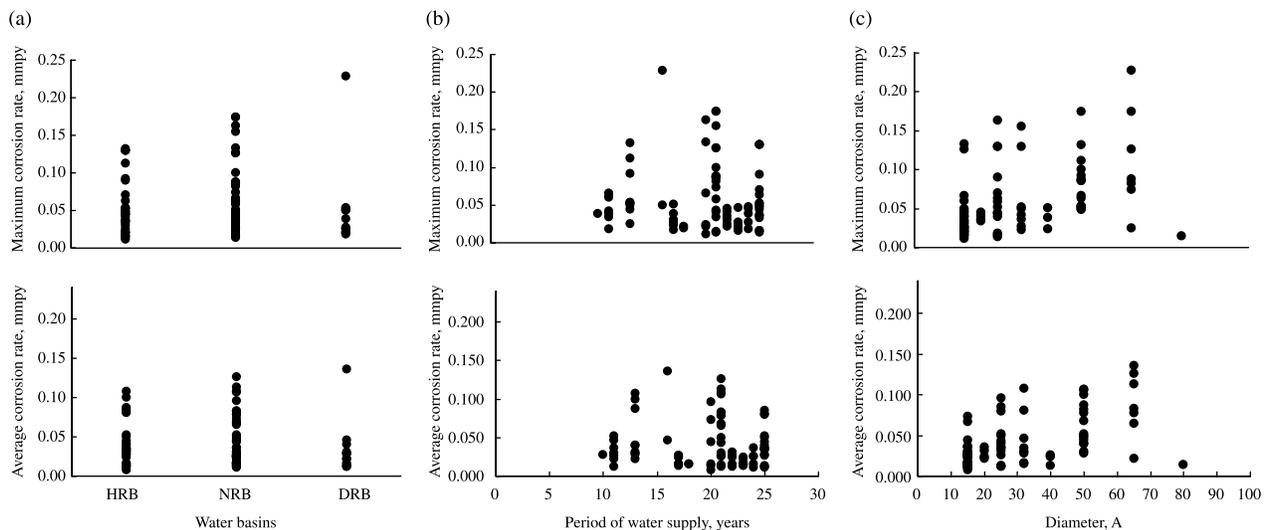
Figure 8 depicts the thickness reduction percentages derived from minimum and average remaining thickness

Figure 8 | Results of maximum and average erosion percent on sampled GSPs.

of the sampled pipes. From the measurements of minimum and average remaining thickness, although a little external corrosion could be seen with the unaided eye, the reduction of thickness due to that could be negligible. The reduction of thickness by external corrosion was not taken into account. As seen in Figure 8 the distributions of average and maximum thickness reduction rates depending on water basins and diameters are presented to be wide, and both the reduction rates become somewhat higher as the age of pipe is longer.

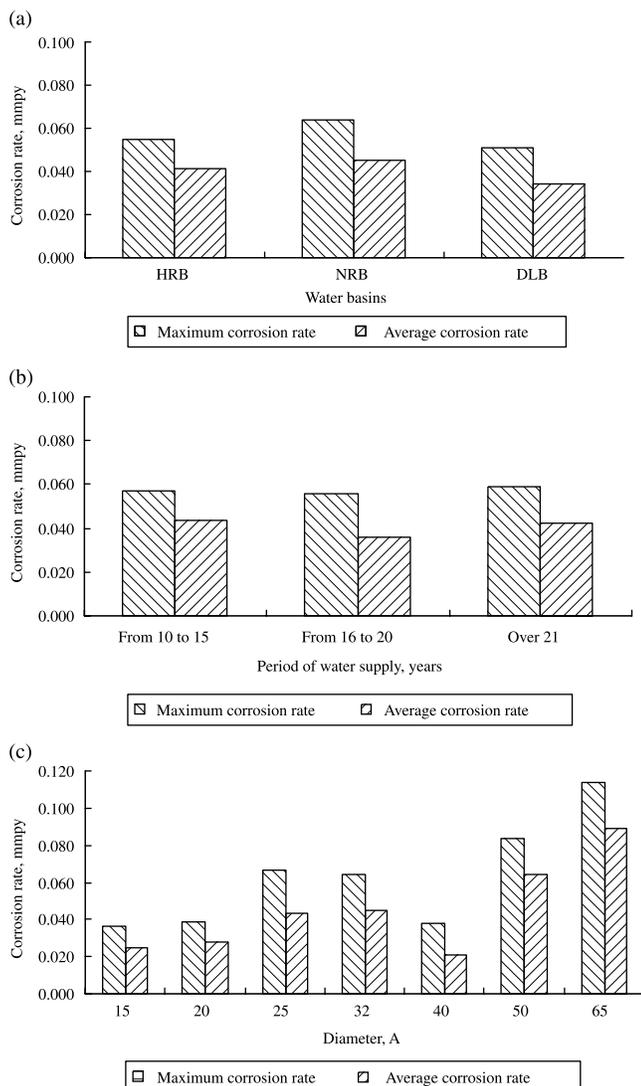
Figure 9 | Maximum and average corrosion rates.

age of pipe and diameters. Figure 9(a) expresses that the maximum corrosion rate in NRB was calculated as 0.064 mmpy, 0.055 mmpy in HRB, 0.051 mmpy in DLB. These results were in good accordance with Lee's researches that the corrosion rate in NRB is relatively higher than those in other basins. Lee *et al.* (2002a, 2002b) revealed that Nakdong-river has the lowest LI (Langelier Index) and the highest LR (Larson Ratio) compared with other rivers (Lee *et al.* 2002a, 2002b) as shown in Table 6.

Investigating the maximum corrosion rate depending on the age of pipe as seen in Figure 9(b), there is little difference, and the corrosion rates are 0.056 ~ 0.059 mmpy. These results did not correspond to the trend of thickness reduction percentages seen in Figure 8. This is due to the fact that the age of pipe was taken into account for deriving the corrosion rate.

From the comparison of each corrosion rate depending on diameters, as diameters increase with the exception of 40 mm pipe, both the maximum and average corrosion rate become higher. For example, the maximum corrosion rate in 15 mm pipe was calculated as 0.036 mmpy. And that in a 65 mm pipe was 0.114 mmpy, which is 3 times as high as the corrosion rate in the 15 mm pipe.
