## Water supply operation: diagnosis and reliability analysis in a Lisbon pumping system

A. B. Almeida and H. M. Ramos

An abnormal accident with no flow in a pumping system occurred with a large displacement of the pipe system. A slow closure of an isolation valve installed in a large suction pipe was the main action. As soon as the valve was closed the 1.6 m diameter pipe moved and the pipe supports were broken, presenting an expansion joint almost fully opened and the main pipe almost broken. This was a critical event that took place in one of the most important pumping stations of the water supply system in Lisbon. In order to avoid future accidents, a detailed analysis was developed as a priority in order to identify the cause of this event. The paper describes the event and the methodology followed in order to fully validate the diagnostic and the proposed chain of events that caused the pipe movement. The process included a careful, *in situ* observation of the system, hydraulic and structural analyses and some site tests. Ironically, the explanation of abnormal events can give the opportunity to better understand the operation of water supply systems. Weak points in the de

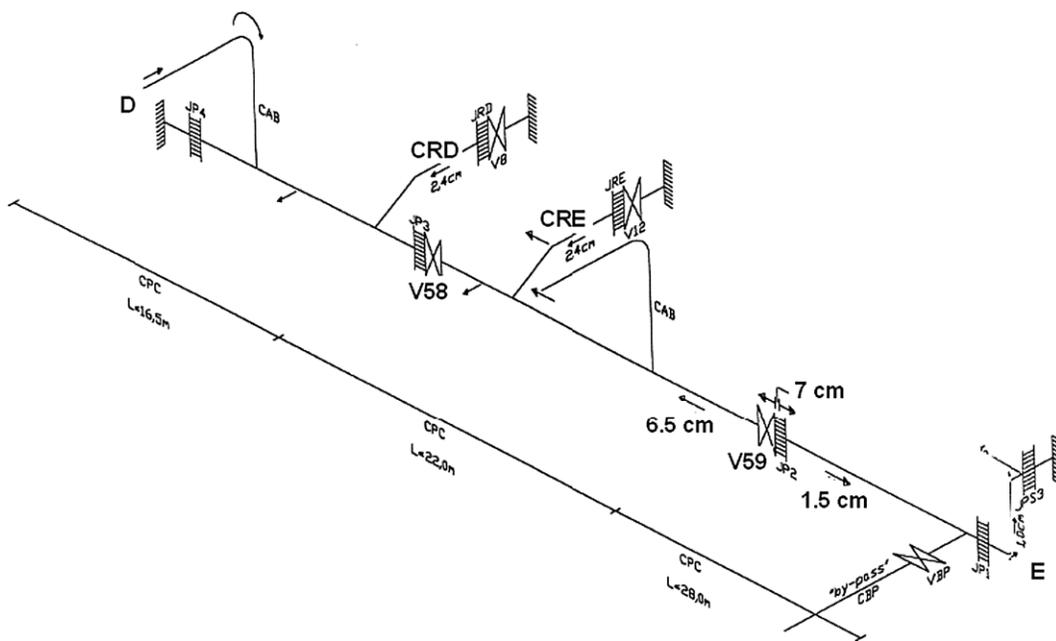
**Figure 5** | General pipe displacements due to the accident.

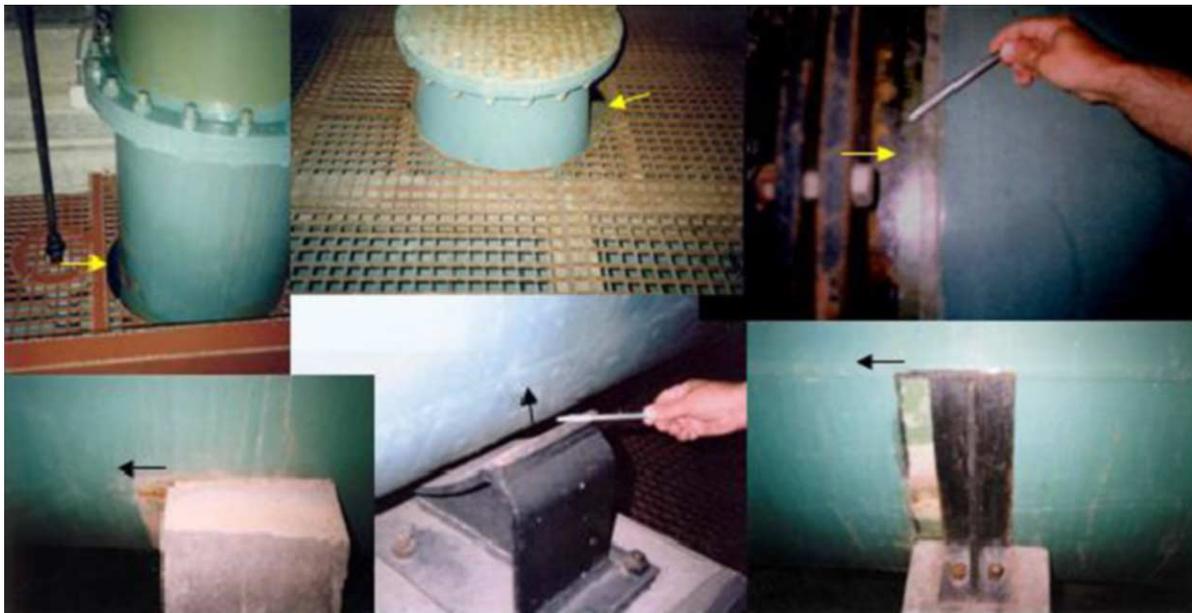
pumping station including pipe CRE and pipe CRD and the pipes connecting the pumps (Figure 6). In Figure 7 the rupture in some concrete blocks of the pipe support is visible.

**Figure 6** | Visualization of different displacements in the pumping-station.

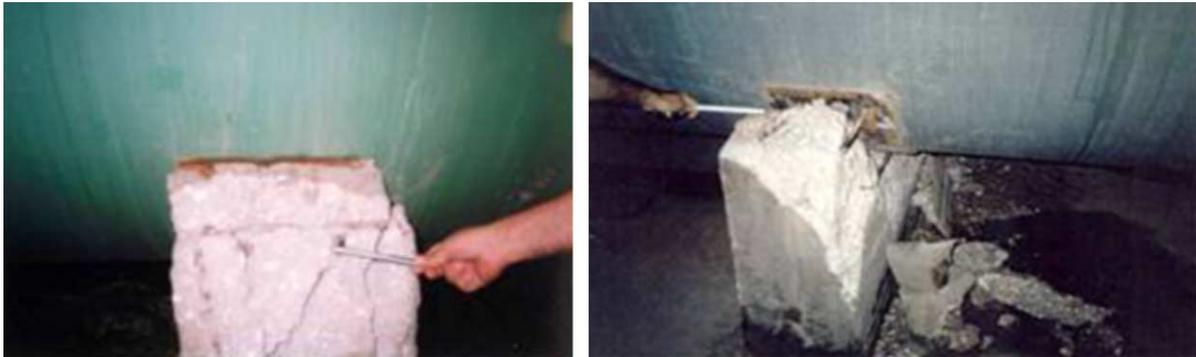
Figure 7 | Visualization of support blocks rupture.

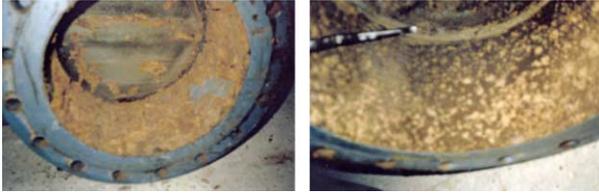
was slightly corroded (a very small leakage was noticed) and the non-return valve was not isolating well enough.

- *in-situ observation*: for data collection and to pay attention to operator description
- *preliminary diagnostic*: existence of differential pressure due to an unbalanced force at V59 as a fact
- *analysis*: bypass and valve inspections leading to the finding of the corrosion in the valve VBP body (Figure 9).

The corrosion in valve VBP (Figure 9) may be due to different circumstances. In fact, the water in the bypass had not moved for a long time, developing slime layers close to the valve, which may have induced the creation of an

anaerobic environment and favourable microbiological activity. Under anaerobic conditions, with the presence of sulphates and organic content in the bulk water, the reduction of sulphates to sulphides by facultative anaerobic microorganisms, such as *Desulfovibrio desulfuricans*, could take place, with iron sulphide deposition which attacked the valve surface. After the development of ‘weak’ zones and small ‘holes’, the significant pressure difference between the two faces of the valve body or the valve nave possibly resulted in water leak movement. Another possibility consists of local chemical corrosion of the valve associated with water quality problems; namely a high dissolved oxygen concentration, a significant electrical conductivity of the fluid and high concentrations of chlorides and/or nitrates and/or sulfates. All these factors contribute to chemical corrosion, the most important being, perhaps, the dissolved oxygen content (aerobic condition). The local hydro-dynamic conditions created after the existence of a hole in the valve body may have accelerated the corrosion process.

Figure 9 | Valve VBP corroded.

(v) The lack of protection against water corrosion attack (e.g. double valve and routine valve inspection, operation and maintenance) was the first cause of the abnormal system behaviour.

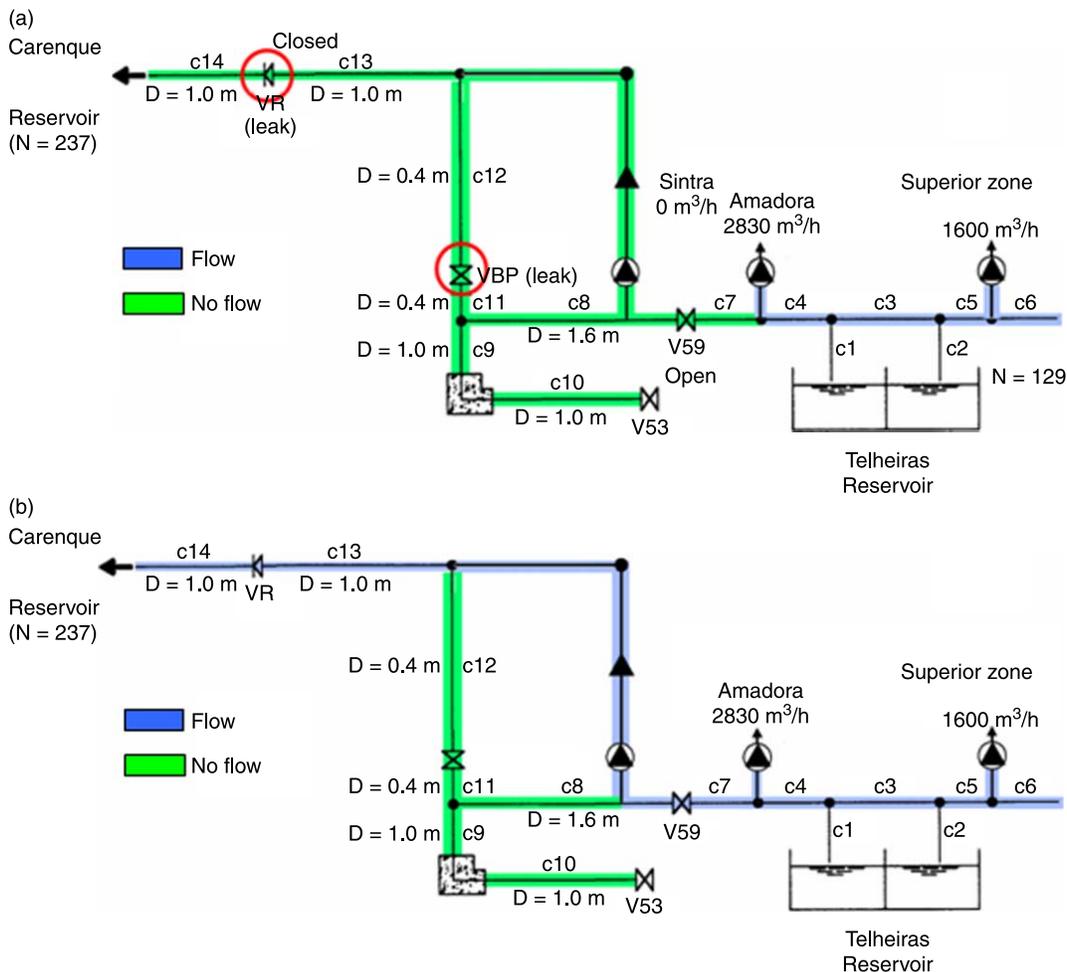
- Sintra pumps during the shutdown induced a residual high head (pressure) between the non-return valve VR and the valve VBP – the average head measured at the valve was 248 m imposed by the manometric head of the Sintra system.
- The simplified hydraulic system involved directly in the dynamic effects associated with the valve closure (V59) is represented in Figure 10.

Figure 10 | Simplified hydraulic system (a) for normal operation and (b) before the accident.

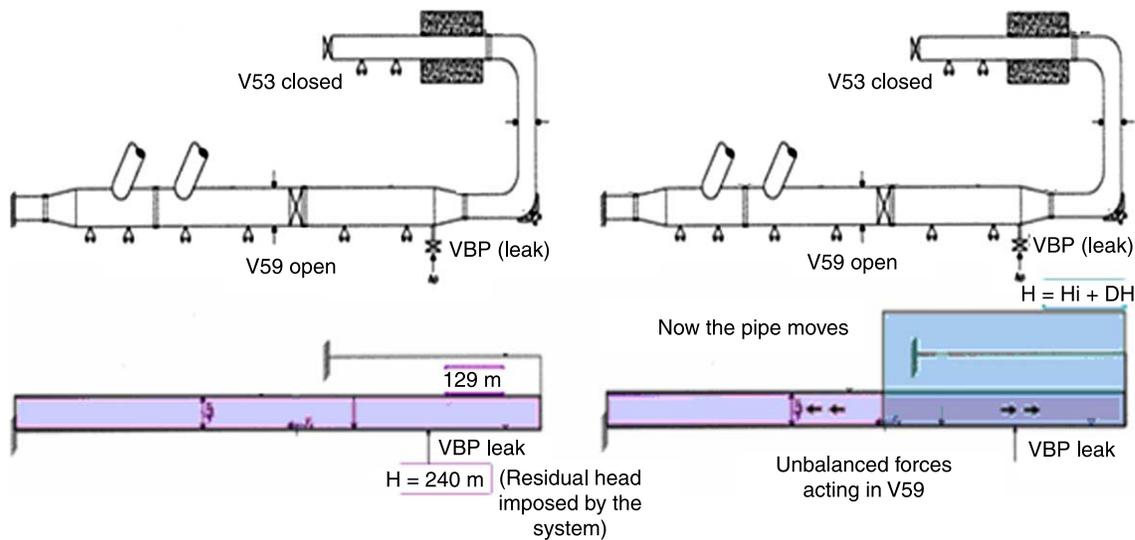
Figure 11 | Pipe branch of V59 and VBP (a) for normal operation and (b) before the accident.

of the unbalanced pressure head on both sides of the valve body due to the effect of an induced leak in the VBP valve.

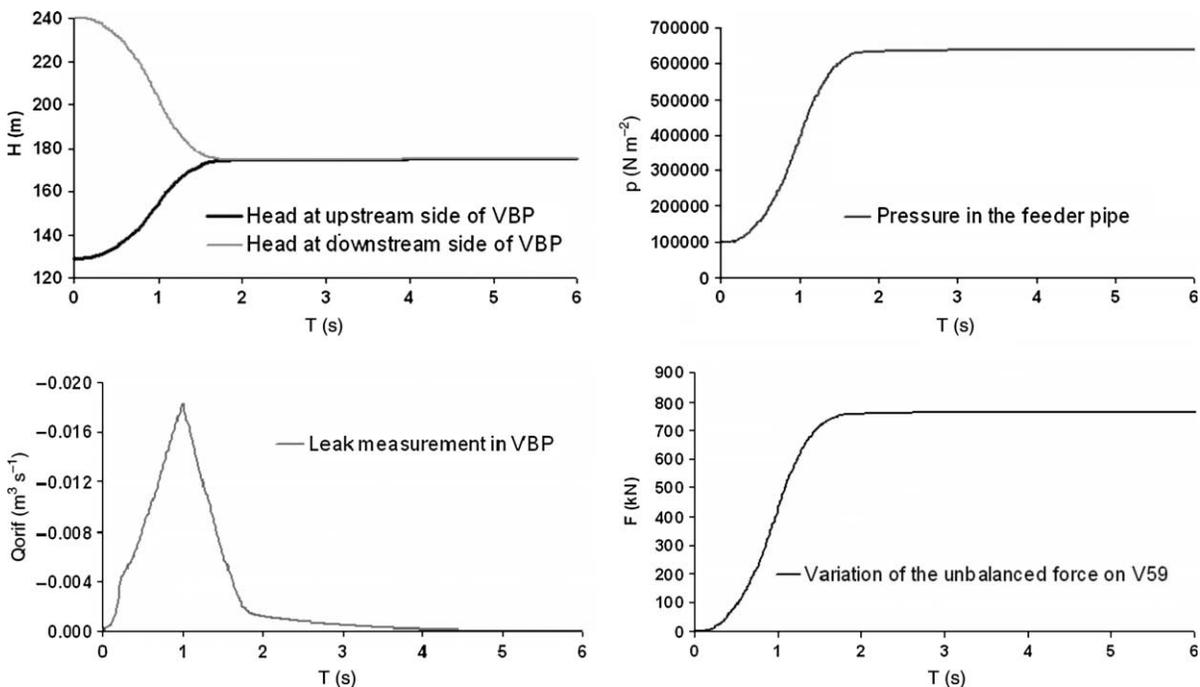
Figure 12 | Unbalanced head and respective force at V59.

Regarding the hydraulic analysis, the rising of the transient unbalanced force acting in the system was verified using an elastic model based on the method of characteristics. The pressure transient analysis associated with the valve V59 closure and the CPC pipe pressure variation due to the VBP leakage (a small orifice as estimated from the valve inspection) were simulated. According to this analysis the dynamic net unbalanced force was estimated (765 kN) as presented in Figure 12.

Due to the unbalanced interior pressure value in valve V59, as shown in Figure 12, by using a hydraulic mathematical flow dynamic model it was possible to simulate the effect of a leakage occurrence in VBP and the induced force of 765 kN, which was responsible for the system motion.

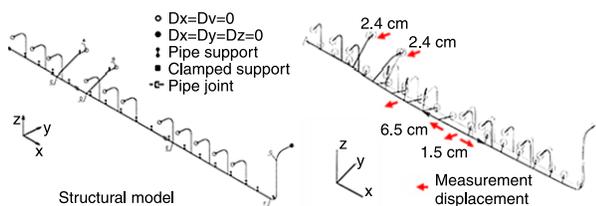
Figure 13 | Structural model and pipe displacements.

A 3D simulation model was also used in the analysis which allows observation of forces and displacements associated with each node (Figure 13). In the pipe structural response (3-D pipe analysis) the main forces are considered as well as the characteristics of the pipe supports. By comparing the pipe displacements obtained by the linear analysis in the computer simulation with those obtained in the field it was possible to calculate the corresponding acting force in the system (850 kN). The magnitude of the acting forces obtained by the hydraulic (765 kN) and structural (850 kN) analysis are rather close and it can be concluded that this seems to confirm the accident diagnostic.
