## Failure mechanisms and condition assessment of PVC push-fit joints in drinking water networks

André Marques Arsénio, Ilse Pieterse, Jan Vreeburg, Rob de Bont and Luuk Rietveld

**Key words** | CCTV, condition assessment, field inspections, joints, PVC

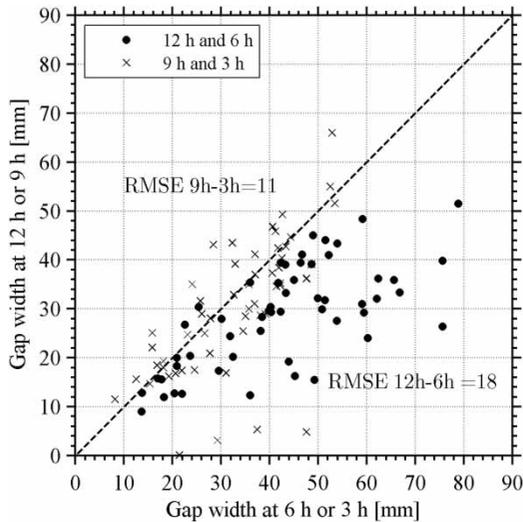
[Figure 6](#) presents the gap width at the pipe's crown (12 h) plotted against the gap width at the pipe's invert (6 h) – a black circle (•) represents an inspected joint. With the exception of two joints, all joints align below the  $x = y$  dashed line. This indicates that the gaps at 6 h are larger than the gaps at 12 h – the pipe is sagging at the joints.

[Figure 6](#) also plots the gap width at one springline (9 h) plotted against the gap width at the opposite springline

**Figure 6** | Joint gap at one position (9 h or 12 h) vs. the joint gap at the opposite position (3 h or 6 h). The dashed line represents  $x = y$ . For the pair 12 h–6 h a value below the line indicates that the gap at 6 h is wider than the gap at 12 h. For the pair 9 h–3 h a value below the line indicates that the gap at 3 h is wider than the gap at 9 h. The RMSE is given both for the pairs 12 h–6 h and 9 h–3 h in mm.

(3 h) – a cross (×) represents one inspected joint. As can be seen, with the exception of four joints, the values of gap width for all joints are nearly aligned along the  $x = y$  dashed line. This indicates that the pipe moves more along the vertical plane than along the horizontal plane. This is confirmed by the RMSE that is lower for the 9 h–3 h pair (11 mm) than for the 12 h–6 h pair (18 mm) by more than 60%. No explanation was found for the four unaligned joints, these values are distributed over the pipe length.

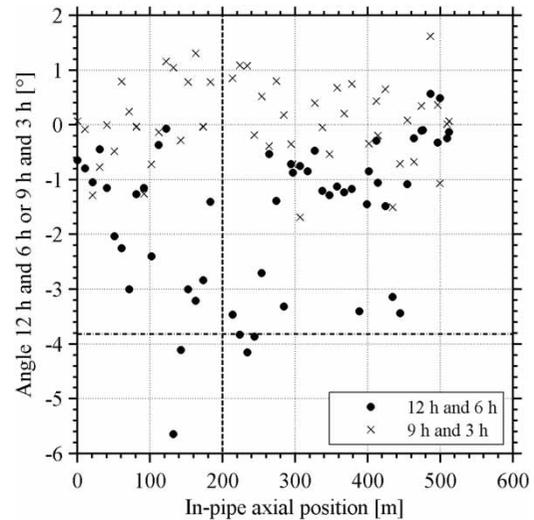
Figure 7 gives the joint angles for the pair 12 h–6 h. A negative angle indicates that the gap at 6 h is bigger than the gap at 12 h, or that the gap at 3 h is bigger than the gap at 9 h. The vertical dashed line ( $x = 200$  m) represents the point where the burst occurred.

**Figure 7** | Angle values for each inspected joint using the CCTV (Equation (1)). The vertical dashed line ( $x = 200$  m) represents the point where the burst occurred. This was the CCTV's access point. The AWWA guideline for installing a PVC pipe is presented as a horizontal dashed line (pipe angle =  $3.82^\circ$ ).

For the 12 h–6 h pairs, two angles were positive, the remaining were negative. Five joints have bending angles below the AWWA guideline. These joints are located in the vicinity of the burst point. Considering that most joint angles were negative (joint gap at pipe invert wider than gap at crown), the pipe would be above ground, assuming that the barrels were not bent (deformed). However, since this situation was not detected, it is concluded that the pipe was sagging below the joints and that the barrels were bent along the length. No extreme values are detected for the 9 h–3 h pair and no angle has a value close to the AWWA guideline limit. Angle values are larger for the 12 h–6 h pair than for the 9 h–3 h pair.

9 h–3 h pair there is no joint angle with an absolute value above  $2^\circ$ . For the 12 h–6 h pair, close to the burst point ( $x = 200$  m), a total of five joints with angles below the AWWA limit were detected, one angle is  $-5.8^\circ$  (Figure 7). Bending may create contact points between the joint's inner wall and the pipe and even between the two pipes inside a joint. Both the contact points and the bending create stress on the pipe. Excessive stress leads to a joint or pipe barrel failure.

For the present situation, the extreme bending angles detected close to the burst point indicate several barrels close to the burst point were bent and, therefore, subjected to stress. It is hypothesized that the pipe failed due to extreme stress and that a pre-emptive inspection would have detected the extreme bending angles and a decision to replace part of the pipe/the whole pipe could have been made, avoiding the failure of the pipe.
