# Resilient water supply system for earthquake and tsunami

M. Miyajima

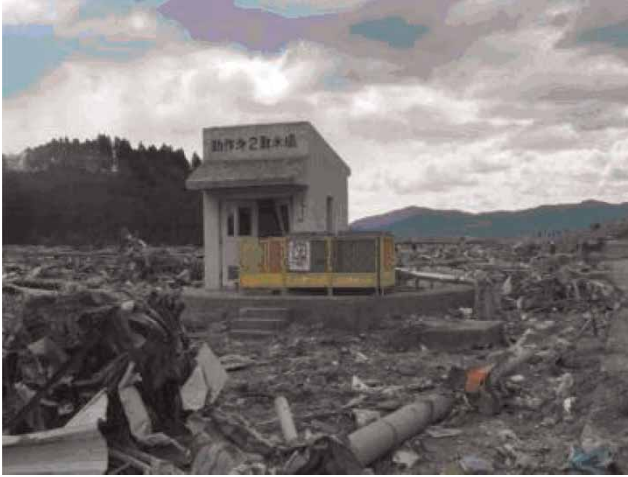
Causes of damage by the tsunami are roughly classified into three categories: inundation, washing away, and scouring of surface ground. Some intake facilities were inundated and have not functioned for a long time because of a high concentration of sodium chloride in groundwater (Figure 1). Figure 2 shows damage to a water pipe bridge, which was completely washed away. It is unknown as yet what caused this kind of damage, water pressure, floating wreckages or both. We need to study the force acting on the water pipe bridge during the tsunami through damage analysis. Figure 3 shows damage to a buried pipeline. The pipe was exposed as the covering soil had been scoured by the tsunami. The mechanism of damage to the pipe, that is, how much force was acting on the pipe in what way, is still unknown and awaits clarification in the future.

**Figure 1** | Inundated intake facilities (Sukedukuri No. 2).

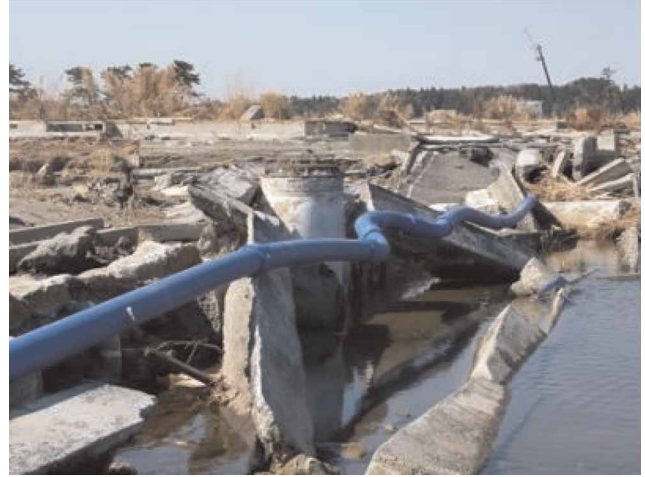
**Figure 3** | Damage to pipe by tsunami-induced scouring.

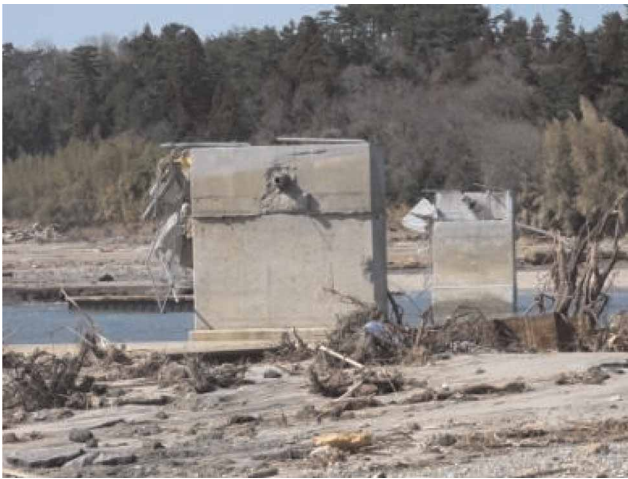
**Figure 2** | Washed-away water pipe bridge.

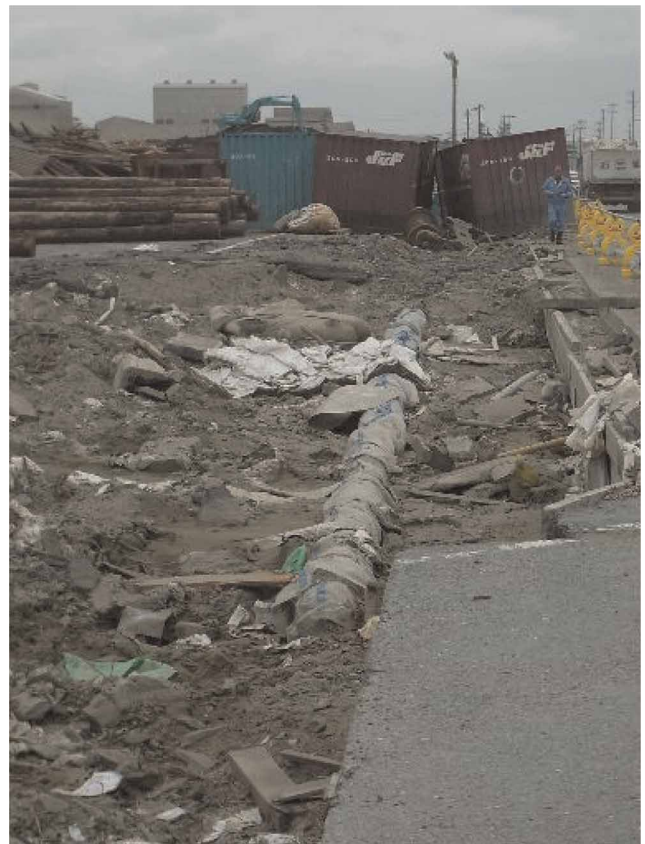
The earthquake-resistant joint ductile iron pipes (ERDIP) did not suffer damage at all in the 2011 Tohoku earthquake. A field survey was conducted on surviving ERDIP buried in the tsunami-hit area at Ishinomaki City in Tohoku region. [Figure 4](#) shows an ERDIP exposed above ground surface by scouring caused by the tsunami. The exposed pipelines were covered by debris of crushed wooden houses and a steel container as shown in [Figure 5](#). This pipeline is ERDIP

**Figure 4** | ERDIP exposed above ground.

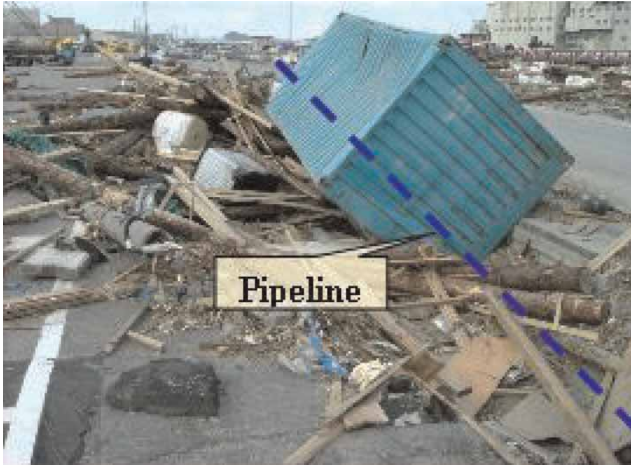
with 300 mm of nominal diameter, installed in 2010. Deformation of pipeline, displacement, and bending angle at each joint were measured for 14 pipes as shown in [Figure 6](#).

Figure 5 | ERDIP covered by debris.

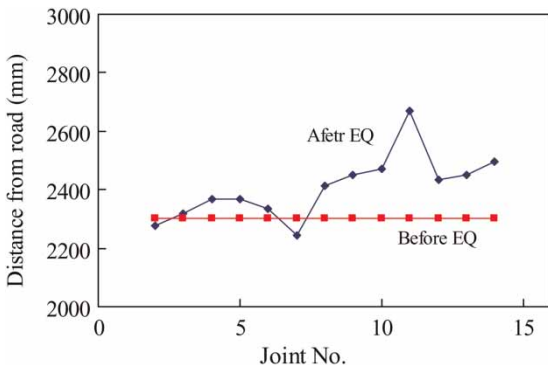
Figure 7 illustrates the horizontal distance to a pipeline from the edge of a road before and after the earthquake. Because the road was not dislocated horizontally or deformed by the earthquake and tsunami, this figure indicates that the pipeline moved about 40 cm. Figure 8 shows the bending angles at joints measured in the field. The maximum bending angle is 7.5 degrees at joint No. 11. It appears that the pipeline was exposed above ground by the scouring, hit by a steel container and debris in the undertow of the tsunami,

Figure 7 | Distance to the pipeline from a road edge before and after the earthquake.

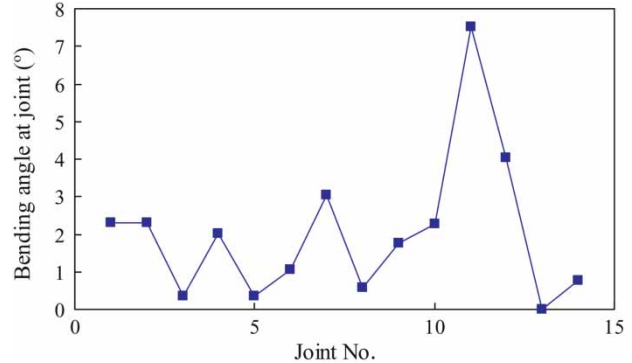
Figure 8 | Bending angle at joint measured at the field.

and moved to the coastline. There was, however, no damage to ERDIP and water suspension did not occur.

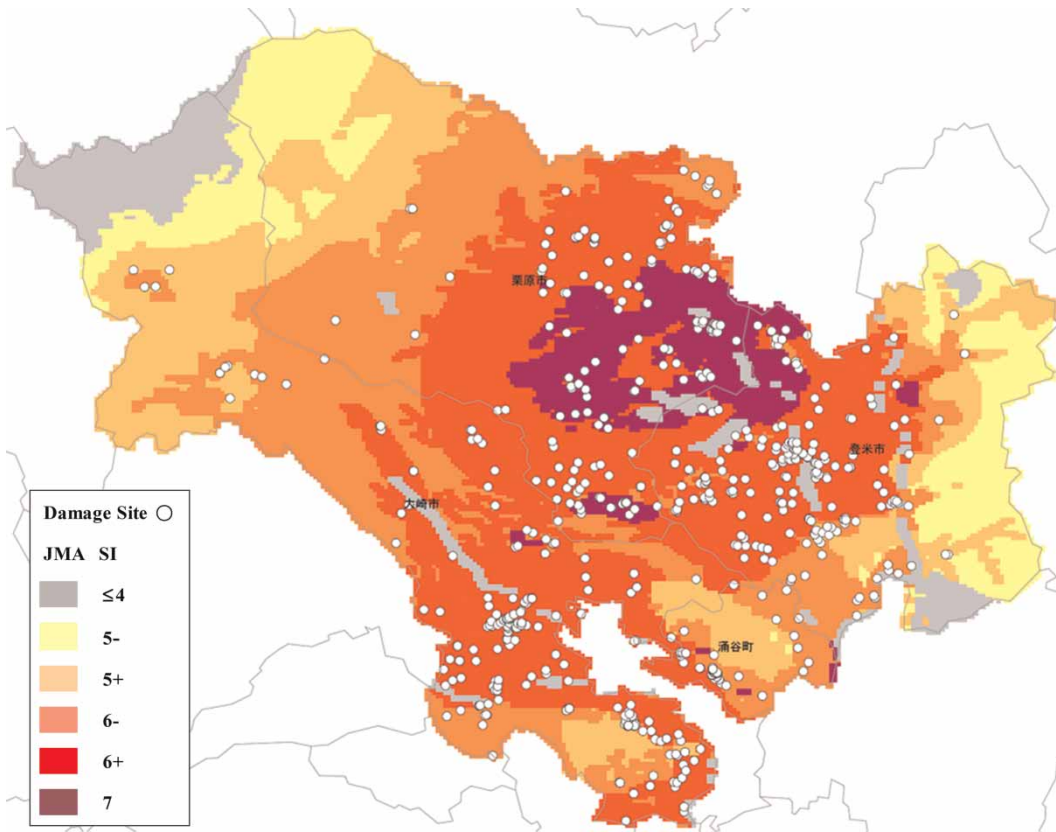
The maximum JMA (Japan Meteorological Agency) seismic intensity of this earthquake was 7, which was recorded in Kurihara City, Miyagi prefecture. 7 is also the maximum grade of JMA scale. The JMA seismic intensity in the surrounding Osaki City, Tome City, and Wakuya Town was 6+. The damage to buried pipeline in those municipalities, including Kurihara City, is discussed here. Figure 9 illustrates the distribution of JMA seismic intensity estimated by QuakeMap (National Institute of Advanced Industrial Science and Technology) and sites of damaged water supply pipeline in the four municipalities. JMA seismic intensity estimated by QuakeMap is given in each 250 m cell. Table 1 lists the number of cells by each level of JMA seismic intensity. According to QuakeMap, 7.6, 33.6, and 23.8% of the total area marks the JMA seismic intensity of 7, 6+, and 6-, respectively.

**Figure 9** | Distribution of JMA seismic intensity and sites of damage.

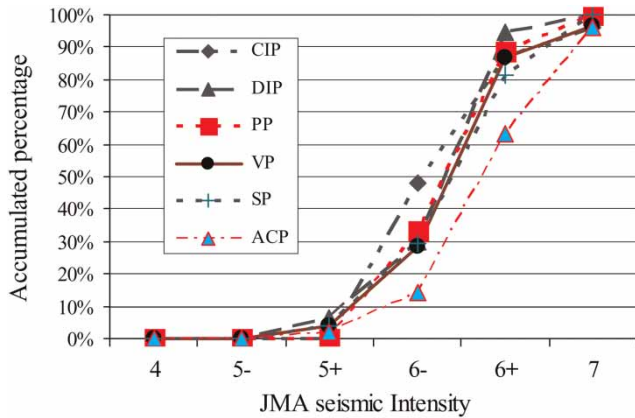
The main types of buried water pipes in Japan are ductile cast iron pipes (DIP), gray cast iron pipes (CIP), steel pipes (SP), polyethylene pipes (PE), polyvinyl chloride pipes, and asbestos cement pipes (ACP). Figure 10 illustrates an accumulated damage rate of each pipe type. This figure indicates that the damage to pipelines starts to occur at 5+ of JMA seismic intensity and the damage rapidly increases at 6+.

Figure 10 | Accumulated damage rate of each pipe type.

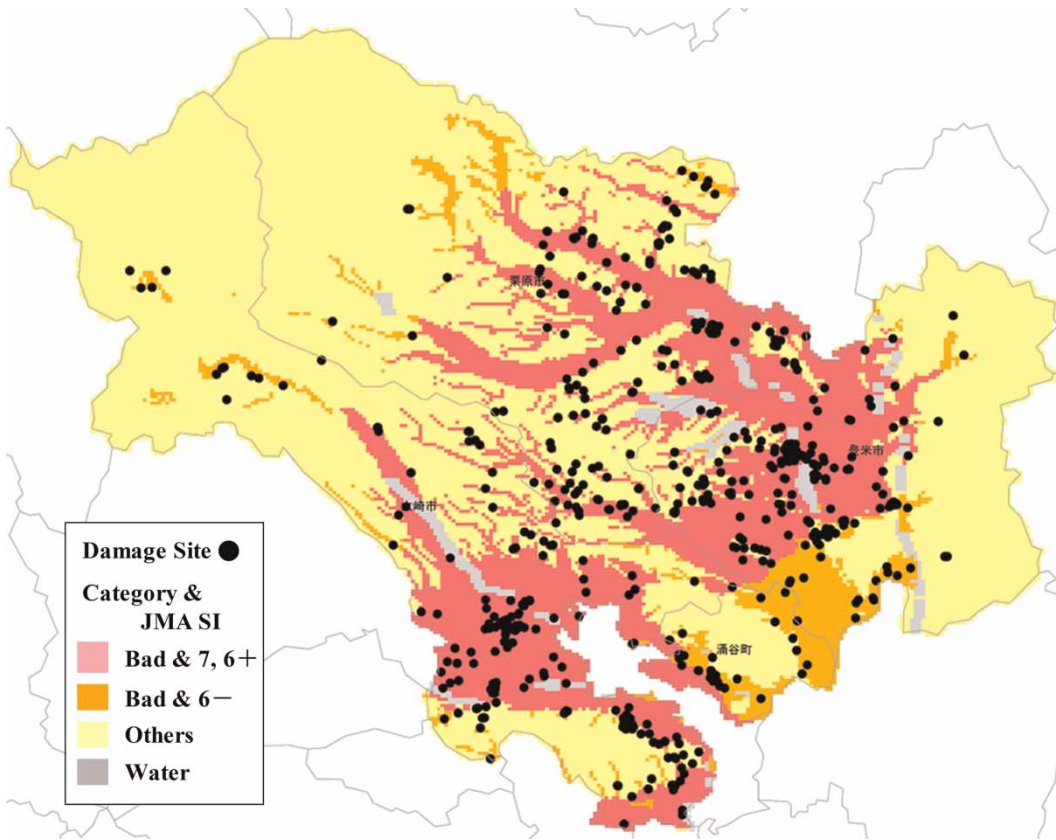
shown in Table 2. Figure 11 illustrates the distribution of ground categories, JMA seismic intensity, and the sites of damage. Much damage occurred at the boundary between Bad of more than 5+ and Others. Figure 12 illustrates a comparison of damage rate by pipe type in the two

Figure 11 | Distribution of ground categories, JMA seismic intensity, and the sites of damage.

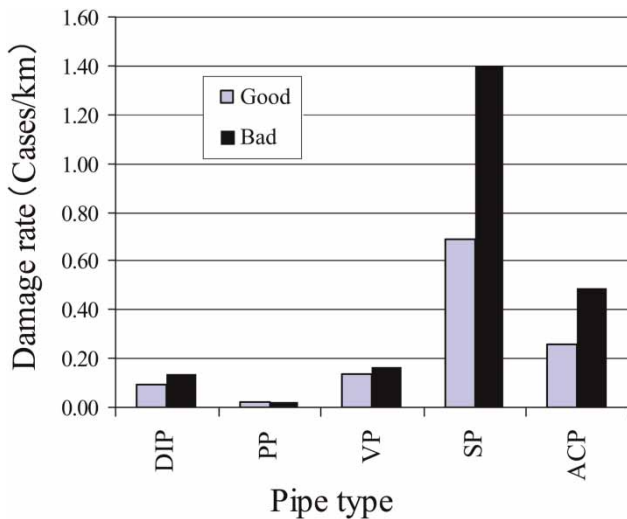
microtopography classification categories. This figure suggests that the damage rates in Bad are much greater than those in Good.

Figure 12 | Comparison of damage rate of each pipe type in microtopography classification category.
