Engineering a Safer World

Systems Thinking Applied to Safety

By: Nancy G. Leveson

B The Loss of a Satellite

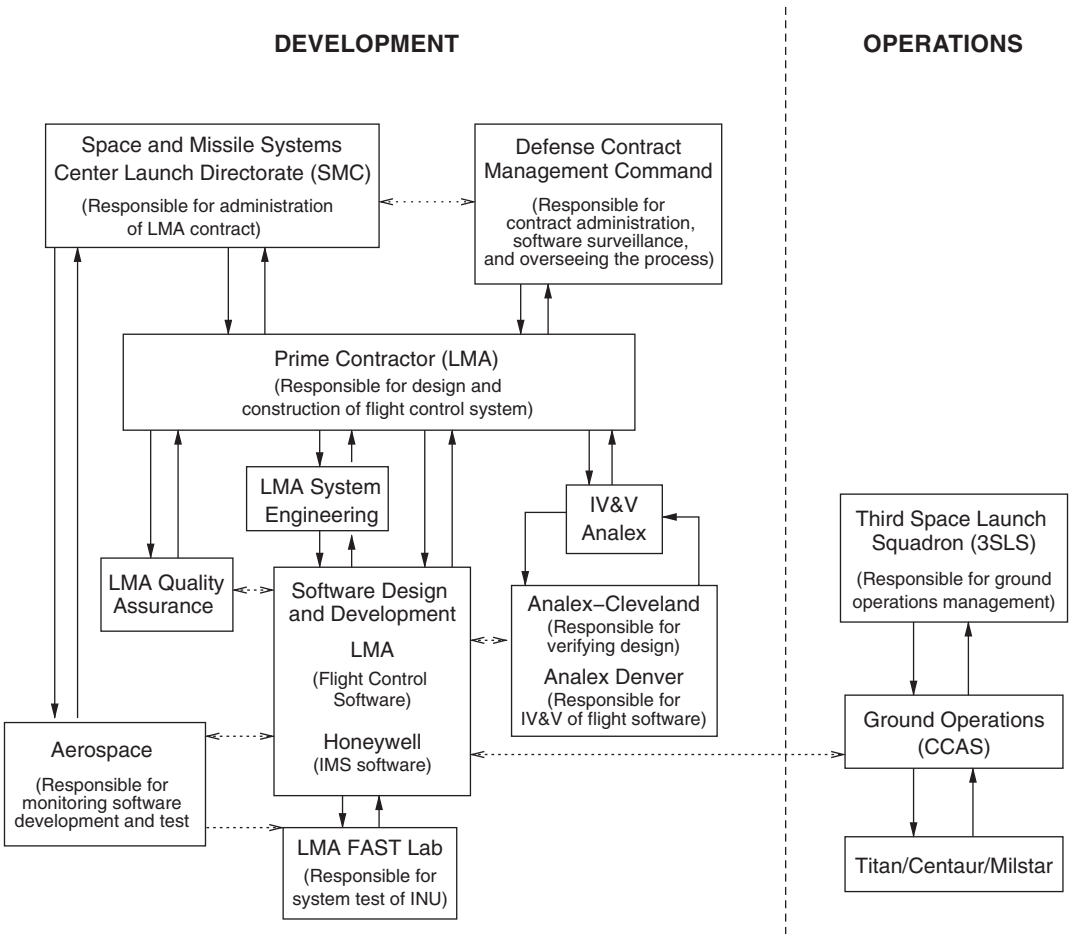
Figure B.1 Hierarchical control structure.

Figure B.1 shows the hierarchical control model of the accident, or at least those parts that can be gleaned from the official accident report.¹ Lockheed Martin Astronautics (LMA) was the prime contractor for the mission. The Air Force Space and Missile Systems Center Launch Directorate (SMC) was responsible for insight and administration of the LMA contract. Besides LMA and SMC, the Defense Contract Management Command (DCMC) played an oversight role, but the report is not clear about what exactly this role was beyond a general statement about responsibility for contract management, software surveillance, and overseeing the development process.

LMA designed and developed the flight control software, while Honeywell was responsible for the Inertial Measurement System (IMS) software. This separation of control, combined with poor coordination, accounts for some of the problems that occurred. Analex was the independent verification and validation (IV&V) contractor, while Aerospace Corporation provided independent monitoring and evaluation. Ground launch operations at Cape Canaveral Air Station (CCAS) were managed by the Third Space Launch Squadron (3SLS).

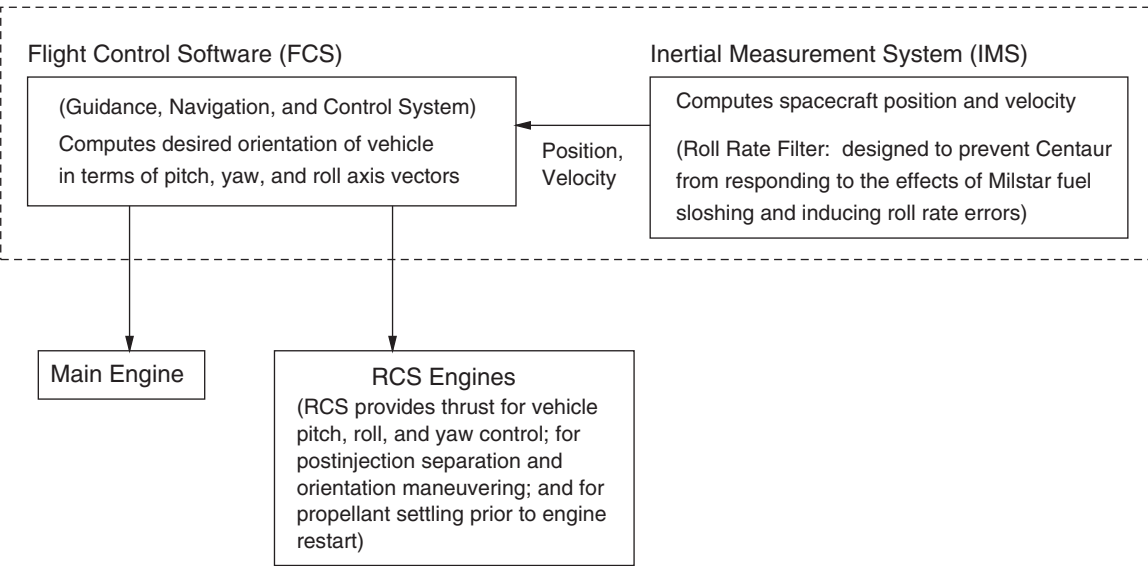
Figure B.2
Technical process control structure for INU.

Description of the Process Controller (the INU): The Inertial Navigation Unit (INU) has two parts (figure B.2): (1) the Guidance, Navigation, and Control System (the Flight Control Software or FCS) and (2) an Inertial Measurement System

(IMS). The FCS computes the desired orientation of the vehicle in terms of the pitch, yaw, and roll axis vectors and issues commands to the main engines and the reaction control system to control vehicle orientation and thrust. To accomplish this goal, the FCS uses position and velocity information provided by the IMS. The component of the IMS involved in the loss is a roll rate filter, which is designed to prevent the Centaur from responding to the effects of Milstar fuel sloshing and thus inducing roll rate errors.

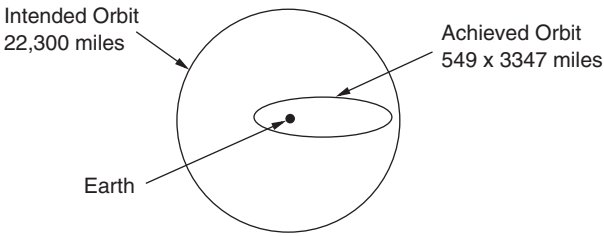
Figure B.3
Achieved orbit vs. intended orbit.

Third Burn: The goal of the third burn was to circularize the Centaur in its intended geosynchronous orbit. The FCS started the third burn at two hours, thirty-four minutes, and fifteen seconds after liftoff. It was started earlier and was shorter than had been planned. The vehicle tumbled throughout the third burn, but without the RCS there was no way to control it. Space vehicle separation was commanded at approximately two hours after the third burn began, resulting in the Milstar being placed in a useless low elliptical orbit, as opposed to the desired geosynchronous orbit (figure B.3).

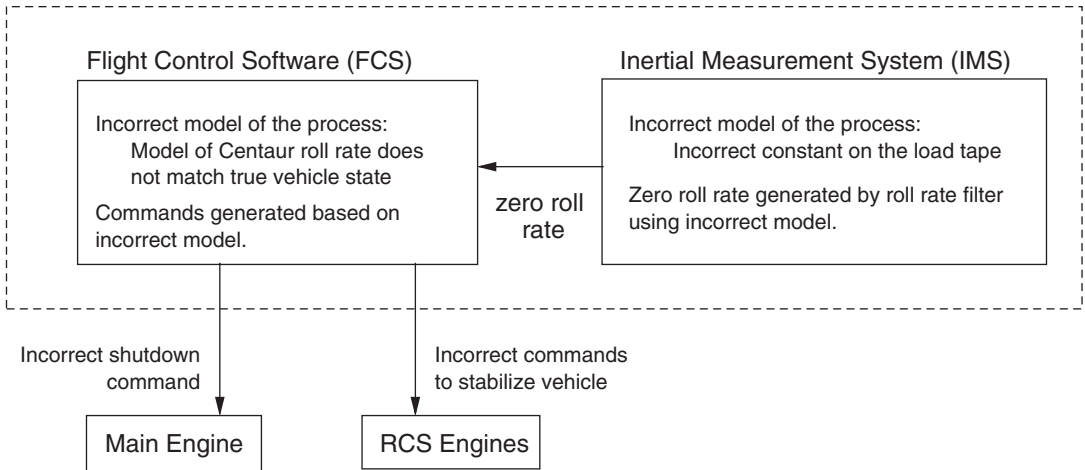
Figure B.4
Control flows at the physical process and software controller levels.

Figure B.4 shows the automated controller flaws leading to the accident. The Inertial Measurement System (IMS) process model was incorrect; specifically, there was an incorrect roll rate filter constant in the IMS software file (figure B.4) that led to a dysfunctional interaction with the flight control software.²

The Flight Control Software also operated correctly, that is, according to its requirements. However, it received incorrect input from the IMS, leading to an incorrect internal FCS model of the state of the spacecraft—the roll rate was

thought to be zero or near zero when it was not. There was a mismatch between the FCS internal model of the process state and the real process state. This mismatch led to the RCS issuing incorrect control commands to the main engine (to shut down early) and to the RCS engines. Using STAMP terminology, the loss resulted from a dysfunctional interaction between the FCS and the IMS. Neither failed. They both operated correctly with respect to the instructions (including constants) and data provided.

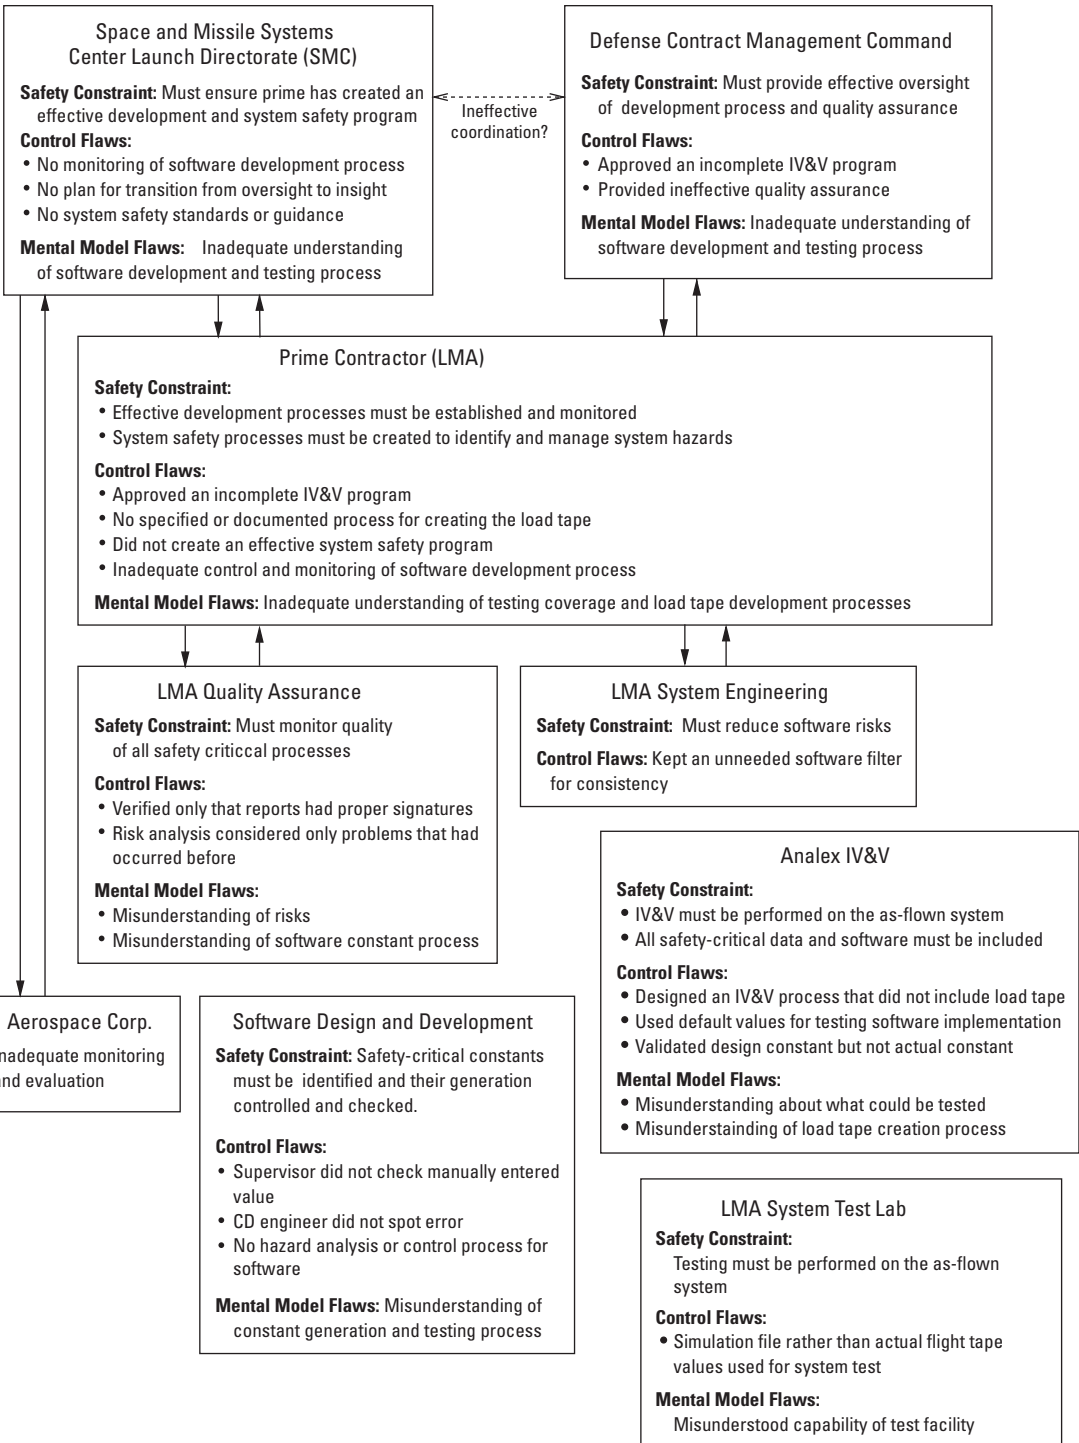
Figure B.5
STAMP model of development process.

Figures B.5 and B.6 summarize the STAMP-based accident analysis.

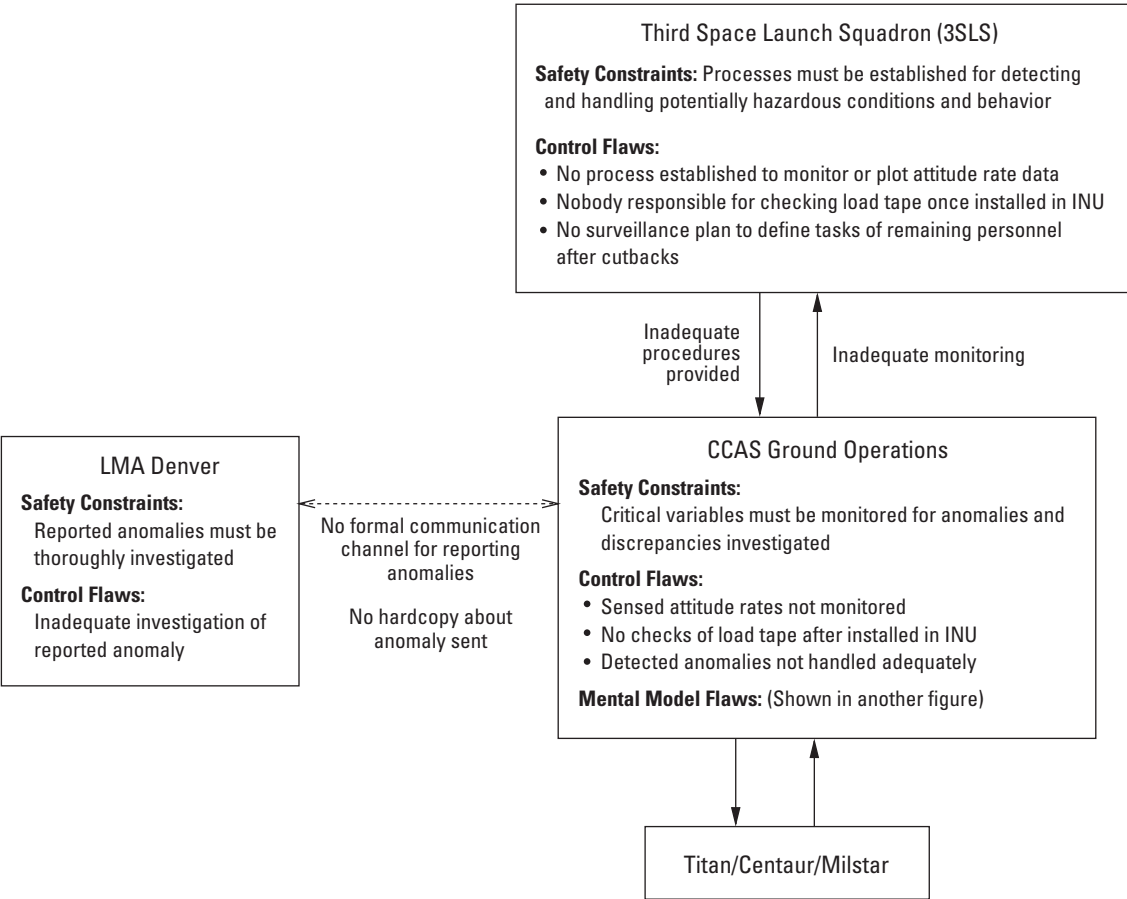
Figure B.6
STAMP model of launch operations process.

The function of launch site operations (figure B.6) is to monitor launchpad behavior and tests and to detect any critical anomalies prior to flight. Why was the roll-rate error not detected during launch operations?

Safety-Constraint Violated: Critical variables (including those in software) must be monitored and errors detected before launch. Potentially hazardous anomalies detected at the launch site must be formally logged and thoroughly investigated and handled.

Context: Management had greatly reduced the number of engineers working launch operations, and those remaining were provided with few guidelines as to how they should perform their job. The accident report says that their tasks were not defined by their management so they used their best engineering judgment to determine which tasks they should perform, which variables they should monitor, and how closely to analyze the data associated with each of their monitoring tasks.
