# INVESTIGATION AND POST SERVICE CREEP TESTING OF A MIS-HEAT TREATED SEAM WELDED GRADE 91 HOT REHEAT BEND

*S J Brett<sup>1</sup>, S Kimpton<sup>2</sup> and A Clark<sup>3</sup>*

*<sup>1</sup>Consultant, <sup>2</sup>Centrica, <sup>3</sup>RWE Generation*

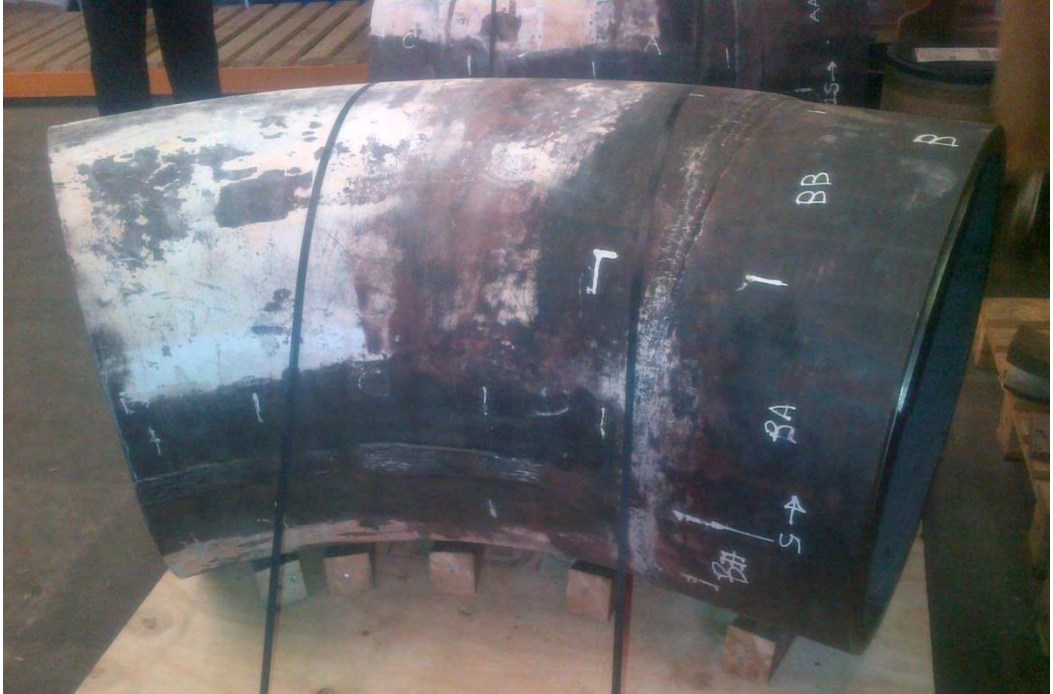
*Fig.1. The bend, cut into two halves for ease of handling. The seam weld at the bend intrados and one of the circumferential welds can be seen.*

The bend and pipe dimensions were 864mm outside diameter and 37mm wall thickness. The bend had been fabricated from two rolled plate sections by longitudinal seam welding at the extrados and the intrados, while each of the adjacent straight pipe sections had been made from plate rolled into a cylinder and welded with a single longitudinal seam weld. The straights had been welded to the bend by two circumferential butt welds. The assembly therefore contained four different parent materials (identified as A and D in the straights and B and C in the bend) and six different welds (identified as 1-6).

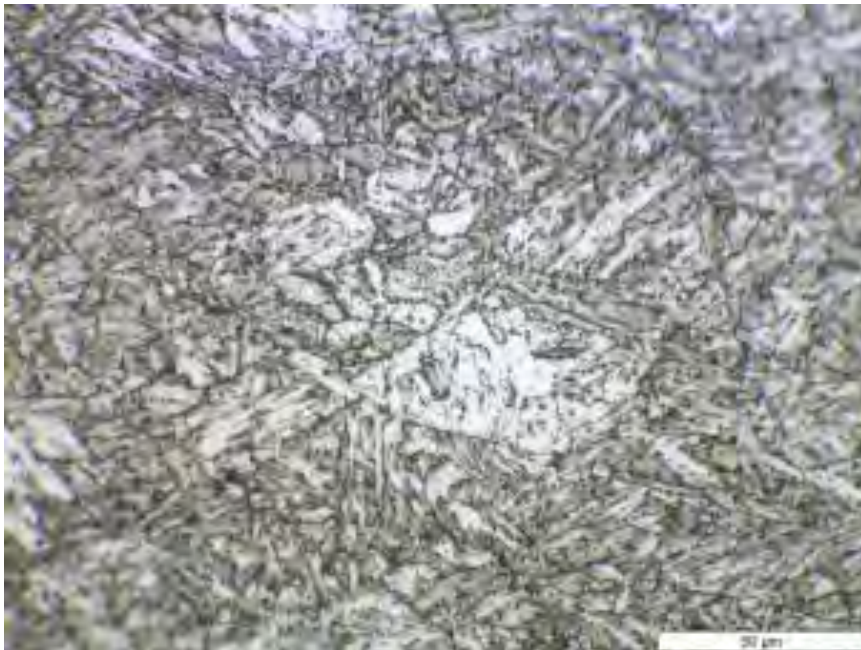
Examples of normal and aberrant microstructures in the same parent are shown below. Fig. 2 shows the normal martensitic microstructure found in Parent B away from the mis-heat treated seam weld. The (prior Austenite) grain size is  $\sim 50\mu\text{m}$ , with an internal acicular lath structure clearly visible, and the average hardness of this material was  $>200\text{HV}$ .

*Fig.2. Normal martensitic microstructure found in Parent B away from Weld 4 (Image provided by AMEC FW).*

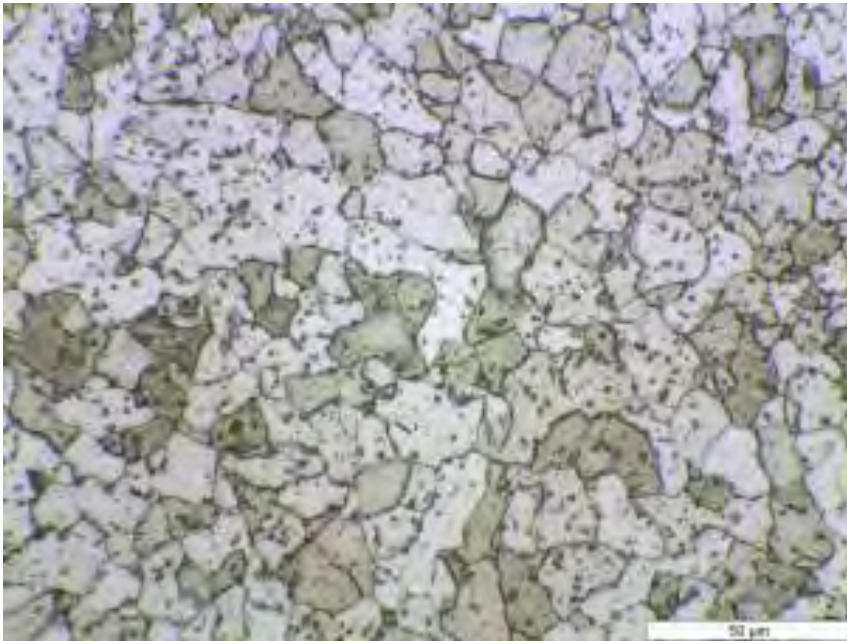
Fig.3 shows the aberrant microstructure found in Parent B near the mis-heat treated seam weld. This microstructure appears to be 100% Ferrite. The grains are featureless, with no evidence of an internal lath structure, and the hardness is much lower ( $\sim 143\text{HV}$ ).

It has been demonstrated that a very similar microstructure can be reproduced artificially by a rapid temperature rise to  $910^{\circ}\text{C}$  in the austenitic region followed by an air cool to  $760^{\circ}\text{C}$ , with a hold at this temperature for 3 hours, before cooling [1]. It is therefore possible that in this case the microstructure was caused by an overshoot during post weld heat treatment of the seam weld before the temperature stabilised at the correct level.

*Fig.3. Aberrant non martensitic microstructure found in Parent B (Image provided by AMEC FW)*

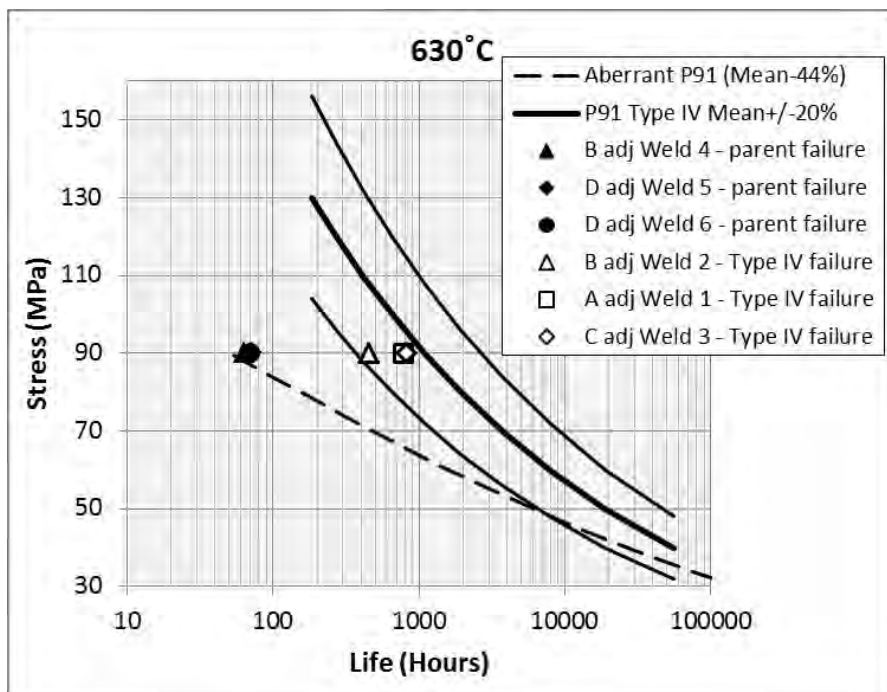
Fig.4. Crossweld rupture tests at 90MPa and 630°C.

A number of shorter term (<1000 hour) crossweld creep rupture tests were initially carried out at 90MPa and 630°C. As shown in Fig.4, two distinct failure behaviours were observed. Where an aberrant non martensitic parent microstructure was present in the specimen, failure occurred in this material. Where no non martensitic parent microstructure was present, failure occurred instead in the Type IV location.

Each parent or crossweld failure time can be used to estimate creep strength with respect to the mean expected value. The stress for a given failure time can be divided by the stress required to produce the same failure time in material with mean properties. The Type IV lines shown in Fig.4 are derived from the mean prediction from the Bell equation [2] with a margin of +/-20% on stress. It can be seen that the Type IV failure times in three different parent materials all fall within this range. In contrast the failure times for the non martensitic parent are much shorter. The dashed line is derived from the mean Cipolla equation for Grade 91 parent [3] reduced by 44% on stress.

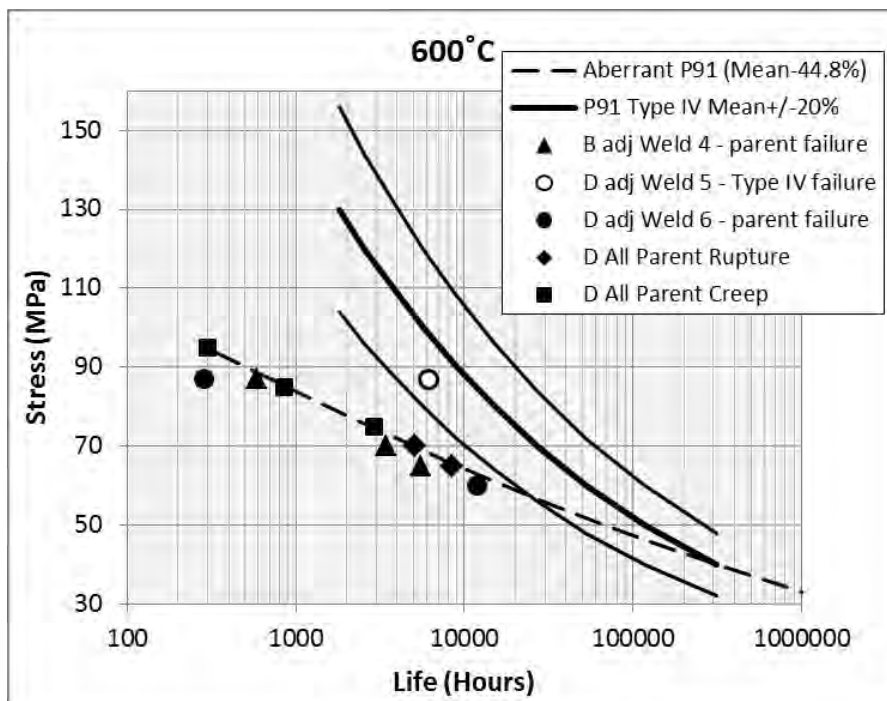
Fig.5. Crossweld rupture tests at 600°C.

Two of the aberrant materials, B and D, were then tested in the range 60-87MPa at 600°C as crossweld specimens to produce somewhat longer term failures. Parent D material from the aberrant band away from the seam weld was also tested in the range 75-95MPa at 600°C as all parent creep and rupture specimens. The results are plotted in Fig.5. Parent B adjacent to Weld 4 and Parent D adjacent to Weld 6 failed in aberrant parent material. One Parent D adjacent to Weld 5 crossweld specimen survived longer than expected, but the post test metallography showed this to be a Type IV failure in martensitic microstructure. It appears that this specimen avoided that part of the bend in which Parent D had a non martensitic structure. As with the similar failures at 630°C, the failure time falls within the expected Type IV range.

Parent D away from the seam weld has an average strength of Cipolla Mean-44.8%. Parent B adjacent to Weld 4 is slightly weaker, with an average strength of Cipolla Mean-47%. Parent D adjacent to Weld 6 has a strength similar to Parent B adjacent to Weld 4.

Type IV cracking may occur circumferentially at circumferential butt welds or longitudinally at seam welds. The alternative failure mode in aberrant parent, should this arise in a pipe section, is expected to occur as a longitudinally orientated split. Considering the behaviour of aberrant material shown in Fig.5, life is best predicted by applying a life reduction factor to the Cipolla 2005 equation [3].

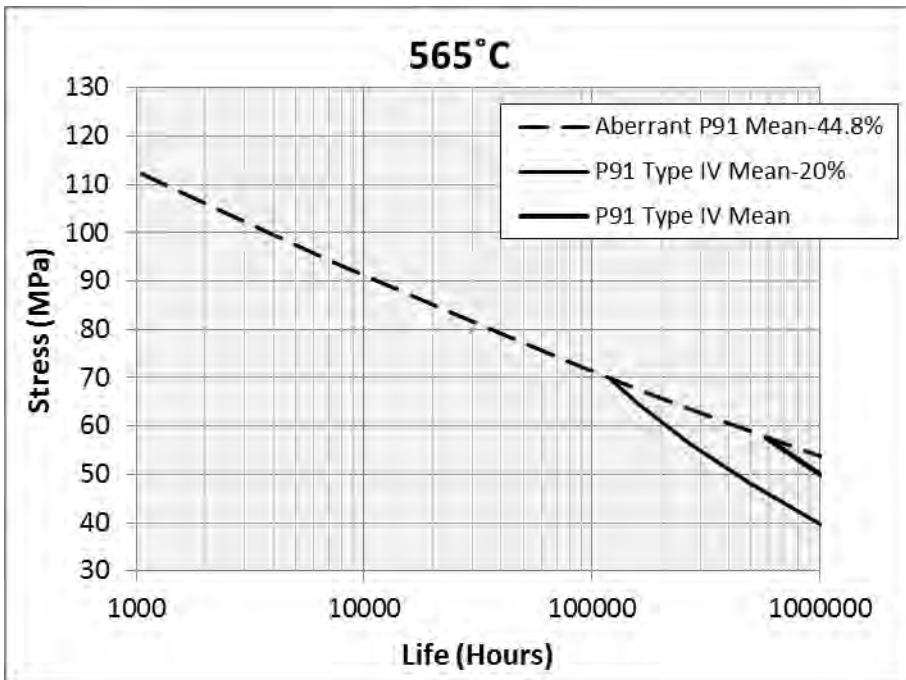
Fig.6. Estimated creep life for Parent D material at the down rated station operating temperature of 565°C.

On the basis of the down rated operating conditions of 565°C and 66MPa for the station concerned, Type IV failure will occur before failure in aberrant material of strength Mean-40%, provided the Type IV strength is in the lower half of the distribution. Failure may occur in aberrant material first if the Type IV strength is towards the top of the range. For

aberrant material of strength Mean-45%, failure in aberrant material will occur earlier than Mean Type IV failure, but later than Mean-20% Type IV failure (ie lower bound Type IV). For the weakest aberrant material strength found in this project, Mean-50%, failure will occur in aberrant material before Type IV failure. This is summarised in Table 3 below, with Figs 6 & 7 showing this information graphically.
