Properties of Aging Pentachlorophenol-Treated Douglas-Fir Crossarms

Christoph Schauwecker Milo Clauson Matthew J. Konkler
Arijit Sinha Jeffrey J. Morrell

©Forest Products Society 2020.
Forest Prod. J. 70(3):364–369.
doi:10.13073/FPJ-D-20-00025

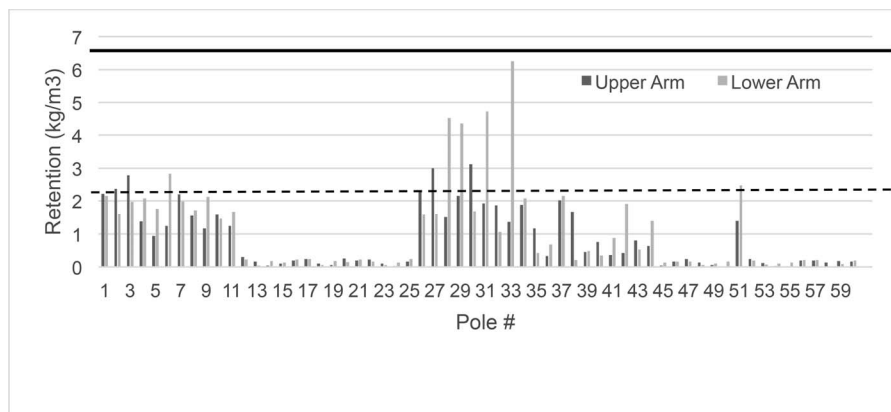
Penta retentions in the arms varied widely, ranging from 0 to 6.25 kg/m³ (Fig. 2). None of the retentions would meet the retention specification. There were also sometimes retention differences between the upper and lower arms in the same pole, but there were no consistent patterns, suggesting that the differences were a result of the inherent variation among different wood samples rather than an effect of position in the wishbone on subsequent preservative migration. It is difficult to infer much from the data because no initial retentions were obtained. However, the results, coupled with the absence of visible decay in the increment cores and the presence of decay fungi in only one of the 120 arms, suggest that the combination of a shallow pentachlorophenol treatment, coupled with the moderate durability of Douglas-fir heartwood, presented an excellent barrier against fungal attack. Previous studies have also noted the excellent performance provided by relatively shallow penta treatments in aboveground exposures (Scheffer and Eslyn 1978).

Figure 2.—Pentachlorophenol (penta) retentions in the outer 15-mm assay zone of 45- to 60-year-old Douglas-fir crossarms. The current American Wood Protection Association (AWPA) retention for penta for this application in Use Category 3B or 4A is 6.4 kg/m³ (AWPA 2019a), representing the upper horizontal line, while the dashed horizontal line represents an approximate threshold for protection against fungal attack in field stake tests.

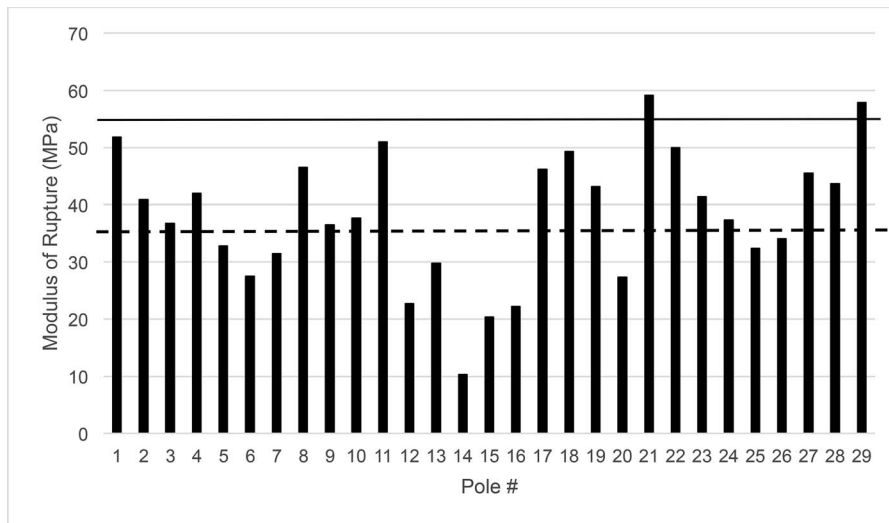
Figure 3.—Modulus of rupture (MOR) of 29 Douglas-fir crossarms exposed in a wishbone configuration for 45 to 60 years and tested to failure in third point loading. Solid arrow on the x-axis corresponds to the assumed MOR of a new arm, while the open arrow corresponds to 67 percent of that value.

MOR of the arms varied widely, ranging from 10.27 to 59.15 MPa with one arm breaking before it could be tested (Fig. 3). The current American National Standards Institute (ANSI) Standard 05.3 indicates that a crossarm less than 3.6 m long has a designated fiber stress of 53.78 MPa ANSI 2019). While this is an average value and not all arms would be expected to have this MOR, it provides a benchmark for assessing residual properties. Only 2 of the 29 arms tested met the benchmark value, suggesting that these arms needed to be replaced because they were below the minimum strength threshold. However, the National Electric Safety

Code also allows timber to degrade to as little as 67 percent of its original capacity before replacement or restoration is required (ANSI 2017). This would result in a minimum required strength of 36 MPa. Eighteen of the 29 arms met these minimum criteria, suggesting that while the arms had experienced substantial declines in properties over time, most were not at risk of imminent failure under normal service conditions. MOR and MOE of the arms were weakly correlated with one another ($R^2 = 0.387$; Fig. 4). Only the MOR results are discussed further since similar trends were noted with MOE with respect to the ability of the inspection tools to assess properties.

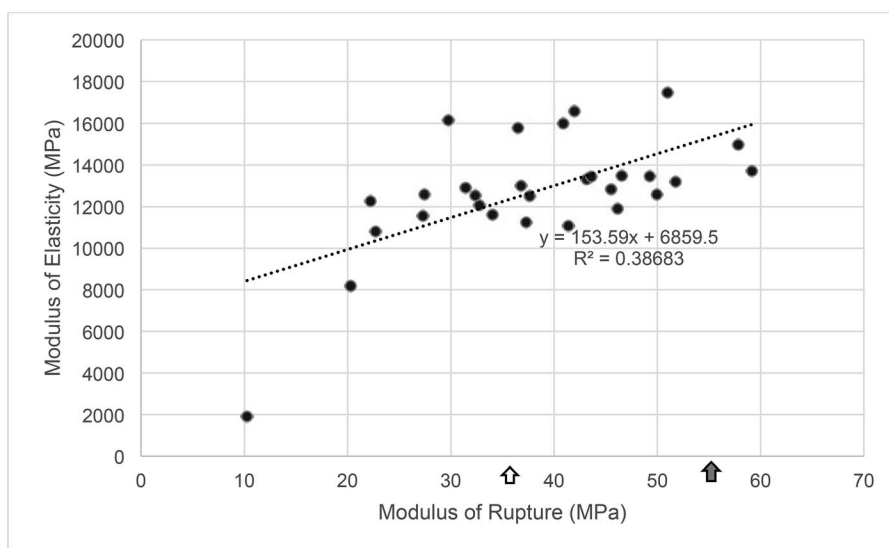
Figure 4.—Modulus of rupture (MOR) versus modulus of elasticity of Douglas-fir crossarms exposed in a wishbone configuration for 45 to 60 years and tested to failure in third point loading. Solid arrow on the x-axis corresponds to the assumed MOR of a new arm, while the open arrow corresponds to 67 percent of that value.

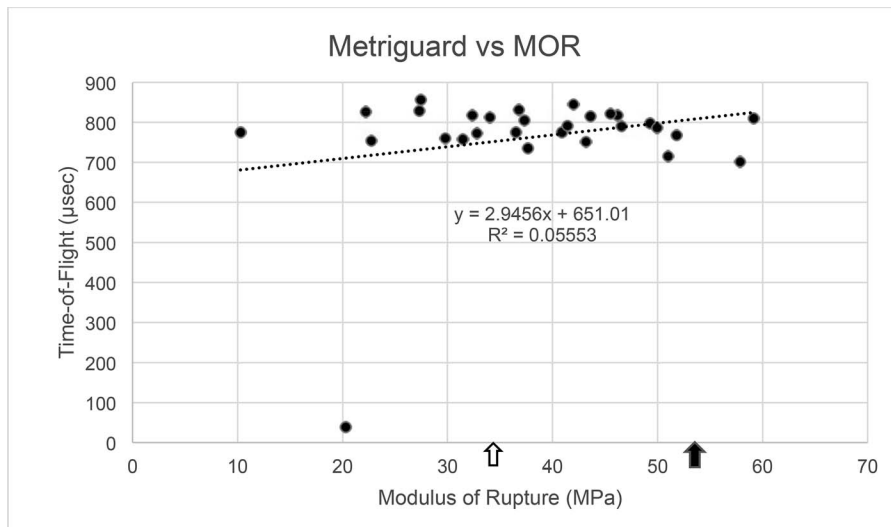
Figure 5.—Modulus of rupture (MOR) versus Metriguard time of flight assessment for 29 Douglas-fir crossarms exposed in a wishbone configuration for 45 to 60 years and tested to failure in third point loading. Solid arrow on the x-axis corresponds to the assumed MOR of a new arm, while the open arrow corresponds to 67 percent of that value.

The Metriguard system found little difference between arms that were above or below the minimum ANSI threshold. MOR was poorly correlated with the results from this device ($R^2 = 0.056$), and most time of flight measurements were between 702 and 857 μs (Fig. 5). The heavily checked surfaces as well as the presence of the holes drilled to accommodate attachments may have affected the functionality of this device. The MK-4 Hammer provides a value between 1 and 10 to denote decayed or sound wood, respectively. All of the results from the 29 arms were between 1 and 2.7, suggesting that the device was also

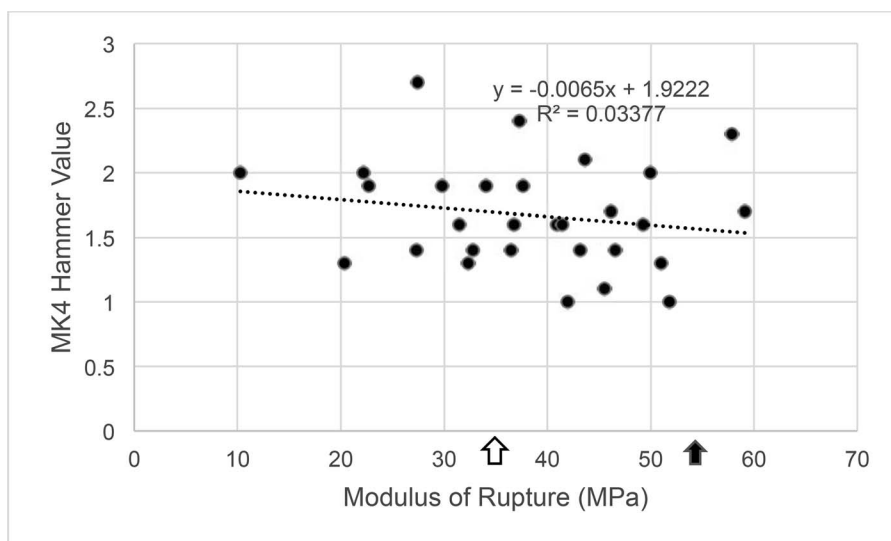
unable to accurately assess condition ($R^2 = 0.034$; Fig. 6). The MK-4 Hammer was able to detect the one heavily degraded arm, but it also tended to reject a number of other arms that full-scale destructive testing suggested still retained sufficient capacity. This conservative approach to sorting may be acceptable given the costs of an unplanned arm failure.

Figure 6.—Modulus of rupture (MOR) versus MK-4 Hammer assessment for 29 Douglas-fir crossarms exposed in a wishbone configuration for 45 to 60 years and tested to failure in third point loading. Solid arrow on the x-axis corresponds to the assumed MOR of a new arm, while the open arrow corresponds to 67 percent of that value.
