Improved Design of a High Density 3D Multichip Module for Class I Medical Devices

Doug Link and Michael Kollar
 Starkey Laboratories, Inc.
 6600 Washington Avenue South, Eden Prairie, MN 55344
 952-641-9401
doug_link@starkey.com
michael_kollar@starkey.com

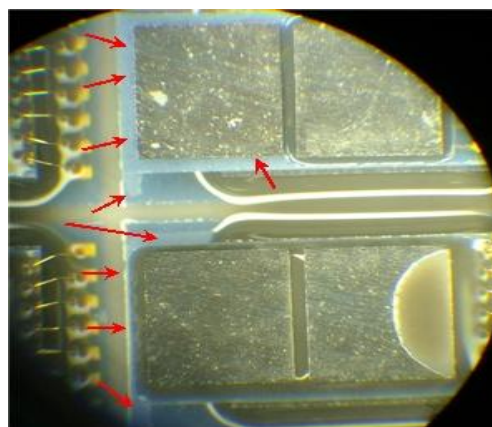
The solder stress test was the first reliability test performed on BGA modules following electrical parametric testing. The solder stress test consists of subjecting the circuits to 3 successive convection oven reflow cycles and a post electrical test. This test simulates the rigors of the manufacturing process including rework and is an indicator of circuit robustness. Nearly 100% of the modules failed the post electrical test. Ink penetration testing of the failed circuits revealed that severe delamination occurred between the underfill epoxy layer and the top dielectric layer of the alumina substrate. The delamination caused electrical failure due primarily to fractured solder joints and cracked microvias within the dielectric structure. A thorough review the BGA assembly process revealed a primary suspect: underfill variation as shown in Figure 4. Anecdotal evidence suggested that insufficient underfill would cause delamination – but a better understanding of

Figure 4: This photo shows typical variation in the amount of wet underfill epoxy observed immediately after jetting on a spin 1 prototype. The red arrows indicate regions where underfill is missing.

To accomplish this we turned to Finite Element Analysis (FEA) – a powerful tool that enabled engineers to study the effects of multiple factors on hybrid thermo mechanical behavior without having to build and test many prototypes.[2] FEA enabled us to study how underfill amount and location affected the interfacial stress present at the underfill-dielectric interface during the solder reflow process. Different underfill materials were also characterized. Figure 5 shows a snapshot from one of the many stress animations that were run. This type of FEA output was useful because it provided a simple visual representation of complex behavior. Insight into the difference between adequate underfill and insufficient underfill was attained. This led to a better definition of underfill jetting requirements.

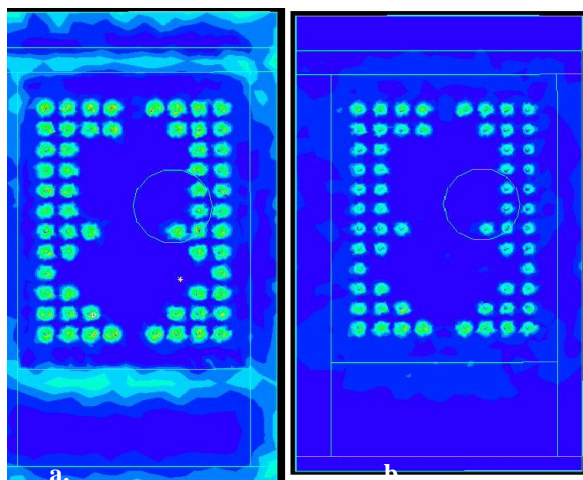
Figure 5: Snap shots from FEA stress animations showing effects of a) insufficient underfill, and b) adequate underfill. Light blue and yellow colors show areas of higher stress that accumulates during the reflow solder process. The plane shown is the interface between the DSP flip chip solder bumps and the ceramic substrate within the BGA module.

Through the use of FEA analysis it became clear that the price of insufficient underfill was higher stress along the edge of the BGA package. We also learned that an FR4 memory PCB would perform better than a ceramic memory substrate, however, FR4 substrates were not readily available so the option was saved for later if necessary. Once the underfill process was optimized we were able to continue by building a batch of improved BGA modules with uniform underfill and continuing with the evaluation process. The spin 2 parts passed the solder stress test and were then subjected to the remaining DVT tests.

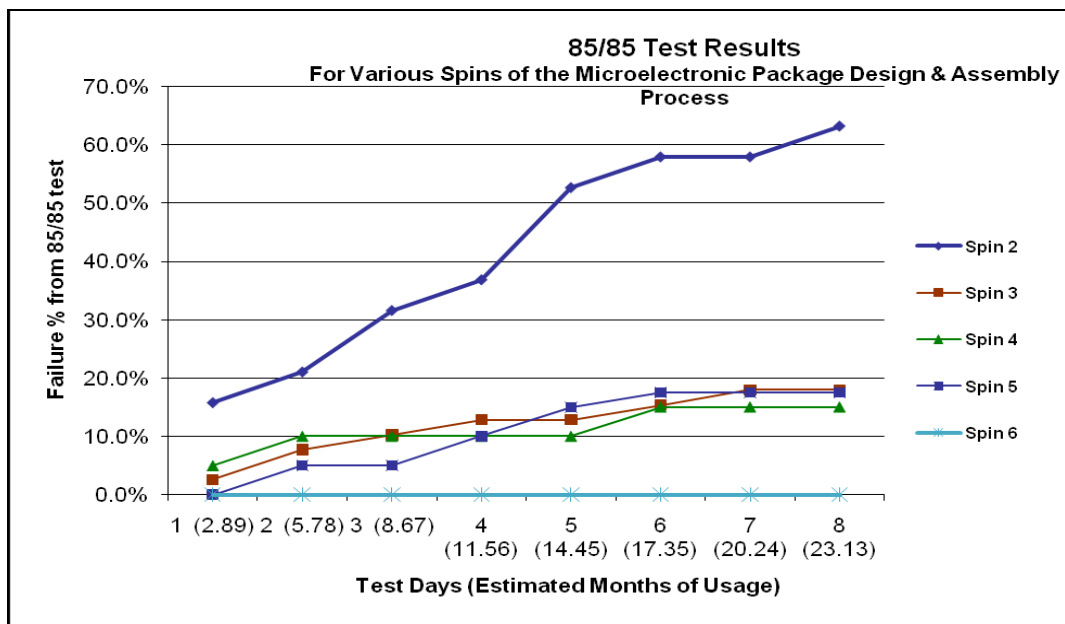
Multiple failure mechanisms were identified during the 85/85 test phase which required a number of fix and retest cycles. The graph in Figure 6 shows the 85/85 results for each successive spin. Following is a discussion of the findings and corrective actions taken for each of these design spins.

Figure 6: Graph showing % failure from the 85/85 test results for successive prototype builds.

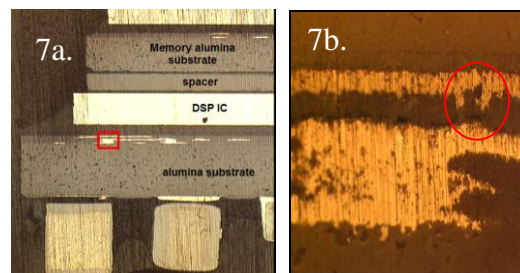
12 of 19 circuits failed due to highly variable drain current observed during the 85/85 test. Experience suggested that metal migration was probably responsible for drain current fluctuations so we searched for dendrite shorts between different electrical nodes. The circuits were removed from the biased test, visually examined (no obvious failure mechanism found), and then subjected to parametric electrical test. Destructive failure analysis (FA) was carried out by carefully microsectioning the module and stopping frequently for high magnification microscopy and continuity testing using a manual microprobe station and multimeter. The primary problem cause was traced to silver dendrites that had grown vertically between metal 2 and metal 3

layers within the thick film BGA dielectric structure as shown in Figure 7. Water and electrical potential are the only two ingredients required to initiate silver migration between silver thick film conductors as described by K. Vu [3]. Many of the dendrites grew from a ground trace in metal-layer 3 to microvias in metal-layer 2 with an electrical potential of about 1.3 VDC between them and separated by as little as 1-5 microns of dielectric in the worst case areas. Typical dielectric separation is ~ 20 microns. The microsections revealed that the thick film microvias were printed too high which reduced the dielectric thickness, enabling silver to migrate through this precariously thin dielectric. These dendrites tended to be clustered along the circuit edge, we assumed, because moisture more readily penetrated these areas. Several copper dendrites were also found growing between solder bumps on the flex underneath the BGA module. This was caused by poor solder mask registration (which exposed copper) and was readily corrected by the flex supplier. Recalling the earlier FEA results, we decided to replace the ceramic memory substrate with an FR4 PCB substrate to further reduce thermal stress making it less likely for the dielectric to crack. The other remedies included reducing the amount of via fill during the thick film printing process and modifying the thick film module layout slightly by moving buried vias further away from the diced edge.

Figure 7: a) Photograph of a defective BGA module in cross section at 50x magnification. The red box shows the dendrite area. b) Dendrite area at 1000x magnification. Silver migration is visible within the red circle.

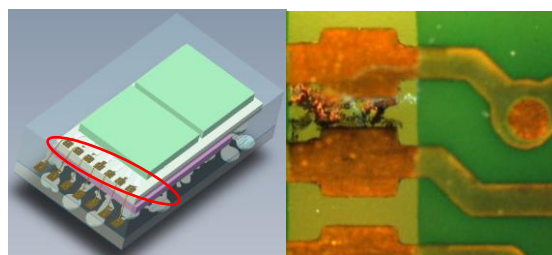
Spin 3 circuits showed a notable improvement in 85/85 testing, but as Figure 6 shows several failures still occurred – again with symptoms of fluctuating drain current and shorts between nodes. Following the same FA process, faults were isolated to two primary locations where again dendrites were found. But this time the dendrites were copper! They had grown between adjacent bond pads on the memory PCB substrate (Figure 8).

SEM/EDS analysis which revealed that the bond pad edges were totally free of the specified nickel/gold plating, exposing copper along this surface. In this application two adjacent bond pads supply 2 V DC to the memory module. With a spacing of 100 μm between pads, the effective electric field strength is 500V per inch, making these pads vulnerable to copper migration. So we hypothesized that copper migration could readily occur between bond pads due to the exposed edge copper. A simple water drop test was conducted to test this hypothesis following the method outline in IPC Test Method 2.6.13 [4]. A bare PCB as received from the supplier (with exposed copper along the bond pad edges) was tested against a thick film ceramic substrate. The bond pads of the ceramic substrate were made of conventional thick film gold at a fired thickness of $\sim 10 \mu\text{m}$ with size and pitch similar to the PCB.

A drop of deionized water was placed atop adjacent bond pads which were energized with a 2VDC potential via a probe station while the pads were observed through the probe station's optical microscope. To our surprise copper dendrites grew from the negative pad to the positive pad within 7-30 seconds! See Figure 8b. In contrast, no metal migration occurred on the thick film substrate after 30 minutes with water and voltage applied. We even tested a slightly different PCB design from another supplier and found that no dendrites formed after 30 minutes between bond pads – the only difference being that the gold plating coverage on the bond pads was uniform. Here is a good point for a more detailed explanation of the copper migration failure mechanism.

Figure 8: a) Internal view of BGA design showing the wire bond pads of the memory module where dendrites formed. b) A copper dendrite that grew between wire bond pads on the bare memory PCB during a water drop test.

4. Take care to specify complete gold (or suitable alternative plating) coverage for bond pads and other connection pads on flex and rigid PCBs even if the PCB is designed to be fully encapsulated at a later operation. No exposed copper! Discuss this with the PCB supplier and verify complete plating coverage with SEM/EDS or other analytical technique upon receipt of the PCBs. Do not rely on standard optical inspection.

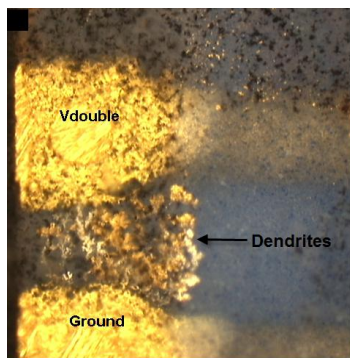
As the graph in figure 6 shows, the spin 4 test results with the ceramic memory substrate were disappointing and about the same as spin 3. This time dendrites were found between the gold wire bond pads of the thick film memory substrate. They were confirmed by carefully lapping down through the BGA's encapsulation and stopping just above the bond pads so as not to disturb the fragile dendrites that were only several microns below. See Figure 9.

SEM/EDS analysis confirmed the dendrite composition was primarily silver and gold. The silver had migrated from the nearby overlap region between the gold bond pad and connecting palladium silver trace. Memory module subassemblies were removed from the build area, just prior to assembly into the BGA module, and examined both optically and using XPS [5]. Optical inspection revealed a thin, oily film on the bond pads; the film was believed to be compounds that had bled out from the underfill fillet. XPS revealed high concentrations of sodium chloride and organic compounds on the thick film memory substrate; particularly around the gold wire bond pads. Had this condition also existed in the samples of the prior spin when dendrites formed on the PCB memory substrate? Quick examination of the prior spin 3 samples gave us the answer: yes, we had missed this contamination. We identified several possible ways the oily film might aid silver migration: a) by behaving as an electrolyte, b) interfering with encapsulation adhesion allowing moisture to penetrate, c) trapping ionic contamination, or d) a combination of these three.

Figure 9: 85/85 test failure with dendritic growth visible between bond pads on the ceramic memory substrate. 200X.

The sodium chloride contamination was traced to the dicing saw which had been plumbed improperly to a water conditioner. The problem was corrected by fixing the plumbing and modifying the rinse method. The organic material on the pads was traced to “bleed out” from the underfill epoxy fillet as expected – the underfill fillet had extended too close to the bond pads. A new underfill material was found to produce better results due to the smaller fillet it produced and its color which made it easier to inspect.

Added design margin was achieved by increasing the spacing between the power supply pads to 200 μm . Again another prototype batch was produced with these modifications and with hope that this would be the last prototype run.

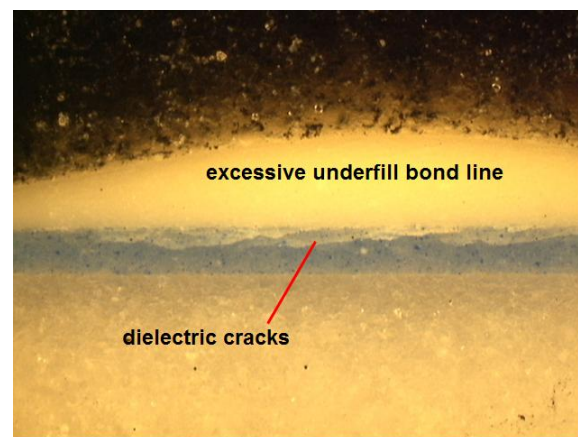
The spin 5 circuits suffered a similar fate to the previous runs. The results were better during the first several days of test, but by the end of the 8 day test 7 of 40 circuits had failed as shown in Figure 6. This time an electrical short was traced to one specific location within the BGA dielectric structure. Silver migration had again occurred between layers, from a metal 3 ground trace down to a metal 2-3 via at a 1.3V DC potential difference. This time however there was an added complication. Small cracks were visible in the dielectric layer along the externally diced edge near the dendrite site. These cracks were believed to be the entry point for water vapor during the 85/85 test. It was an interesting coincidence that cracks were found in samples with thicker underfill bond lines as shown in Figure 10. The prior FEA work had shown that thicker underfill tended to induce higher localized stress so we decided to reduce the underfill thickness to 25-50 μm by further tuning of the underfill jetting process. Also, the dicing saw feed rate was reduced slightly as a preventive measure.

Figure 10: External side view of module showing cracks in the blue dielectric of an 85/85 test failure at 200x. Silver migration was found inside the component near this cracked region. Underfill bond line of 100-125 microns was deemed excessive.
