Environmental impact of cured-in-place pipe renewal on an asbestos cement water main

John C. Matthews, Ryan J. Stowe and Saiprasad Vaidya

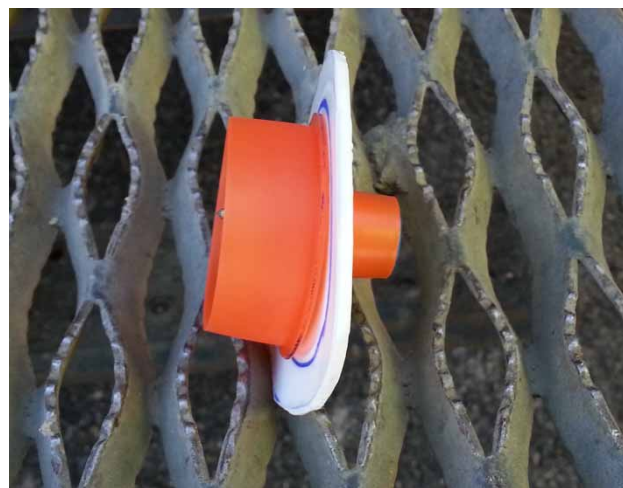
Prior to lining, the host pipe was inspected via closed-circuit television (CCTV) to determine condition and locate all services. After the inspection, the pipe was cleaned using a water jet and any remaining water was removed using a squeegee. Once the pipe was dry, the services were plugged to prevent blockage during liner installation (Figure 1). Services up to 50-mm (2-in) were plugged using the CCTV robot.

Figure 1 | Assembled service connection plug.

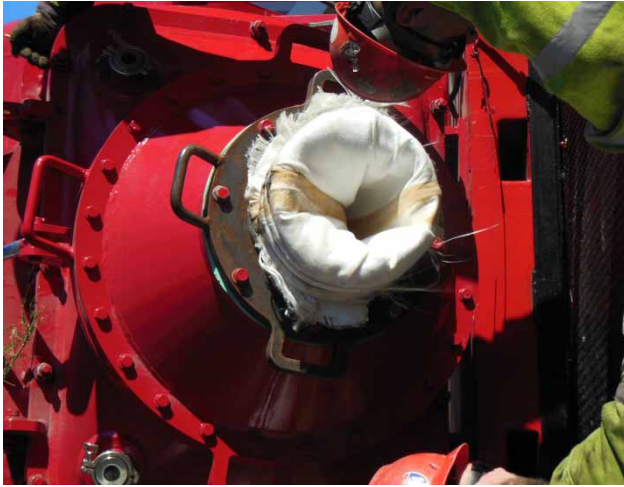
The liner was prepared off-site where it was impregnated with a thermosetting epoxy resin. The installation procedure used was inversion, which is a common method for CIPP insertion that has been around for more than 40 years. The pit where the liner was inserted into the pipe from the inversion truck was designated Station A. Once in position, a short length of liner was pulled through the opening of the pressure vessel, inverted, and attached to the sidewalls (Figure 2).

Figure 2 | Inverted liner end attached to pressure vessel opening.

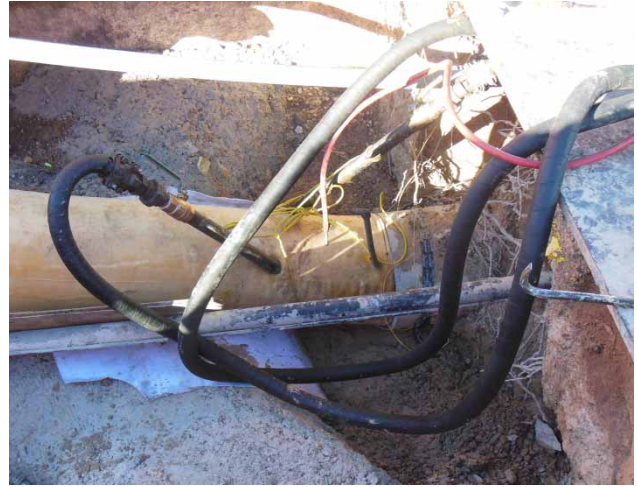
The liner was thermally cured using steam. The pressure vessel located at Station A regulated the steam into the liner at a pressure of 69 kPa (10 psi). The temperature of the steam at Station A was between 82 °C (180 °F) and 99 °C (210 °F). The steam exited the liner at Station B through two hoses that served as vents. Each vent hose was connected to a sharpened, metal pipe called a ‘stinger’, which was used to puncture the protruding liner (Figure 3) as a means to regulate the liner’s internal pressure and temperature.

Figure 3 | Liner punctured by stingers at Station B.

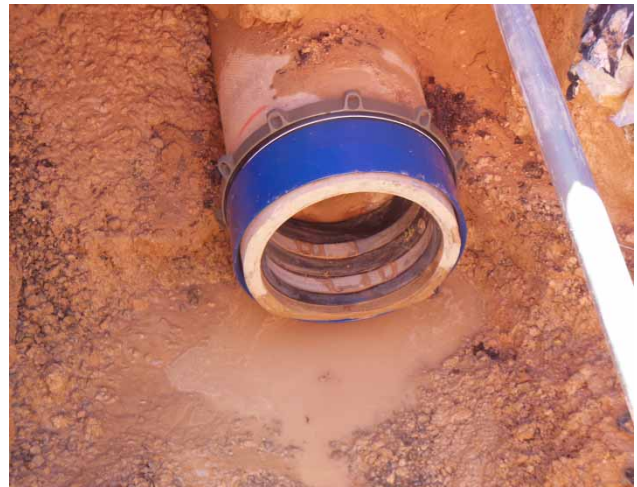
Curing of the liner was accomplished by maintaining the set temperature, which lasted around 3 hours after reaching an even temperature. Following curing, the liner was allowed to cool to ambient temperature for 1 hour. Once the liner had cooled, the stingers were removed and the liner was cut flush with the end of the pipe. End seals were installed at each end to prevent water from getting behind the liner once the pipe was back in service (Figure 4).

Figure 4 | Finished end seal.

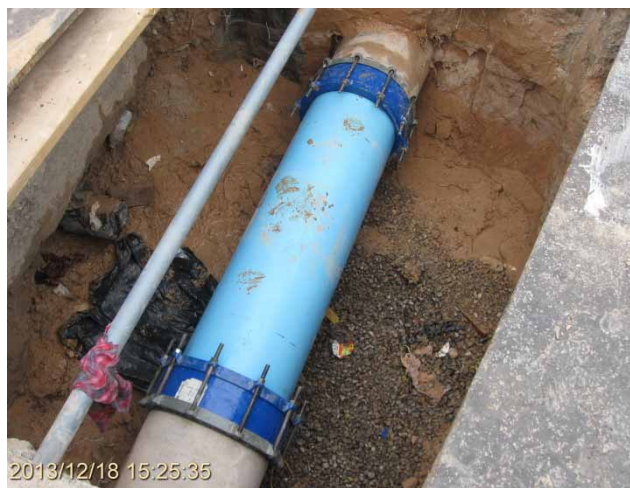
Post-lining included service reinstatements, disinfection, reconnection of the water main, and the removal of the bypass. Services were reinstated robotically with a cutting tool that allowed it to cut out the plugs. Of the 31 services, only one did not allow for robotic reinstatement and had to be excavated. The lined sections of AC were joined using C905 polyvinyl chloride (PVC) pipe (Figure 5). Finally, the entire length of pipe was disinfected, the bypass was removed, and the site was restored.

Figure 5 | Lined AC pipe sections connected by PVC pipe.
