Environmental impact of cured-in-place pipe renewal on an asbestos cement water main

John C. Matthews, Ryan J. Stowe and Saiprasad Vaidya

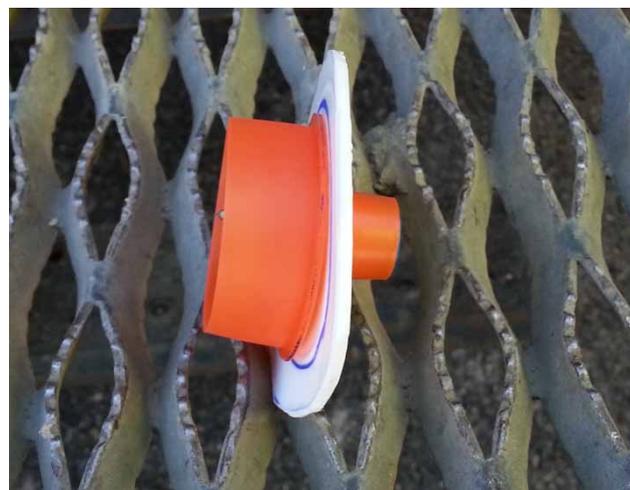
Prior to lining, the host pipe was inspected via closed-circuit television (CCTV) to determine condition and locate all services. After the inspection, the pipe was cleaned using a water jet and any remaining water was removed using a squeegee. Once the pipe was dry, the services were plugged to prevent blockage during liner installation (Figure 1). Services up to 50-mm (2-in) were plugged using the CCTV robot.

Figure 1 | Assembled service connection plug.

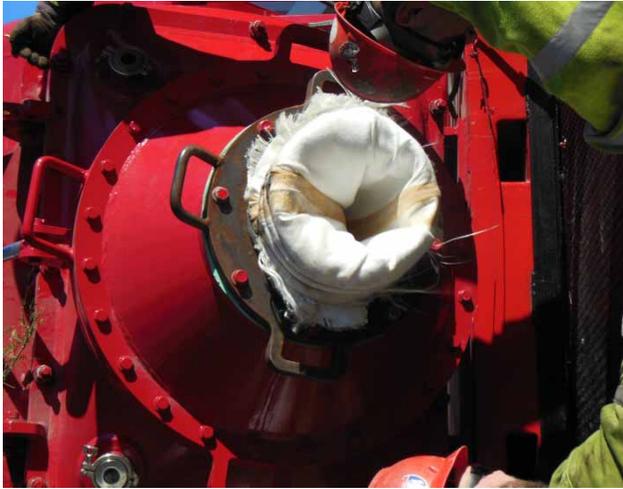
The liner was prepared off-site where it was impregnated with a thermosetting epoxy resin. The installation procedure used was inversion, which is a common method for CIPP insertion that has been around for more than 40 years. The pit where the liner was inserted into the pipe from the inversion truck was designated Station A. Once in position, a short length of liner was pulled through the opening of the pressure vessel, inverted, and attached to the sidewalls (Figure 2).

Figure 2 | Inverted liner end attached to pressure vessel opening.

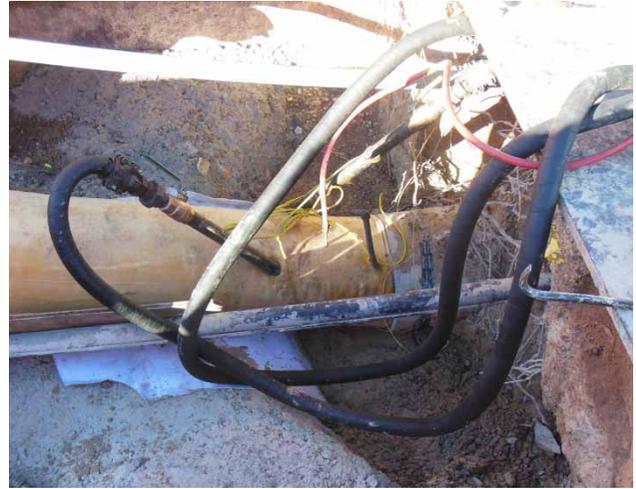
The liner was thermally cured using steam. The pressure vessel located at Station A regulated the steam into the liner at a pressure of 69 kPa (10 psi). The temperature of the steam at Station A was between 82 °C (180 °F) and 99 °C (210 °F). The steam exited the liner at Station B through two hoses that served as vents. Each vent hose was connected to a sharpened, metal pipe called a ‘stinger’, which was used to puncture the protruding liner (Figure 3) as a means to regulate the liner’s internal pressure and temperature.

Figure 3 | Liner punctured by stingers at Station B.

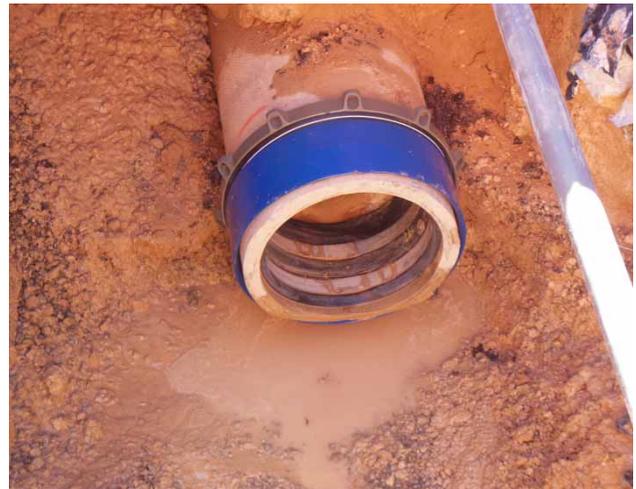
Curing of the liner was accomplished by maintaining the set temperature, which lasted around 3 hours after reaching an even temperature. Following curing, the liner was allowed to cool to ambient temperature for 1 hour. Once the liner had cooled, the stingers were removed and the liner was cut flush with the end of the pipe. End seals were installed at each end to prevent water from getting behind the liner once the pipe was back in service (Figure 4).

Figure 4 | Finished end seal.

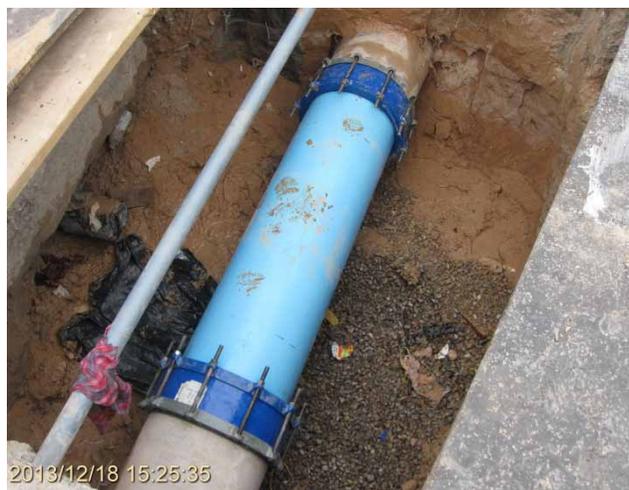
Figure 5 | Lined AC pipe sections connected by PVC pipe.
