## Exposure of Ceramics and Ceramic Matrix Composites in Simulated and Actual Combustor Environments

Karren L. More, Peter F. Tortorelli,  
Mattison K. Ferber, Larry R. Walker, and James R. Keiser  
Oak Ridge National Laboratory  
Oak Ridge, Tennessee

Narendernath Miriyala, William D. Brentnall, and Jeffrey R. Price  
Solar Turbines Incorporated  
San Diego, California

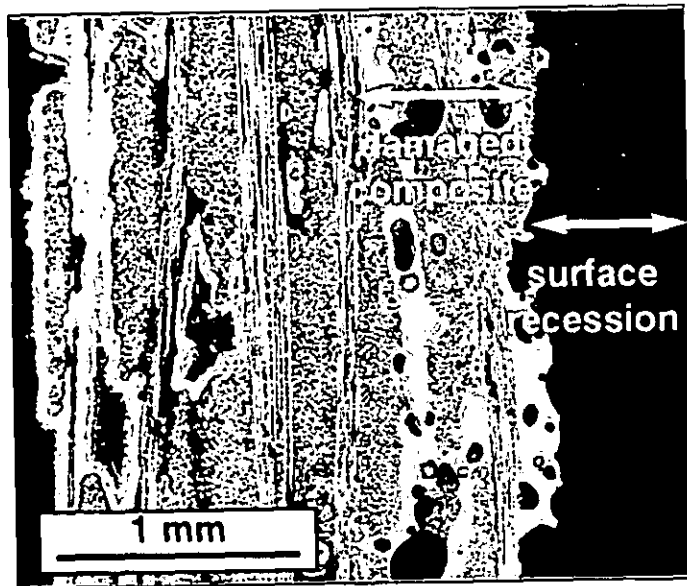
Microstructural examination of the inner liner showed that significant surface recession occurred during the ARCO test. As shown in Figures 5(a) and 5(b), comparing sections of the inner liner from the top surface (CFCC exposed to the lowest temperature during the engine test) and from the center of the exposed surface of the inner liner (near maximum damage area), respectively, recession of about 20% of the inner liner thickness was observed and another 25% of the CFCC exhibited microstructural damage (see arrows in Figure 5(b)). The damage assessment indicated that not only was the protective SiC seal coat (initially ~60  $\mu\text{m}$  thick) completely removed during engine testing, but the CFCC constituents themselves had reacted to form a low melting point glass at the liner surface. The oxidation of the SiC seal coat (and matrix) resulted in the rapid formation of surface silica; the silica then formed volatile reaction products in the water containing environment (Opila and Jacobsen, 1998, Robinson and Smialek, 1998) resulting in accelerated SiC recession. The projected CVD SiC recession after 1000 h under lean-burn conditions, estimated from burner rig studies performed at NASA Lewis, is ~150  $\mu\text{m}$  at 1200°C, 0.6 atm H<sub>2</sub>O, and a gas velocity of 33 m/s (Robinson and Smialek, 1998). The maximum temperature during the ARCO test could not be accurately measured since the thermocouples failed in the early stages of the field test. However, based on the intermittent visual inspections of the liners during the ARCO test, the seal coat on the inner liner (and locally on the outer liner) was breached relatively early in the test indicating that the temperature was ~1200°C, and possibly as high as 1260°C at the hot spots on the inner liner.

Figure 5. Microstructural damage at outer surface of inner liner after the ARCO test. (a) Section of liner taken from top (cooler) edge of liner showing intact SiC seal coat and non-damaged composite and (b) section taken from center of exposed surface showing significant surface recession, loss of most of the seal coat, and extensive composite damage below the surface. Damage regions below surface consist primarily of reacted matrix constituents that form glass and loss of fibers.

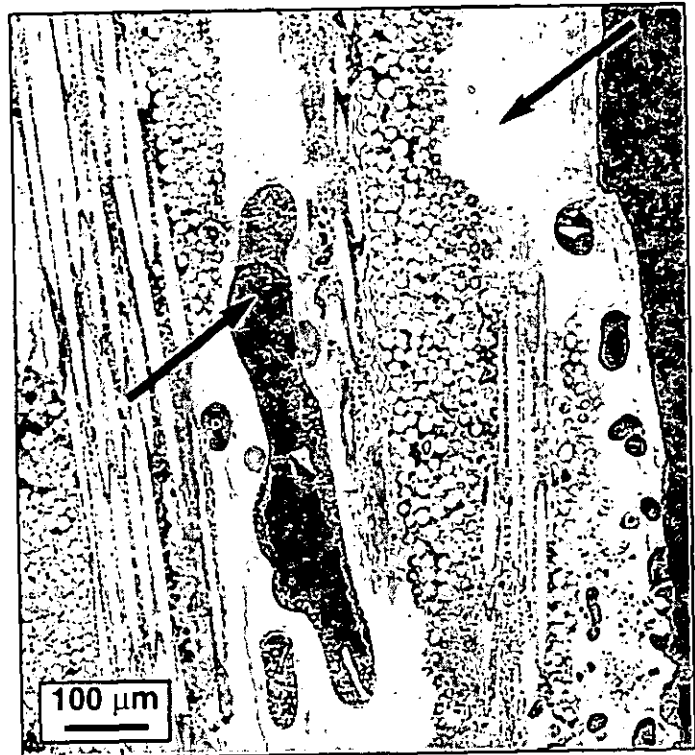
Typical microstructural damage observed at the outer surface of the inner liner is shown in Figure 6. Large "pools" of glass were observed; the CG Nicalon™ fibers and associated matrix constituents reacted with the glass and entire fibers tows were consumed during glass formation (as shown in Figure 7). While most of the glass was primarily silica, small amounts of

boron were found in these areas (additional matrix constituents were the source of the B), which caused a reduction in the glass melting point. Matrix constituents containing boron therefore contributed significantly to the glass formation. Similarly damaged areas were also identified well below the exposed surface of the inner liner (arrows in Figure 6) and were primarily associated with areas of large porosity (these composites typically were only about 85-90% dense), indicating significant oxidation in these areas also. Formation and subsequent recession of the glass product was the primary degradation mechanism of the outer surface of the inner liner. The process was accelerated by the damage formed below the surface.

Figure 6. Typical microstructural damage observed at the outer surface of the inner liner. Arrows indicate areas of "pooled" glass observed throughout damaged region.

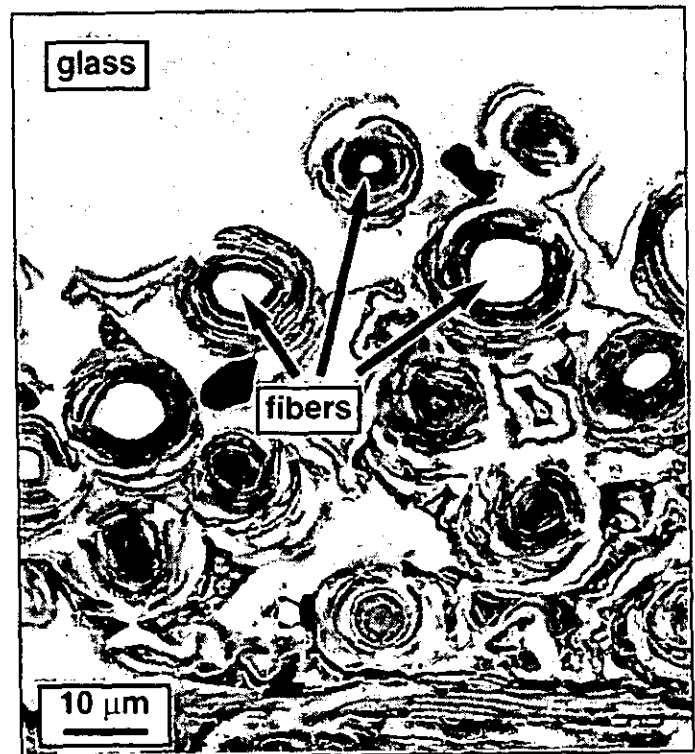
Figure 7. CG Nicalon™ fibers were consumed during extensive matrix glass formation within damaged regions near exposed surface of inner liner. Arrows indicate fibers at different stages of reaction with glass.

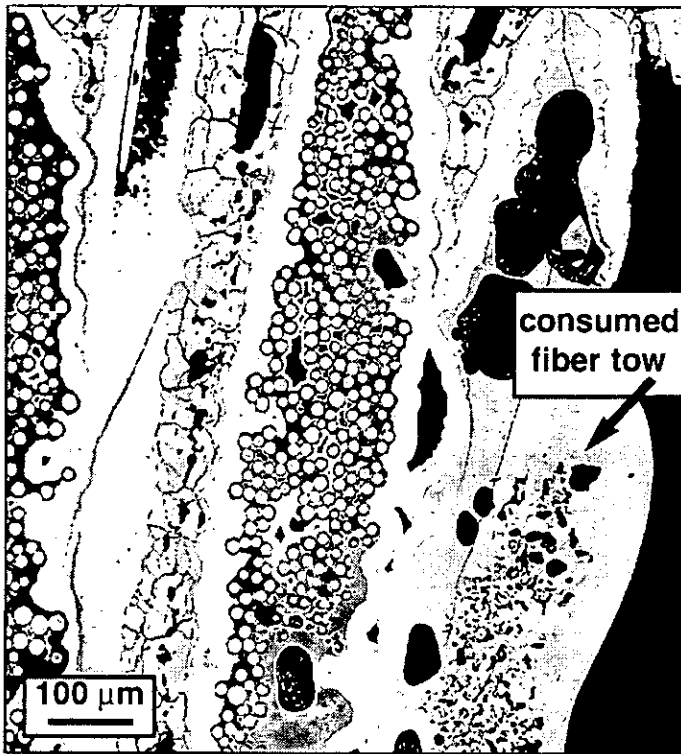
Evaluation of the injector impingement areas on the inner surface of the outer liners showed similar microstructural damage as that observed on the inner liner, albeit to a much lesser extent; the SiC seal coat was completely removed in these localized areas, but only the top CG Nicalon™ fiber ply was adversely affected, as shown in Figure 8. In the areas surrounding the injector impingement regions, the SiC seal coat was somewhat thinned (the thickness of the remaining seal coat depended primarily on the local temperature), but remained intact. The surfaces of pores below the liner surface were oxidized (this was most pronounced below the injector impingement areas) and in many instances, matrix and fiber damage around these pores was observed well into the bulk of the underlying CFCC. Clearly, on both the inner and outer liner working surfaces, the "white areas" indicated complete loss of the protective SiC seal coat. This will be used in future borescope inspections as an indication of the point at which the protective seal coat is breached.

Figure 8. Typical microstructural damage observed at the inner surface of the outer liner after the ARCO test. Microstructural degradation was similar to that observed for the inner liner.

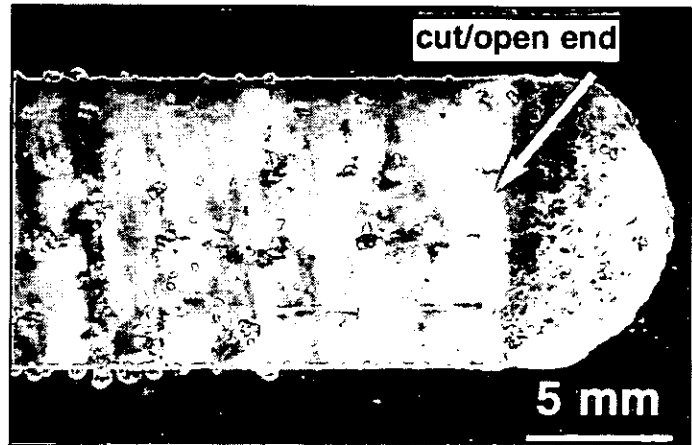
liners (which have no open or cut ends). Figure 9 is a photograph of the Enhanced SiC/SiC specimen removed after 500 h. Note the excessive amount of glass protruding from the surface cut before the test; not only is there usually no seal coat on these ends, but the exposed fiber ends and open areas into the matrix contribute to accelerated degradation. The specimen for microstructural analysis was cut at least 1 cm below this open surface.

Figure 9. Surface of Enhanced SiC/SiC specimen after 500 h exposure in ORNL rig. Material was co-processed with CFCC liners in ARCO test. Specimen geometry contributed to significant glass formation at cut/open edges.

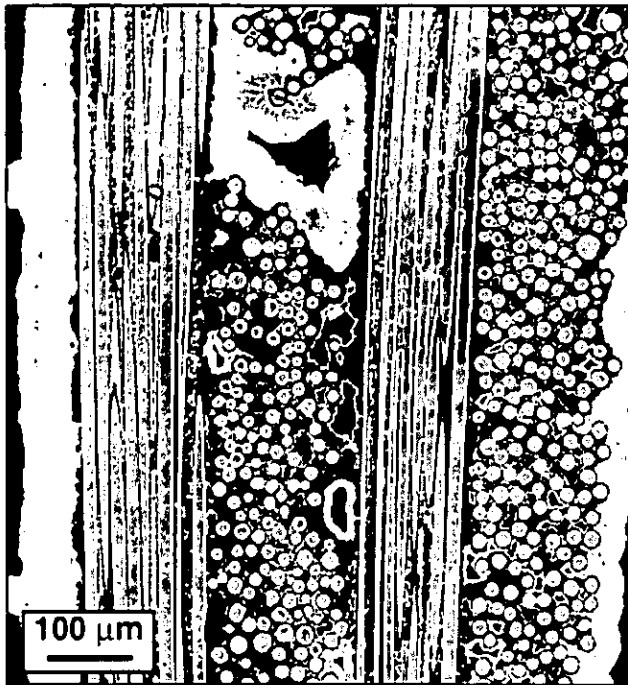
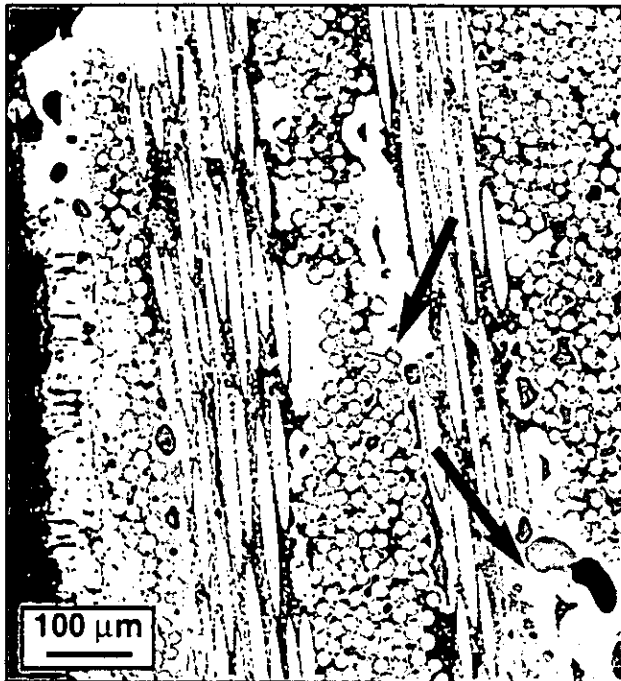
Cross-sections of the as-processed Enhanced SiC/SiC composite before and after exposure in the ORNL rig for 500 h are shown in Figures 10(a) and 10(b), respectively. The SiC seal coat was fully oxidized across the specimen surface and fiber tows below the surface showed areas of constituent reaction (arrows in Figure 10(b)). The damaged composite areas in the ORNL-exposed specimen were structurally similar to those observed for the same material after the ARCO test (see Figure 6); localized areas of constituent reaction (glass formation) are noted in Figure 10(b). The same specimen was placed back in the ORNL rig for an additional 500 h, thus exposing the material for approximately the same amount of time achieved in the ARCO test. After 1000 h in the ORNL rig, the microstructural degradation was extensive, as shown in Figure 11, and was nearly identical to that observed for the same material engine tested at ARCO. There was significant glass formation at the surface.

Figure 10. A comparison of cross-sections of the (a) as-processed Enhanced SiC/SiC material and (b) the Enhanced SiC/SiC CFCC after exposure in the ORNL rig for 500 h. Compare localized microstructural degradation (reacted matrix constituents) in Figure 10(b) (indicated by arrow) to inner liner degradation shown in Figure 6.

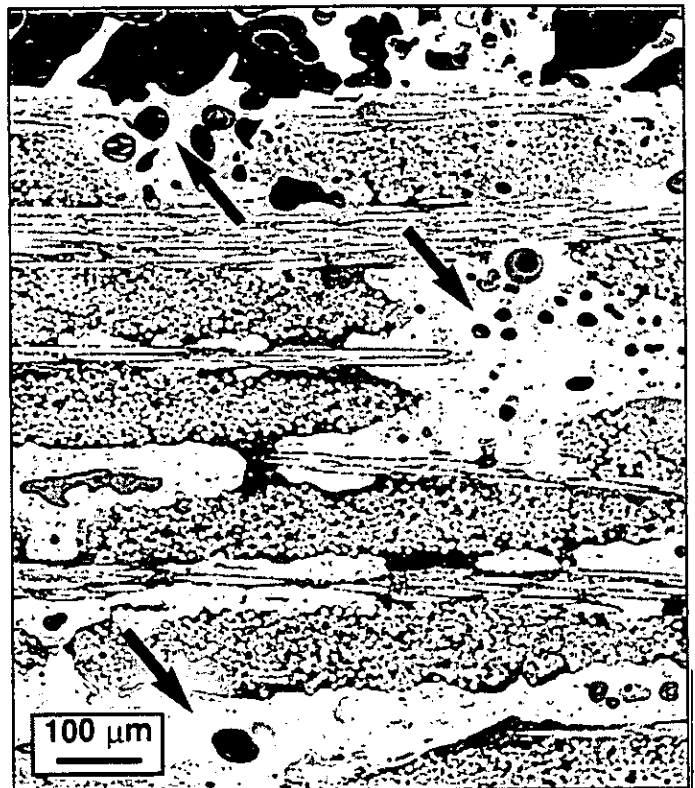
Figure 11. Microstructural degradation of Enhanced SiC/SiC CFCC after exposure in the ORNL rig for 1000 h. Compare microstructural degradation (reacted matrix constituents) in Figure 11 (indicated by arrow) to inner liner degradation in Figure 6.

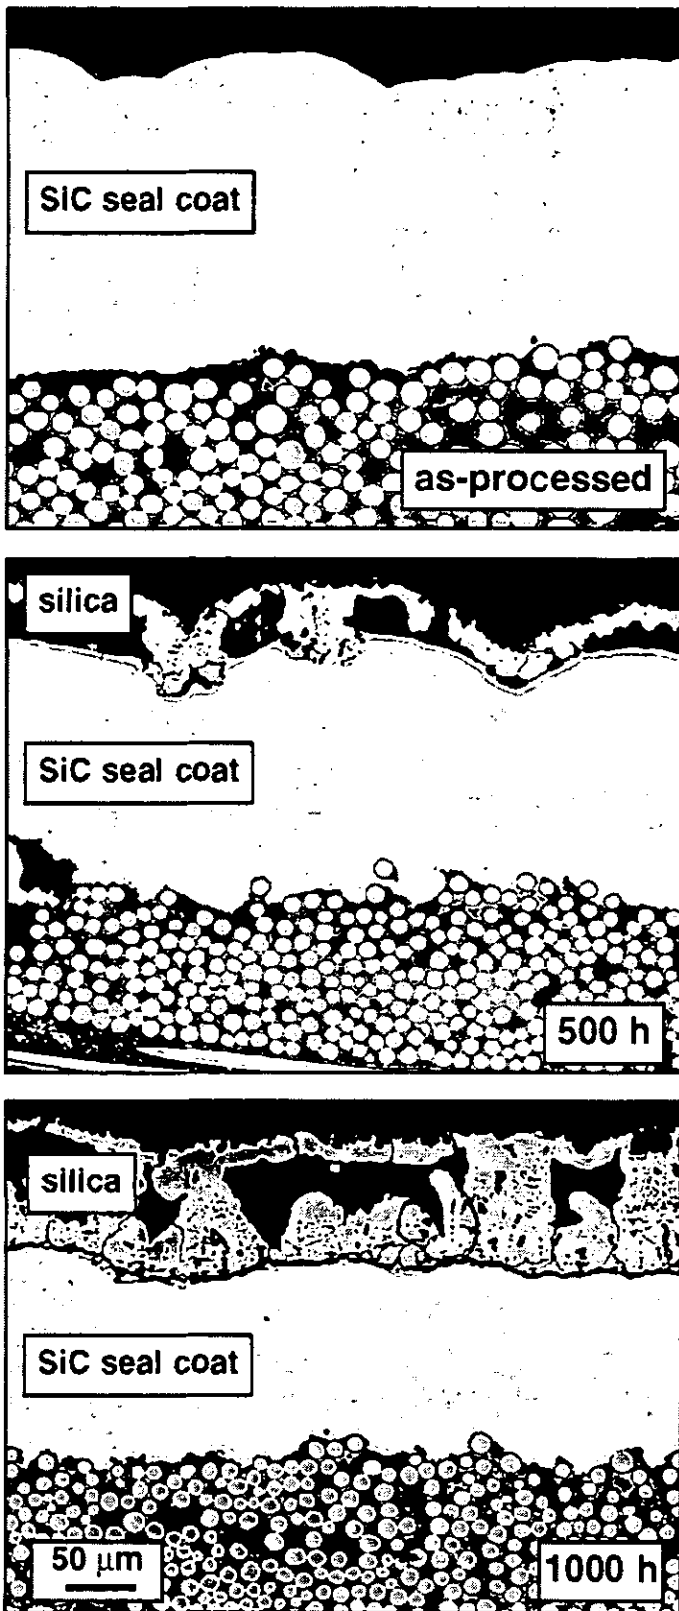
The Enhanced SiC/SiC sample with a thick CVD SiC seal coat was used to determine the CVD SiC oxidation/recession rate in the ORNL rig. Figure 12 shows the oxidation of the SiC seal coat for three sequential 500 h exposures. It was determined from direct microstructural measurements that the SiC seal coat recessed by oxidation at a maximum linear rate of approximately  $45 \mu\text{m}/500\text{h}$ . Clearly, the oxidation/recession rate of the SiC was accelerated in the ORNL rig compared to rates reported previously for CVD SiC exposed at lower water vapor pressures (Opila, 1994 and Opila,

Figure 12. CVD SiC seal coat oxidized for 500 and 1000 h. It was determined from direct microstructural measurements that the SiC seal coat recessed by oxidation at a linear rate of approximately  $45\mu\text{m}/500\text{h}$ .
