## ADVANCES IN GAS TURBINE BLADE REPAIR BY LASER WELDING

### ABSTRACT

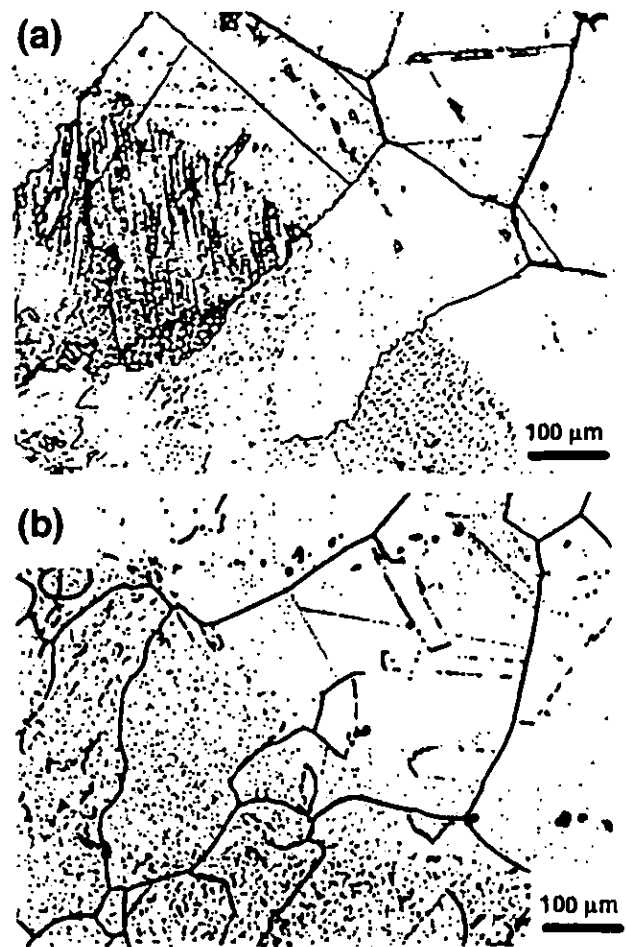
FIGURE 5 – METALLOGRAPHIC EXAMINATIONS  
a) BEFORE HEAT TREATMENT  
b) AFTER HEAT TREATMENT

The metallographic specimens (figure 5) show a very narrow heat-affected zone in which, after heat treatment, it is almost impossible to distinguish the transition to base material. The weld area is sound and has a good bonding to the base material. No cracks or porosities were detected. By means of EDS microanalysis the chemical composition of base material, heat-affected zone and weld zone was checked, with the results contained in figure 6: the composition is practically the same. A microhardness testing was performed along a welded and heat treated specimen, with the results shown in figure 7.

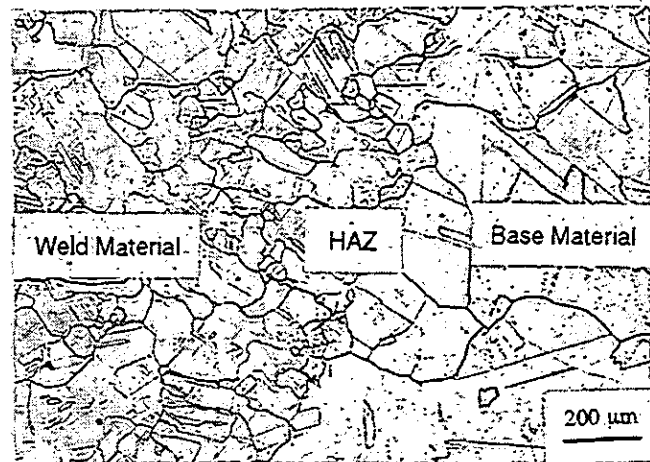
FIGURE 6 - MICROGRAPHIC EXAMINATION AND EDX MICROANALYSIS OF THE WELDED AREA

CHEMICAL COMPOSITION (WEIGHT %)							
	Ni	Co	Cr	Al	Ti	Mo	Si
BASE	57.1	12.8	19.1	1.83	3.18	6.71	0.18
HAZ	56.6	12.7	18.9	1.77	3.04	6.54	0.35
WELD	57.7	13.0	18.9	2.15	2.9	6.09	0.14

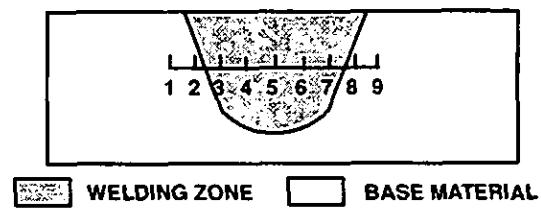
FIGURE 7 - VICKERS HARDNESS VALUES ALONG THE WELDED SPECIMEN

Indentation spacing: 3 mm

POSITION	HV 0.3
1	391
2	384
3	331
4	346
5	308
6	315
7	334
8	379
9	387

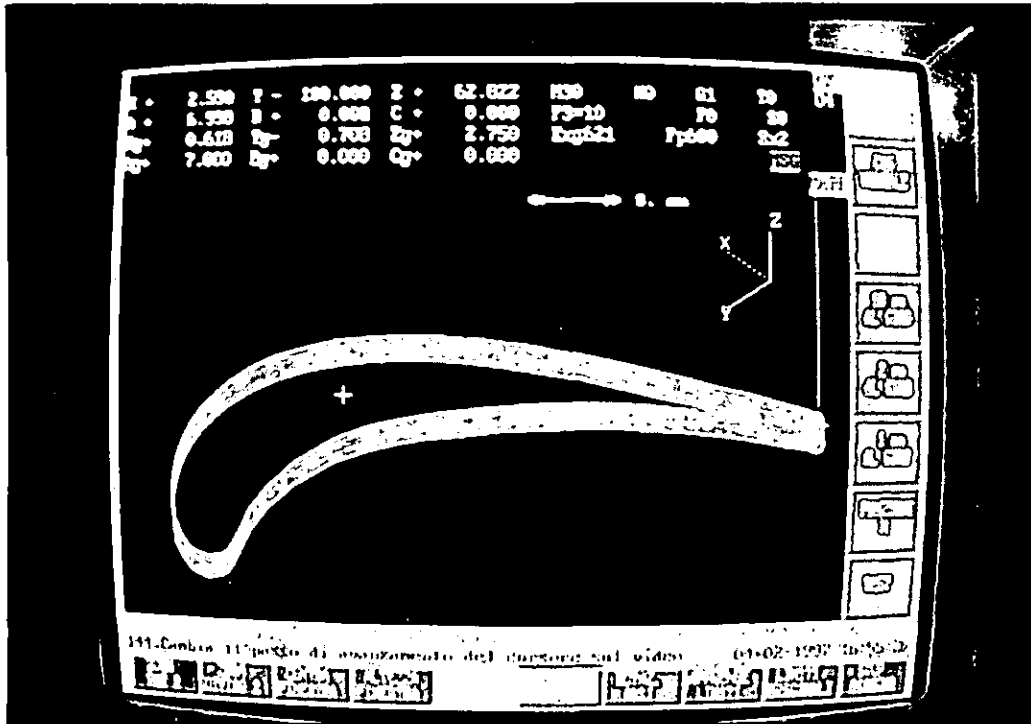
FIGURE 8 – LASER WELDING PROGRAM FOR THE BLADE TIP

To perform the repair cycle on actual components it was necessary to set a CNC program able to rebuild the original blade geometry by multi-layer cladding (figure 8). This per-

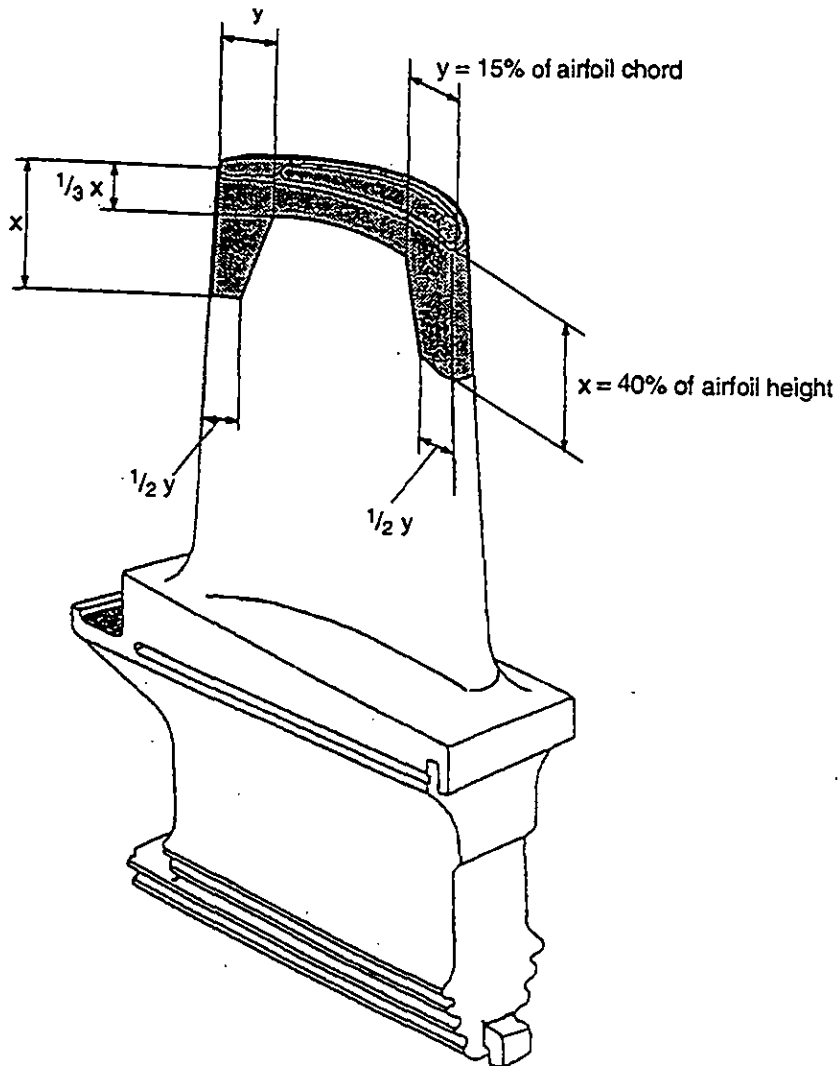
FIGURE 10 – SKETCH OF WELDING REPAIR LIMITS

The use of the welding repair process by laser with a filler material having mechanical properties similar to the base alloy, can allow not only to increase the reparability area on the tip of the airfoil, but also to be able to repair critical areas of the blades. Figure 10 shows the present limits of reparability by means of TIG welding using Inconel 625 alloy as filler metal: the darker area shows the zone where the welding repair is allowed. It is possible to fill material not exceeding 25 % of the entire darker area volume, while with laser welding, the target is to fill up to 100 % of the volume. It will of course be necessary to evaluate, case by case, the economical benefit of extended repair as compared to component scrapping.
