## Monitoring the quality of sewer renewal using polymeric systems in Sweden

Parastou Kharazmi

KTH Royal Institute of Technology, Brinellvagen 23, SE-100 44, Stockholm, Sweden

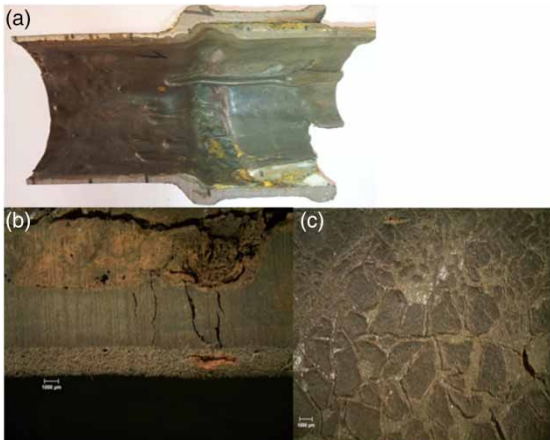
Images 1 (a), (b) and (c): sample 1.

<p>Images 1 (a), (b) and (c) – sample 1 was relined using the modified epoxy polymeric system. Defects include thickness variation and runs (1(a)), cracks (1(b)) and surface cracks (1(c)). Corrosion between the liner and host surface was also observed in some places.</p>

One of the repeated issues was uneven lining thickness – i.e., too much or too little material being applied. Excessive material application, contrary to the manufacturer's recommendations, can lead to a range of defects, including runs, which can be seen in Image 1(a) and Images 3 and 6(a).

If the dry film is too thick, this limits liner flexibility and can cause stress failure cracks – Images 1 (b) and 6 (a). The surface cracks seen in Image 1(c) – the so-called alligator defect – may also be due to excessive application. When the film is too thick, the top layer can cure faster than the rest, causing surface cracks after all the layers are cured. Small areas of excess material – see Image 6(a) – can be due to faults in the spray machine used for application.

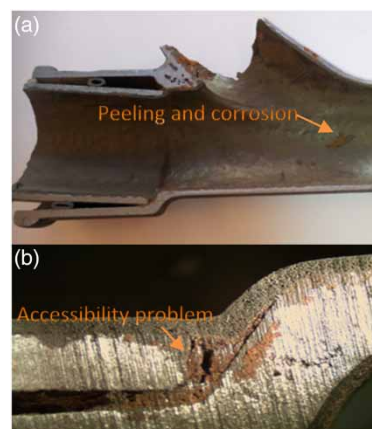
Image 2 (a) and (b): sample 2.

Images 2 (a) and (b). The pipe was relined using the modified epoxy polymeric system. Defects include liner peeling (2(a)), un-coated spots and areas without liner coverage, particularly where access was difficult (2(b)) and some corrosion.

In samples 2, 4 and 7, however, material application was inadequate in places, such that the surface cover was insufficient. Applying a uniform layer of liner can be difficult for pipe segments such as sample 2, due to its specific design and structure. The coating application was so poor in sample 4 that many areas were left without coverage – Image 4. The impregnation of material was very poor in sample 7.

Poor surface preparation can cause peeling – Image 2(a) – probably due to contamination reducing the strength and bonding inside the material, which can be pulled or flake away from between coating layers (Image 2(a)), or between the coating and the pipe – e.g., along the edges of sample 3 (Image 3). Delamination or segregation – sample 5 – probably occurs due to inadequate surface preparation.

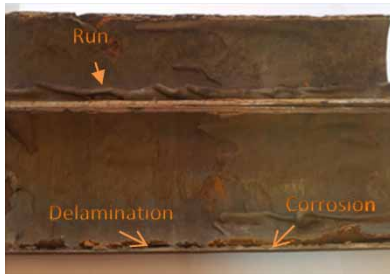
Image 3: sample 3.

Image 3. The pipe was relined using the modified epoxy polymeric system. Defects include runs, loose adhesion of epoxy lining to the host, liner delamination from the pipe, corrosion, and uneven liner film application.

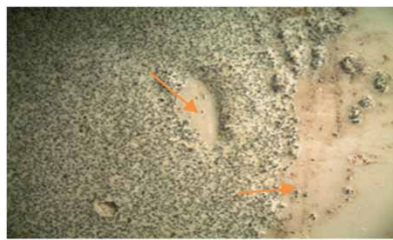
Image 4: sample 4.

Image 4. The pipe was relined using the modified epoxy polymeric system. The relined pipe was removed after only 2 weeks because the application failed, leaving a non-uniform, inadequate lining film. Many parts had no liner coverage.

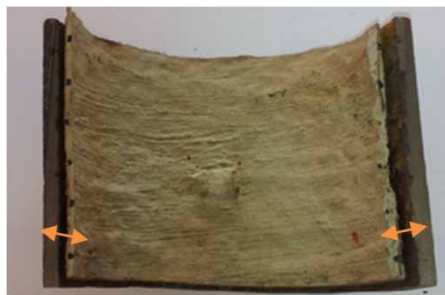
Image 5: sample 5.

Image 5. The pipe was relined using the reinforced polyester polymeric system. Defects include delamination and the lining thickness not being uniform. When the piece of pipe was cut, the lining layer came off, revealing corrosion underneath.

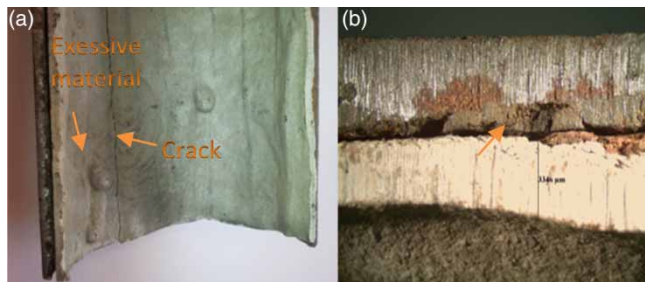
Image 6 (a) and (b): sample 6.

Images 6(a) and (b). The pipe was relined with reinforced polyester and had been in use for only seven days before being removed due to application failure and defects. The excessive film application, thickness variations and cracks can be seen in 6(a), with corrosion between the liner and host pipe (6(b)). Other defects were also observed.

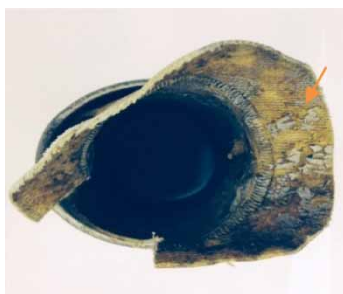
Image 7: sample 7.

Image 7. The pipe was relined using the flexible sleeve method and the sample removed shortly after installation due to the poor quality of the renovation. Impregnation of the material into the textile was very poor, as can be seen. The technical history available for the rehabilitation was insufficient to enable analysis of the cause of the issue.

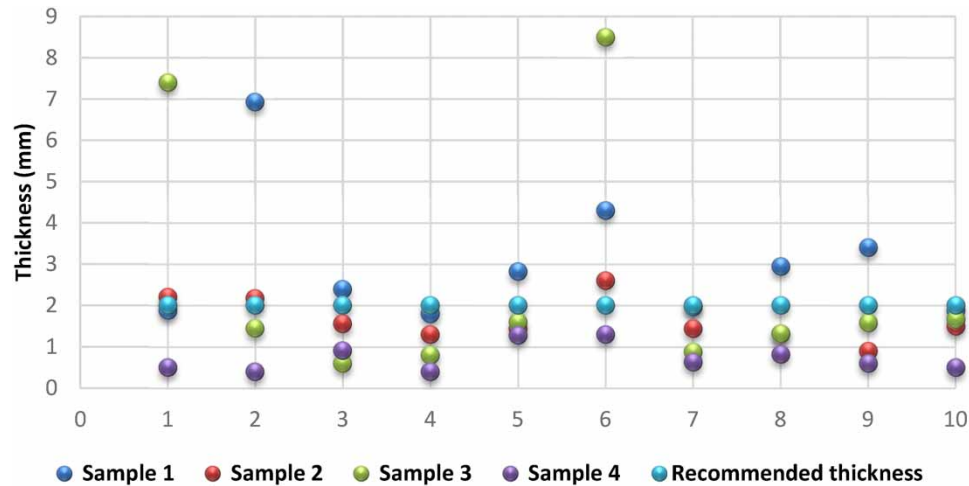
**Figure 1** | Ten thickness measurements (five points from each edge of each sample) for samples 1 to 4 (relined with epoxy) and compared with the recommended thickness.

The nominal dry film thickness for liners based on modified epoxy is 2 mm, if applied in two layers, so that each layer is between 900 and 1,100  $\mu\text{m}$  in thickness. For reinforced polyester coatings, the total thickness of the three layers is recommended to be 3 mm (Jotun 2016). However, thickness measurements at different places in the samples used revealed significant variation (Kharazmi 2019).

As Table 3, and Figures 1 and 2 show, the liners applied in samples 1, 3 and 6 exhibited large thickness variations.
