Anesthesiology  
62:207-208, 1985

### A Case of Artifactual S-T Depression

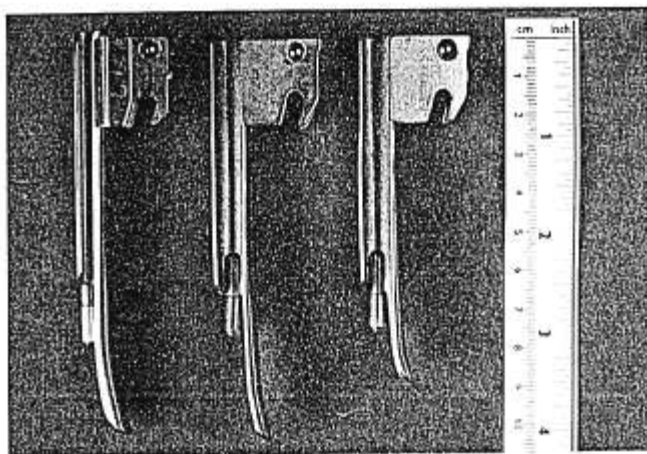
I have modified the Welch-Allyn Miller I blade by removing the distal 13 mm of the blade and refashioning the distal end with a slight curve. Figure 1 shows the standard Welch-Allyn and Penlon Miller I blades and the shortened Welch-Allyn version. The modified blade has a working length of 67 mm, compared with the original 80 mm length. On laryngoscopy, the lamp is closer to the larynx, greatly improving illumination. With the manufacturer's models, the pharyngeal and paraepiglottic tissues often prolapse onto the lamp.

FIG. 1. Left: Standard Penlon Miller I blade. Middle: Standard Welch-Allyn Miller I blade. Right: Shortened Welch-Allyn Miller I blade.

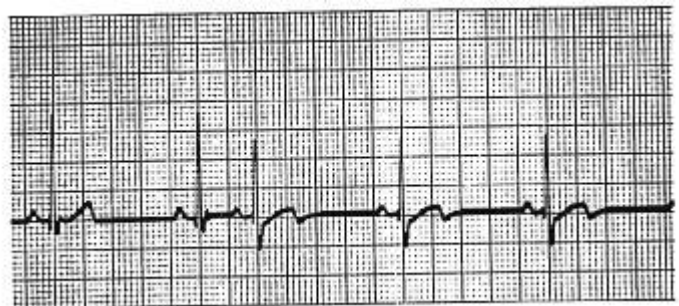
*To the Editor:*—Recently, during a routine cholecystectomy, new and significant S-T segment depression appeared on our Hewlett-Packard® #78304A ECG monitor. This occurred while we monitored lead II (fig. 1). Fortunately, the depression lasted only a few minutes and resolved spontaneously without treatment.

After resolution, we checked all the lead wire attachments; each was well secured. Then, accidentally, we found that minor movement of the patient cable holding the lead wires could produce or terminate the S-T segment changes at will.

The New Dimensions in Medicine (NDM) fully shielded ECG lead wire with snap electrode connector

FIG. 1. New and significant S-T segment depression and T-wave configuration change occurring with minor movement of the NDM patient cable: lead wire interface.
