Anesthesiology
69:803-804, 1988

ECG Artifact Produced by Crystalloid Administration through Blood/fluid Warming Sets

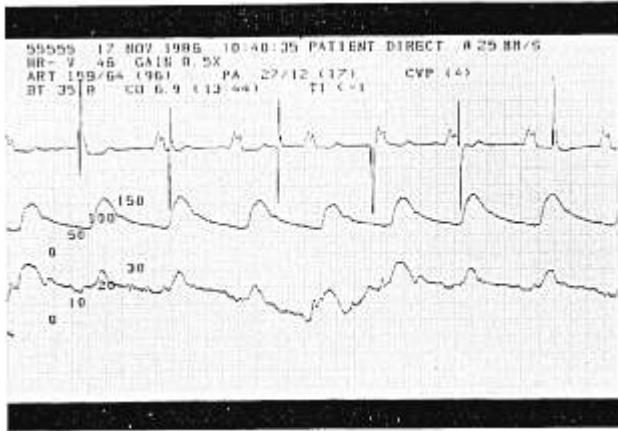
FIG. 1. ECG artifacts with amplitudes of 6.2 mV displayed on lead V₅ with a drip rate of 53 drops/minute.

In one particular situation, as illustrated in figure 1 during the infusion of Lactated Ringers solution, larger artifactual spikes of 6.2 millivolts (mV) appeared on lead V₅ coincident with a rate of 53 drops/minute from the drip chamber mounted on the warming unit. Due to the magnitude of these artifacts relative to the patient's R wave amplitude, the heart rate algorithm is counting the drip rate instead of R waves, or sometimes a combination of the two. Figures 2 and 3 illustrate the presence of the artifact in multiple ECG leads, and the inverse relationship between the artifact amplitude (1.1 mV and 0.1 mV, respectively), drop rate (83 drops/minute and 375 drops/minute), and possibly drop size, which is characteristic of the generation of static electricity from water droplets.

In each case, the artifacts could be eliminated by: 1) stopping fluid flow into the drip chamber mounted on the blood warmer; 2) disconnecting the fluid path from the warming set to the patient by turning a stopcock; 3) filling the drip chamber mounted on the blood warmer with enough fluid such that no droplets could be formed, while relying on the drip chamber near the fluid container for flow rate estimation; and 4) providing an electrically conductive pathway across the drip chamber that prevents charge separation and accumulation.

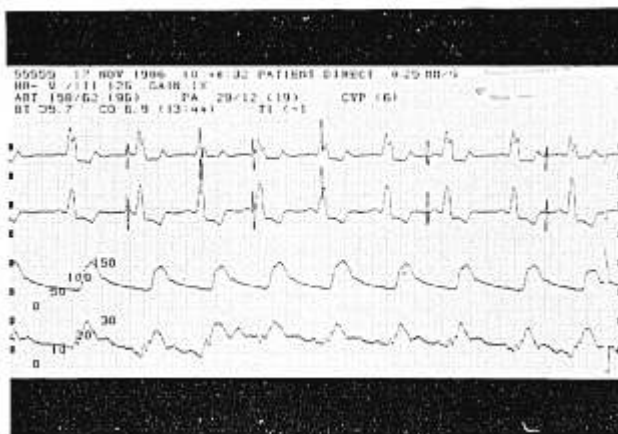
FIG. 2. ECG artifacts with amplitudes of 1.1 mV displayed on leads V₅ and III with a drip rate of 83 drops/minute.

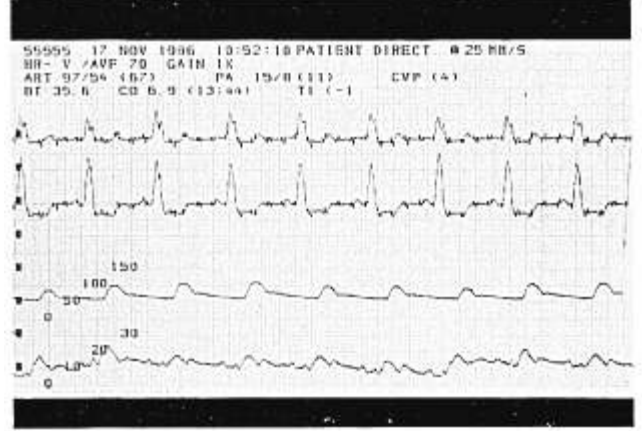
FIG. 3. ECG artifacts with amplitudes of 0.1 mV displayed on leads V₅ and AVF with a drip rate of 375 drops/minute.
