Case Report

A Severe Reaction to Ni-Containing Orthodontic Appliances

Olga Elpis Kolokitha^a; Evangelia Chatzistavrou^b

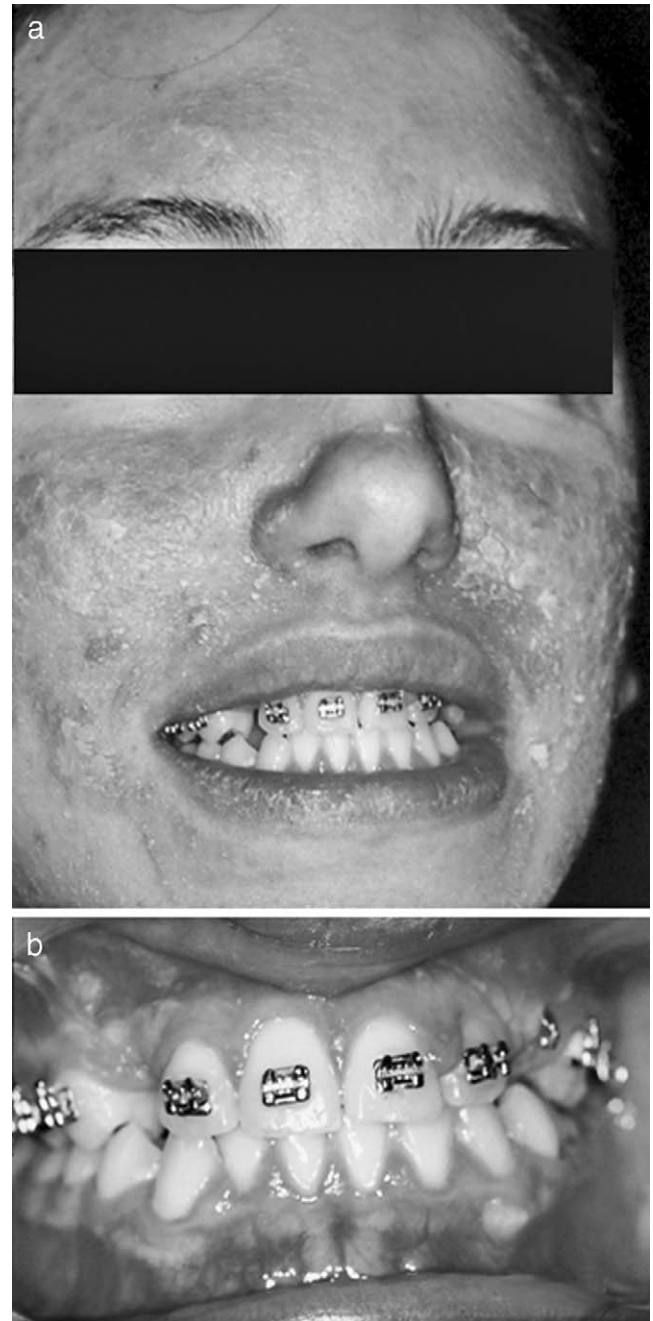
The patient returned 15 days later presenting the typical signs of eczematous and urticarial reactions of the face: redness, irritation, itching, eczema, soreness, fissuring, and desquamation as well as intraoral diffuse red zones (Figure 3a,b). At that time, it was noted that the ligature tie attached to the bondable button of impacted maxillary right canine was missing. Immediately, the patient was referred to an allergist where, after the ordinary diagnostic patch testing, allergic contact dermatitis was confirmed with highly positive results on nickel (++++) and thiomersal (++)). The facial allergic reactions improved shortly after removal of the attached button of the upper maxillary left canine (Figures 4a,b). The patient started treatment for the facial signs with the proper medicine as prescribed by a dermatologist, and all fixed appliances were removed until after her allergy signs and symptoms disappeared.

Figure 3. (a) Facial photograph after surgical exposure of the canines presenting eczematous and urticarial allergic reactions. (b) Intraoral photograph after surgical exposure presenting intraoral diffuse red zones.

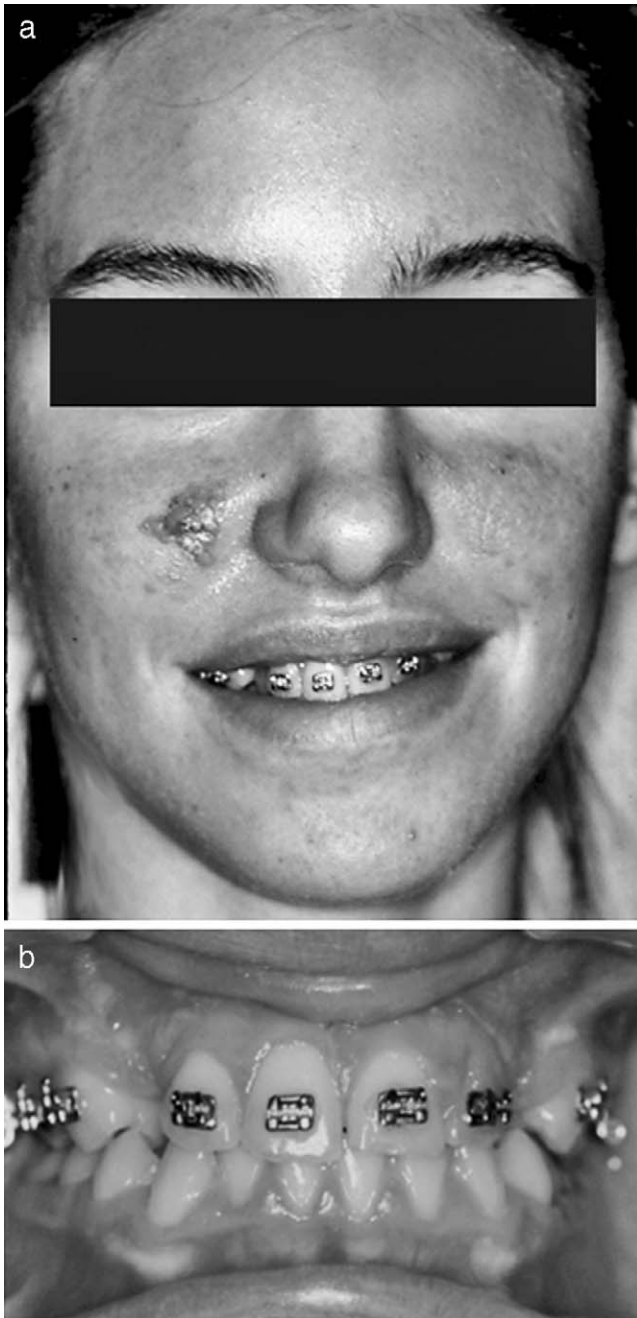
Figure 4. Improvement of (a) the facial and (b) intraoral allergic reaction after removal of the impacted canine button of 23.

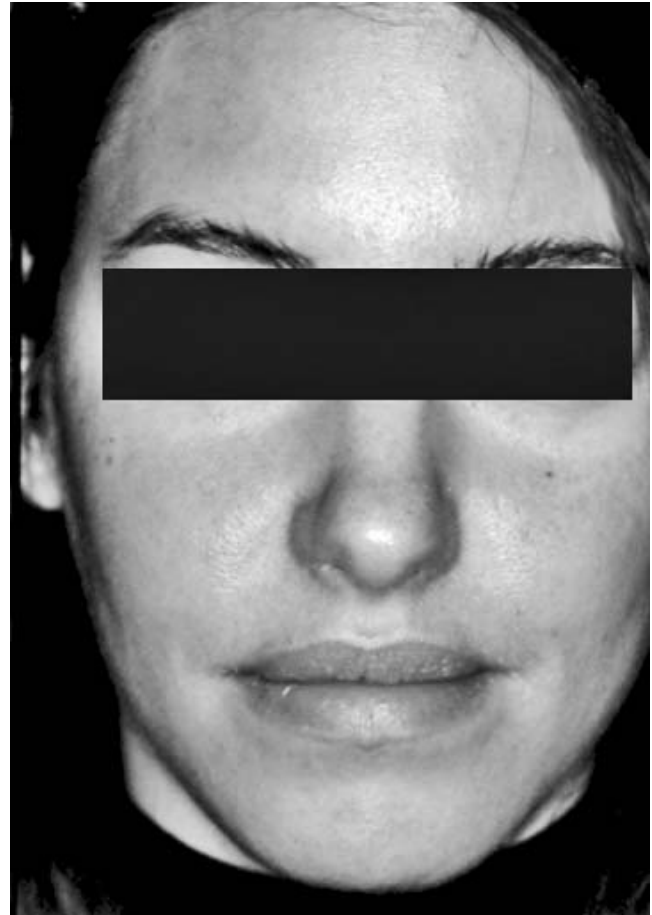
Seven months after her last appointment at the orthodontic office, the patient came back to resume treatment, with obvious signs of total healing of her previous face allergic reactions (Figure 5). Given the confirmed diagnosis of nickel allergy, the treatment planning was modified with the use of ceramic brackets and coated NiTi archwires for leveling and alignment (Figure 6).

Figure 5. Total healing of facial allergic reaction.
