## CORRESPONDENCE

### A New Device for Topical Anesthesia

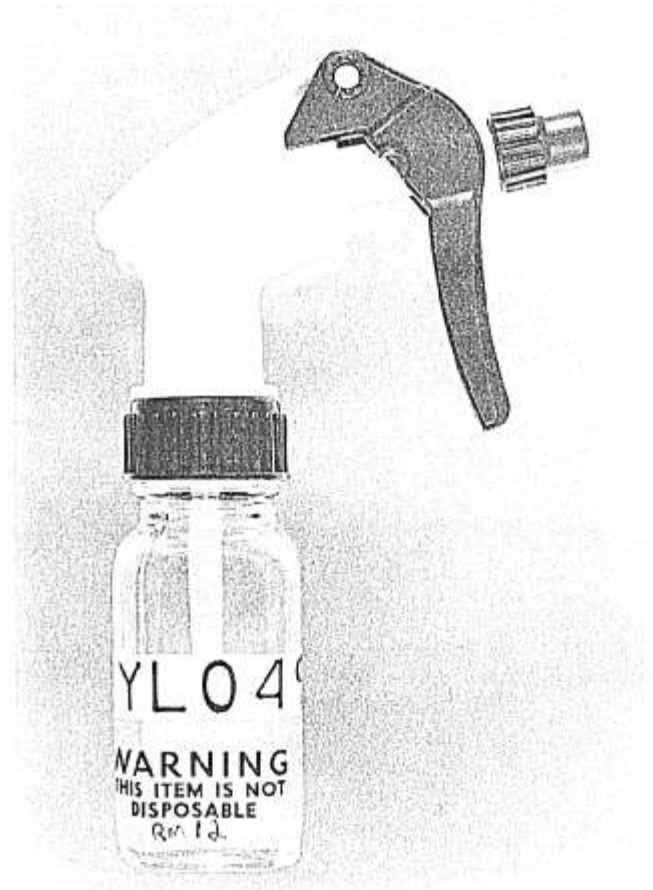
*To the Editor:*—We have developed a new and inexpensive device for topically delivering a local anesthetic to the upper airway. It is composed of a plant sprayer purchasable in any hardware store, and is adjustable to provide a jet or a spray (fig. 1). It is necessary to shorten the plastic device that is submersed in the Xylocaine® solution. We had difficulty in finding an appropriate size bottle, but found one from Scientific Products Company (17111 Radial Avenue, Irvine, California 92714). This is a 2-ounce, clear glass bottle, number B 725-2, with a number 28 cap size.

FIG. 1. A new and inexpensive device for delivering a topical local anesthetic.

machine top fairly well, it is quite reasonable in cost, and it operates well for long periods of time. We have measured the volume delivered each time and find it to be approximately 0.5 ml, which would be approximately 20 mg Xylocaine® if a 4 per cent solution is used. We feel that this is an acceptable, safe, simple, efficient, and economical device that could be utilized widely.
