### Lamp Placement and the Miller I Laryngoscope Blade

### A Case of Artifactual S-T Depression

### An Unusual Source of Leak in the Anesthesia Circuit

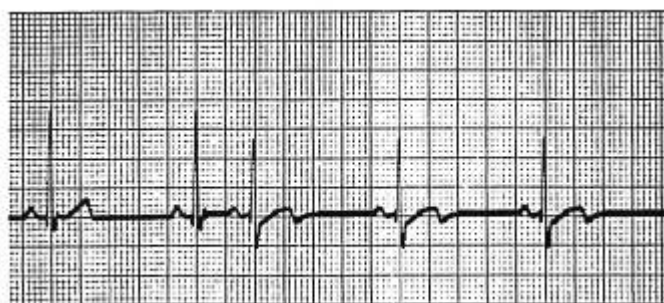
FIG. 1. New and significant S-T segment depression and T-wave configuration change occurring with minor movement of the NDM patient cable: lead wire interface.

*To the Editor:*—Recently, during a routine cholecystectomy, new and significant S-T segment depression appeared on our Hewlett-Packard® #78304A ECG monitor. This occurred while we monitored lead II (fig. 1). Fortunately, the depression lasted only a few minutes and resolved spontaneously without treatment.

After resolution, we checked all the lead wire attachments; each was well secured. Then, accidentally, we found that minor movement of the patient cable holding the lead wires could produce or terminate the S-T segment changes at will.

and 04 series patient cable is excellent electrical equipment, which has functioned reliably for us over the last 5 years. As a result, we evolved a policy of replacing reusable electrical equipment only when damage was obvious or suspected. In retrospect, the lack of a regular replacement schedule is what enabled a damaged system to simulate intermittent artifactual S-T segment depression.
