The Dromedary Sign—An Unusual Capnograph Tracing

Case Report

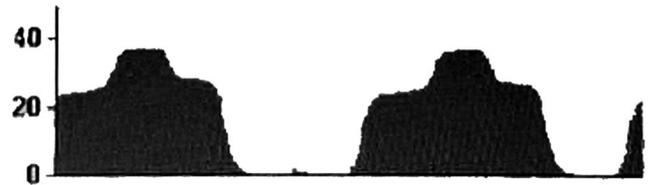
Fig. 1. A triphasic capnograph demonstrating the dromedary sign.

The measurement of end-tidal carbon dioxide is a fundamental component of patient monitoring during anesthesia. Any abnormalities must be noted, investigated, and treated accordingly. To our knowledge and subsequent review of the literature, the observed abnormal capnograph waveform (fig. 1) was unlike any previously reported. The gas analyzer in the Dräger Apollo anesthesia machine aspirates 200 ml/min (\pm 40 ml/min) of respired gases from the elbow connector at the Y piece through the sample line and water trap for the measurement of end-tidal gas partial pressures. Biphasic, dual-plateau

We hypothesized that this triphasic capnogram was a result of increased dyssynchrony between the positive-pressure phase of mechanical ventilation and the arrival of the end-tidal gas at the gas analyzer. During expiration, negative pressure at the crack in the water trap allowed room air to enter the sample, thereby decreasing the carbon dioxide concentration by sample dilution (first plateau). At the initiation of inspiration by the mechanical ventilator, the negative pressure at the cracked water trap is reversed as the piston exerts positive pressure (peak inspiratory pressure), represented by the higher plateau (hump). The higher plateau most accurately represents end-tidal carbon dioxide as sample dilution is eliminated. We hypothesize that the third plateau was due to the increased sample line volume. This increases the dead space and therefore the time between expiration and the arrival of end-tidal carbon dioxide at the analyzer. Assuming a 200 ml/min sample flow rate, a 1.5-ml increase in sample-line dead space could be expected to result in a 0.45-s increase in transit time. Thus, the positive-pressure phase of inspiration shifts to the left (longer transit time) in the capnograph waveform. At the end of the positive-pressure phase of mechanical ventilation, the expiratory carbon dioxide in the sample line is diluted again as a result of the leak in the water trap producing the lower plateau (third plateau).

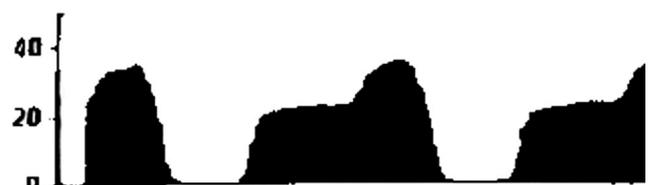
Fig. 2. An example of the capnogram after replacement of the original (modified) sample line (5.2-ml dead space) with a new standard length sample line (3.7-ml dead space). Note that the midcapnograph hump has moved to the right (shorter transit time) of the capnograph tracing.

of the capnogram (fig. 2). Next, the water trap was inspected and cracks were seen (fig. 3). Because a new water trap was not immediately available, the cracked water trap was wrapped with a 3M Tegaderm dressing (3M Health Care, St. Paul, MN) and reinstalled. This resulted in a normal appearing waveform (fig. 4).

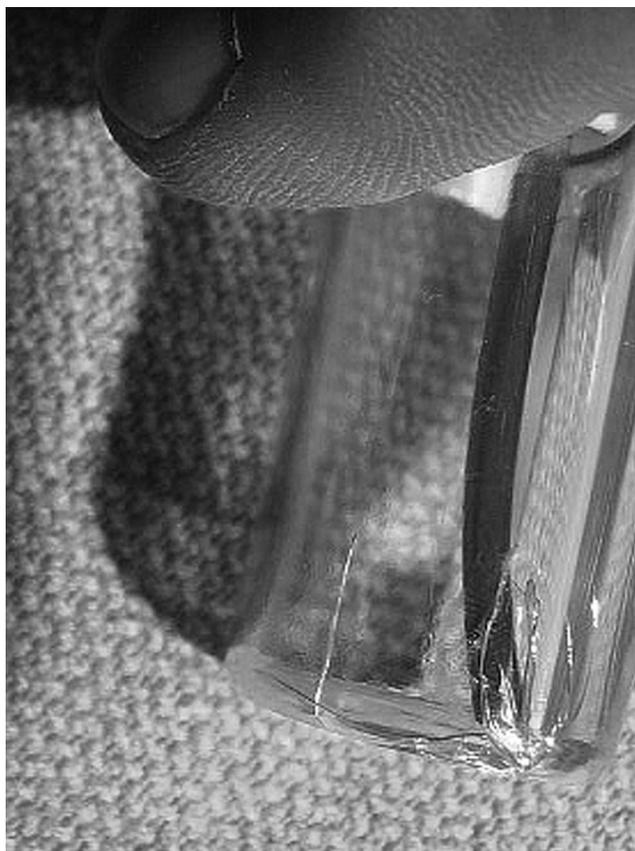
Fig. 3. Cracked water trap.

Therefore, the transit-time delay caused by the addition of dead space in the sample line combined with a cracked water trap that aspirated room air into the expiratory gas sample resulted in the appearance of a midexpiratory hump on the capnogram. This case illustrates the need to understand capnography and the importance of machine checks given that erroneous end-tidal carbon dioxide measurements should be recognized to avoid inaccurate clinical decisions. The manufacturer may consider adding a machine check for the cracked water trap or any additional leaks from the circuit in the automated machine-check algorithm.

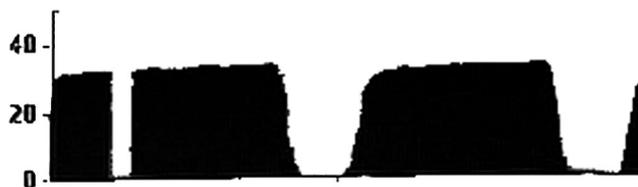
Fig. 4. Example of a normal-appearing capnogram after wrapping the water trap with a 3M Tegaderm dressing (3M Health Care, St. Paul, MN) and with a normal length sample tube.

To investigate the cause of the midplateau hump (or dromedary sign, given its resemblance to a single humped camel), we examined the gas sample line, which consisted of normal sample-line tubing (anesthesia gas sampling line, GE Health Care, Helsinki, Finland, 3 m or 10 feet, with a dead space of 3.7 ml) to which had been added a 24-inch arterial extension tubing (volume 1.5 ml; Hospira, Lake Forest, IL). To determine if this modified sample line contributed to the leak, we placed it under water in a high-pressure system; no leak was observed. By way of confirmation and to examine the effect of further increasing the sample line's dead space, we sought to recreate the dromedary sign in this same patient. We peeled the 3M Tegaderm HP dressing off the water trap and reinstalled it. We also reinstalled the original modified sample line. The abnormal capnograph waveform reappeared (see fig. 1). We then added a second 24-inch extension tubing (total length, now 14 feet; dead-space volume, 6.7 ml) and noted that the hump moved from the midplateau position to the left of the capnograph (fig. 5). After a new sample line without extensions and a new water trap were installed, a normal waveform was again observed (fig. 4).

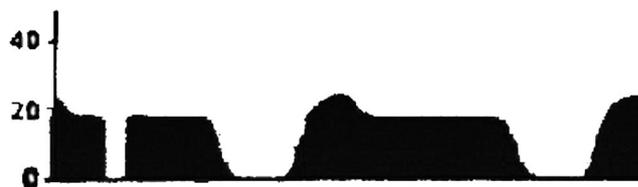
Fig. 5. An example of the capnogram after adding an additional 24 inches (additional 1.5 ml of dead space) of arterial tubing to the original (modified) sample line (6.7-ml total dead space). Note that the original midplateau hump has moved further to the left of the capnogram (longer transit time).
