GE Healthcare Response to Aestiva CO₂ Absorbent Cartridge Issue

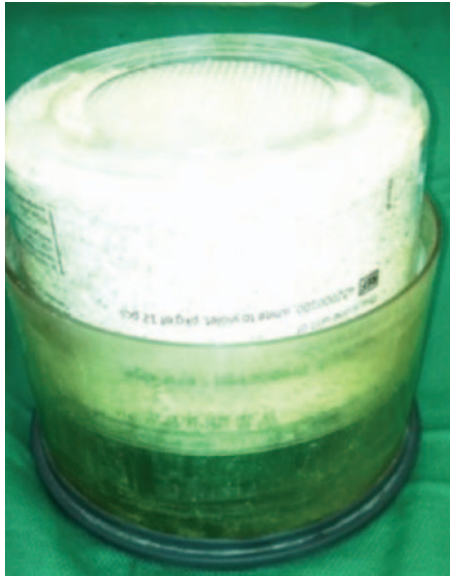
Fig. 2. Reanimated photo showing the initial point of friction that prevented extraction of the Medisorb® cartridge (GE Healthcare, Waukesha, WI), once inserted upside down into the canister.

We also question the need for a tapered design of the absorbent cartridge that allowed this human error to jam a cartridge into a canister (fig. 2). We speculate that the cartridge is tapered to prevent inversion once the proximal end turns purple from spent absorbent, and we welcome the manufacturer's comment on this point.

the fact that a taper is required for normal manufacturing as part of the molding process. The taper also allows for proper positioning (centering) of the cartridge in the canister to adequately maintain a seal.

You effectively addressed the issue by swapping the canister. These canisters (0229-3015-800) are available for order in case you would like to have extra canisters available at your facility.
