Participant approach model in a basin: A case study from Turkey

Key words: Basin, Participatory approach, Problem, Watershed management

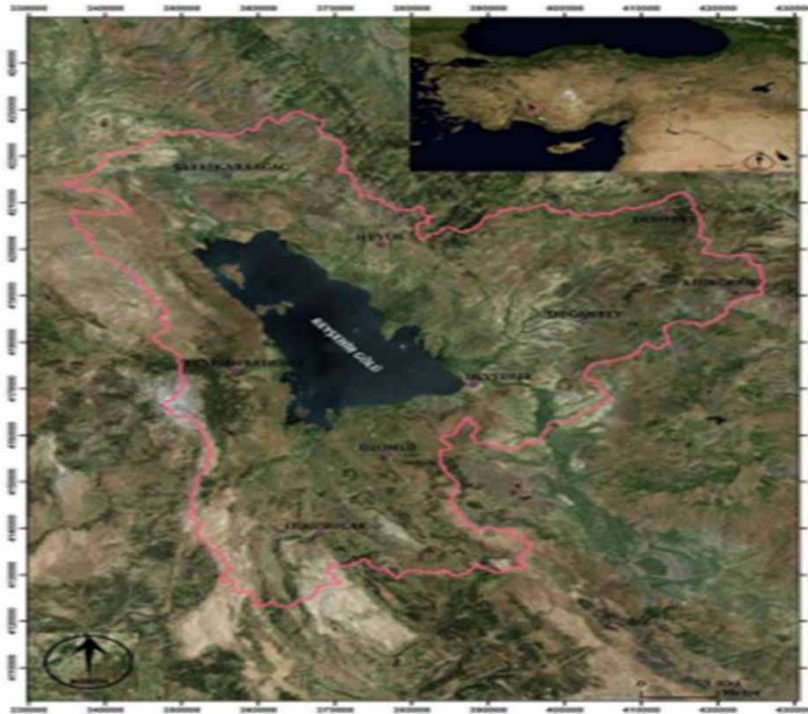
Fig. 1 | View of the Beyşehir Lake Basin.

The research area is located within the boundaries of the Konya province, in the southern part of Turkey. The Konya main basin covers almost 7% of Turkey with an area of approximately 5.0 million hectares (mha) (Anonymous, 2017). The studied basin is a part of the Konya main basin and covers totally 730,800 ha including a 65,100 ha water surface. While a large part of the Beyşehir Lake Basin remains within the provincial borders of Konya, there are also parts within the provincial borders of Isparta and Antalya (Figure 1). So, the basin is managed by three provinces.

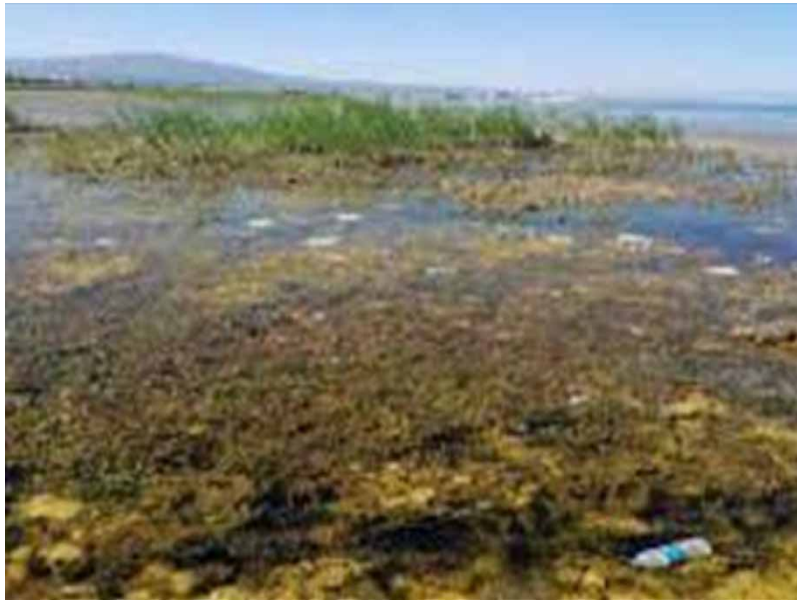
Fig. 4 | Lake eutrophication problem.

The primary problems in the lake were the pesticides and fertilizers that mixed with the lake from the settlements and caused water pollution and eutrophication. With the formation of eutrophication, an oxygen-free environment began to form on the shore of the lake and an unpleasant odor was emitted. One of the main causes of eutrophication was that the lake plants cover the entire surface of the lake because of overgrowth, and as a result, the sun's rays cannot penetrate to the lower layers of the lake sufficiently (Figure 4). Furthermore, the lake was not covered with reeds all around, but the shores up to 100 m in some places started to bear reeds and the lake started to age biologically. In the future, if eutrophication continues to spread, it can cause extreme mass death and pose an incredible threat to the life in the lake.
