MANAGEMENT OF AN IMPLANT CASE THAT REQUIRED RETREATMENT: A CASE REPORT

Charles S. J. Samborski, DDS

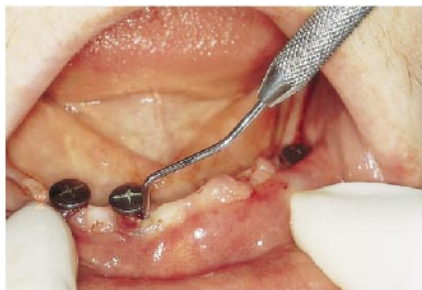
FIGURE 2. An intraoral view of implants in sites #27, 25, and 20 illustrating 10 mm pocketing on the implant in site 25.

The patient returned to my office after 28 months in the same nonrestored state with continued discomfort of all remaining implants. Generalized pocketing of 10 to 12 mm was noted on implants in the 27, 25, and 20 sites. All were now suppurative. The implant in site 20 demonstrated continued bone loss but was nonmobile (Figure 2). Implants in sites 27 and 25 were mobile. The patient was placed on amoxicillin (500 mg qid) for 10 days. Tooth 22 was extracted. The lower partial denture was converted to an immediate transitional denture (Figure 3).

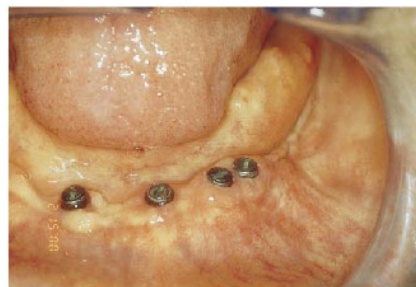
FIGURE 10. This intraoral view demonstrates post-operative healing.

low up revealed no postoperative discomfort or paresthesia. Sutures were removed in 2 weeks. Healing was uneventful (Figure 10).

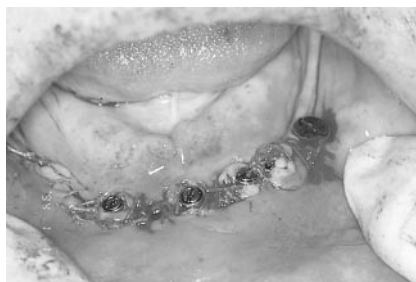
FIGURE 8. The intraoral post-operative view illustrates continuous cross suturing. The implant in site #20 has not been removed yet.

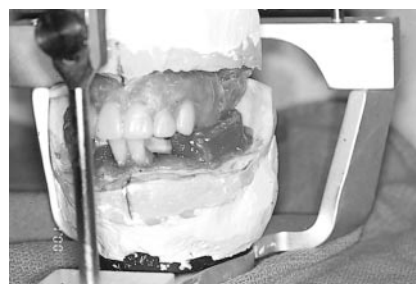
FIGURE 11. This view demonstrates the articulated centric relation record.

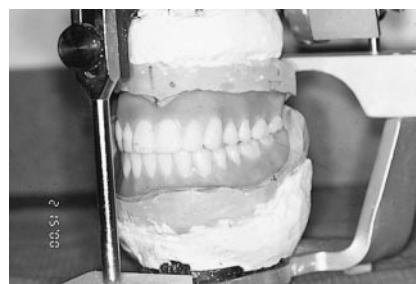
FIGURE 12. A full arch denture set-up in a posterior lingualized occlusal scheme to verify an accurate centric relation.

After a 4-month healing period, osseointegration of all 4 implants was confirmed clinically. A full arch maxillary and mandibular denture set-up in a lingualized occlusal scheme was completed. Particular attention was taken to satisfy the patient's desire for proper mold and shade selection. Anterior tooth positioning was completed chairside, assuring acceptable lip support and proper phonetics (Figure 11). A centric relation record was captured and a full arch set-up was used to verify all of the stated requirements (Figures 12 and 13). The mandibular alignment would now dictate bar design and fabrication.

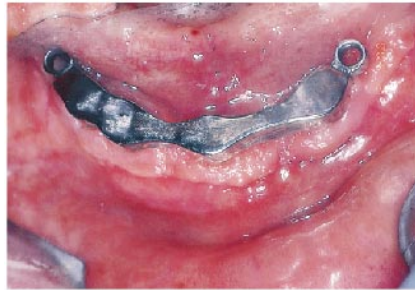
FIGURE 17. This intraoral view demonstrates the cast bar with bilateral distal ERA attachments.

Four uniposts (3.5–10°; Implantatum, Suncoast Dental) were tried in, aligned, and permanently cemented with Panavia 21 (JP Morita) (Figure 14). Angulations were previously determined at the time of surgical placement. The 4 posts were reduced occlusally, slotted, and a final impression taken using Reprosil (Dentsply) in a custom tray (Figure 15). A cementable, one-piece, cast gold bar with low profile, distal ERA attachments was fabricated and returned for verification to assure a passive fit (Figures 16 and 17).

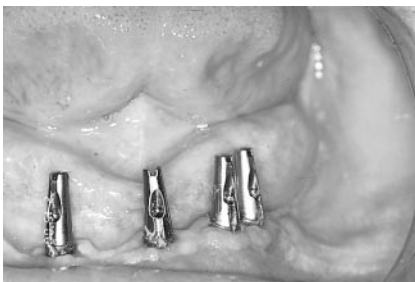
FIGURE 14. This intraoral view demonstrates 4 uniposts after alignment and cementation.

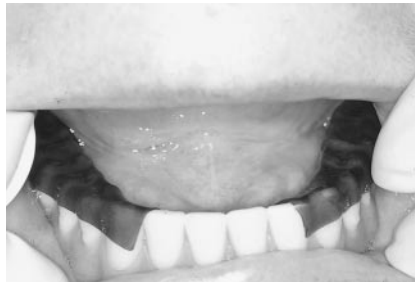
FIGURE 18. Occlusal indicator wax is used to verify bilateral balance.

made prior to final processing. A provisional maxillary denture was returned and Hydro-cast (Kay See Dental) functional impression material was added to record accurate tissue representation. The lingualized occlusion was checked with occlusal registration wax (Kay See Dental) to assure bilateral stability (Figures 18 and 19). The maxillary denture was precision processed and returned for patient delivery. The finished mandibular bar was permanently cemented with Panavia 21. Routine postoperative care, including the use of a Hydrofloss Oral Irrigation (HFI) device, was reviewed. Routine postoperative checkups were scheduled (Figures 20 through 25).

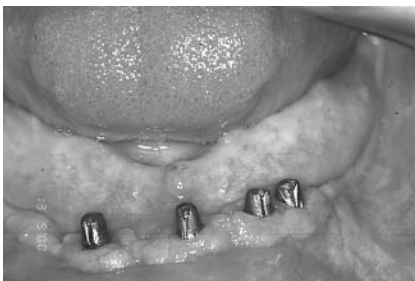
FIGURE 15. This intraoral view demonstrates the shortened slotted uniposts prior to custom bar fabrication.

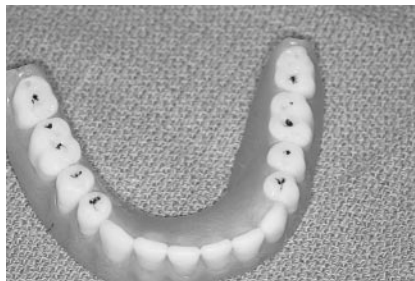
FIGURE 19. Bilateral occlusal balance can be easily verified on the lower denture assuring denture stability.

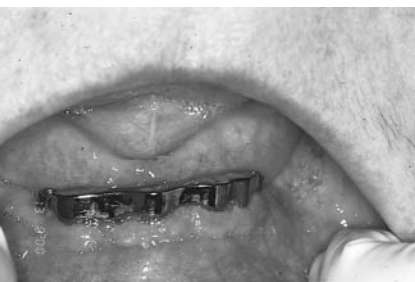
FIGURE 16. This intraoral view demonstrates the low profile custom fabricated gold bar.

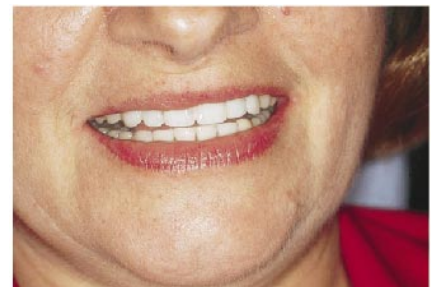
FIGURE 24. This postoperative frontal view illustrates a natural looking smile line and a good prosthetic result.
