# POWER CONSUMPTION COMPARISON OF FIVE BUILDING ENVELOPES IN THE NORTHERN PRAIRIE CLIMATE OF MANITOBA

## ABSTRACT

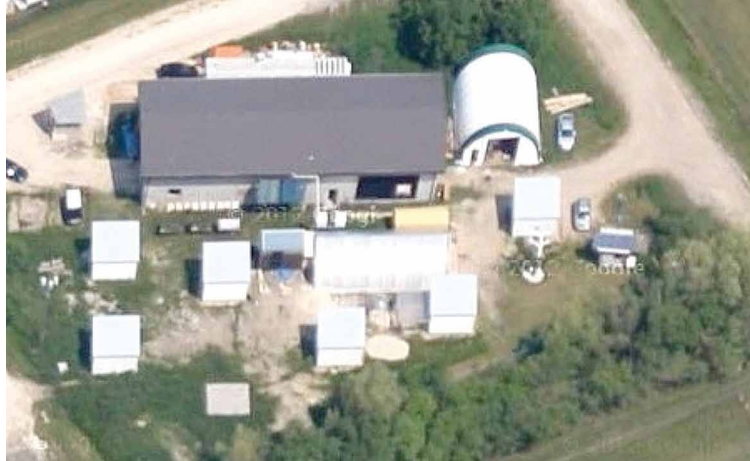
**FIGURE 1.** Aerial view of alternative village.

The results presented in this paper are the first of a long-term building envelope research project at the Alternative Village (AV) at the University of Manitoba in Winnipeg. Data reported in this paper are for the period from October 2011 to April 2012. The AV is a 0.6 ha. site on the university campus. Figure 1 provides an aerial view of the village. The small square structures are the test buildings discussed in this paper.

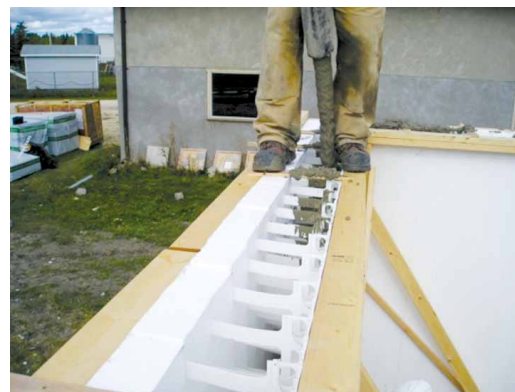
**FIGURE 4.** Pumping concrete into PVC stay in place Wall System.

Two structures were built using a Stay in place PVC concrete form system (PVCCF). It is comprised of a polyvinyl chloride form with 102 mm of expanded polystyrene (EPS) foam exterior insulation (Fig. 4). One wall had 102 mm

of concrete and the other had 204 mm identified as PVCCF4 and PVCCF8 respectively in this paper. The premise behind this approach is to use the concrete as a thermal mass for heat storage, a well-known concept [10]. A total weight of approximately 11,000 and 22,000 kgs of concrete was in the PVCCF4 and 8 respectively.

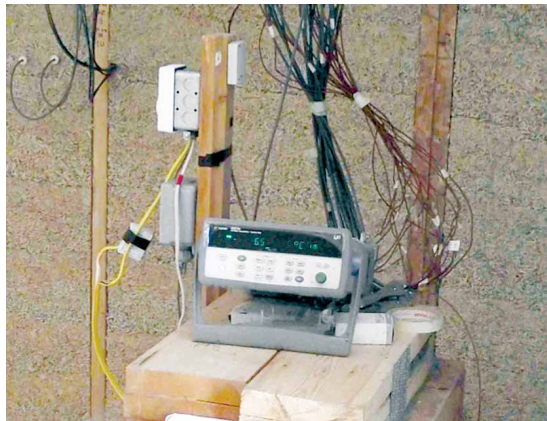
**FIGURE 5.** Data Acquisition System.

Each test structure was equipped with an Agilent 34972A-LXI data switch with u three 34901A multiplexers (Fig.5). This system was used to read and record thermocouple and heater run time used to determine energy consumption. An Onset U12-011 with an inductive coil on/off sensor was used to provide a backup reading for internal ambient temperature and relative humidity. Additional backup readings for heater run times were recorded using an Onset U9-004 motor on/off sensor.

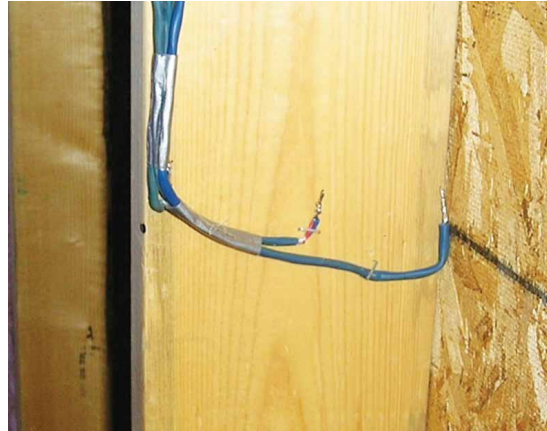
**FIGURE 6.** Thermocouples along stud.

Temperature was monitored with T-type thermocouples located within the wall system. The temperature was monitored at three locations through the cross section of each building envelope. In the wood frame structure 24 thermocouples were installed through the insulation and along the wall studs (Figs. 6, 7) to investigate thermal bridging at the framing members. A total of 17 locations were monitored in the Stay in place PVC concrete for buildings (Fig. 8) with 12 locations in the PUR SIP structure (Fig.9). The ambient indoor and outdoor temperatures were recorded at each building. Readings were recorded at 30-minute intervals over the study period.
