Thermally induced strains and stresses in cast iron water distribution pipes: an experimental investigation

ABSTRACT

Key words | asset management, cast iron, induced stress, leakage

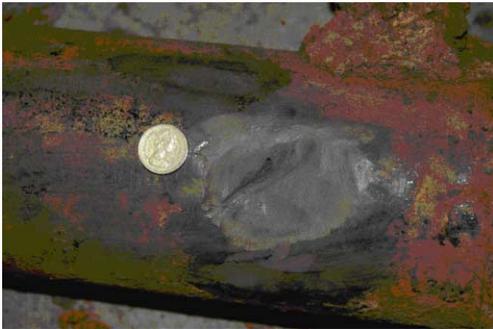
Figure 1 | Typical surface condition of supplied cast iron pipe showing extensive graphitic corrosion of pipe wall.

A number of lengths of $\sim 4''$ (~ 100 mm) internal diameter plain and jointed cast iron distribution pipe were sourced from service in the ground at five different locations, A–E, courtesy of Thames Water plc. Table 1 summarises the six pipe samples used for tensile testing in the present study. The samples provided were of length 1.5–2.5 m and had a nominal outer diameter of 125 mm with a wall thickness in the range 10–12 mm. The pipes were typically encrusted in a mixture of soil and corrosion product. It should be noted that in selecting samples for testing it became apparent that some of the pipes supplied were badly affected by graphitic corrosion (Figure 1). Such pipes could not be tested because the gauges employed to measure the thermal strain could not be bonded reliably to such a surface. In addition, it was found that some badly graphitised pipes were prone to through-wall leakage when subject to the 4 bar (~ 400 kPa) of water pressure employed in the tests. This had the potential both to disrupt the strain measurement system and to lead to water ingress into the loading frame used to restrain the pipe samples.

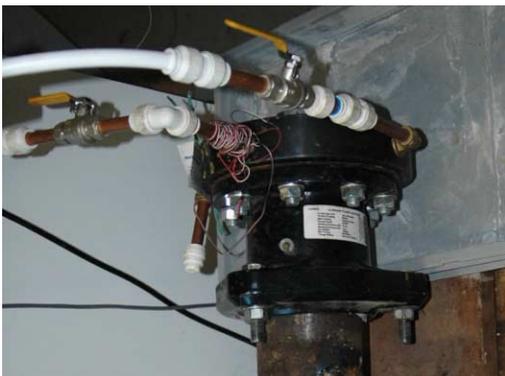
Figure 2 | Modified top end-plate to allow entry and exit of the cooling water.

The end-plate at the top of the pipe length was then fitted. This had been specially adapted to allow both entry and exit of the pressurised cooling water (Figure 2). The

inlet point was connected to a special ‘dip tube’ which allowed the pressurised, temperature controlled, water to enter the test pipe near to the bottom endplate. The water then flowed back up the length of the test pipe and exited at the underside of the top end cap. This arrangement helped to ensure complete circulation of the water and uniform cooling (or heating) of the pipe along its length. The system was designed to allow the water to be recirculated through the temperature control system (Figure 3).

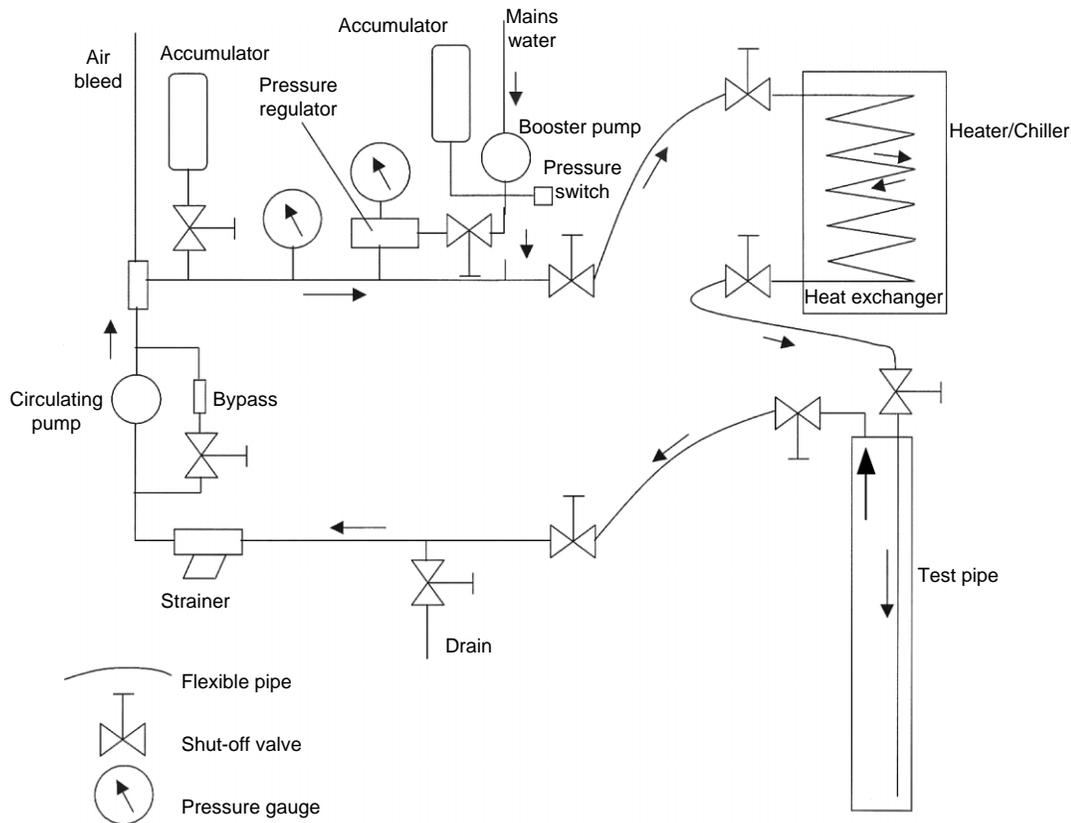
Figure 3 | Details of thermal cycling equipment.

Temperature control of the circulated water was accomplished using a heater/chiller chamber. The chamber contained two 30 m lengths of 10 mm diameter copper pipe connected in parallel. The water flowing through this heat exchanger was heated (or cooled) depending on the temperature of the chamber relative to the water. Water flows from the circulating pump, through the heat exchanger, through the pipe and back to the pump (Figure 3). Air was removed from the water by an air separator on the flow side of the pump and bled off from a vertical collection pipe. An automatic bypass was in place around the pump to avoid damaging the pump in the event of the heat exchanger freezing. Tap water was used in all of the experiments reported here. This limited the minimum temperature which could be employed in each thermal cycle to about 2°C in order to avoid problems of freezing within the cooling circuit.

The system was pressurised by a booster pump, running at 5.5 bar, via a pressure regulator set to 4 bar. The booster pump was fitted with an expansion vessel to reduce the number of starts made by the pump. The heating/cooling water circuit also had an expansion vessel to compensate for the change in volume of the water with temperature. The rate of change of temperature is controlled by the thermal mass of the system and the various heat losses (and gains) to the environment. The connecting pipe-work and the cast iron pipe under test were lagged with a combination of glass fibre and foam insulation to reduce uncontrolled heat loss (or gain) from the environment (Figure 4). This also helped to provide a uniform temperature along the length of the specimen. The pipe wall temperature was measured using a thermocouple attached to the outer surface. A second thermocouple was used to measure the air temperature in the laboratory during each experiment.

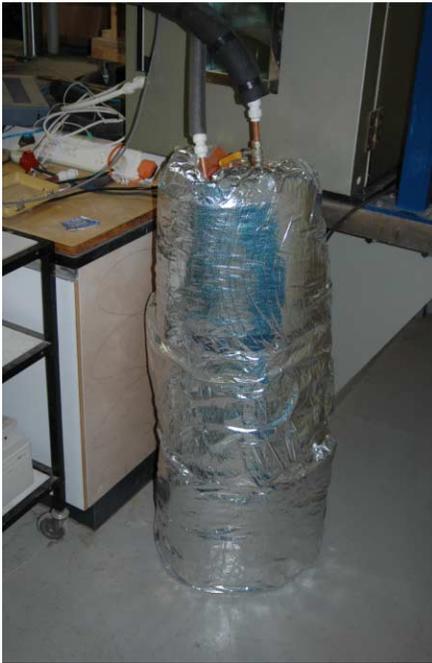
Figure 4 | General arrangement of unrestrained pipe test showing position of top end-plate and thermal insulation in place.

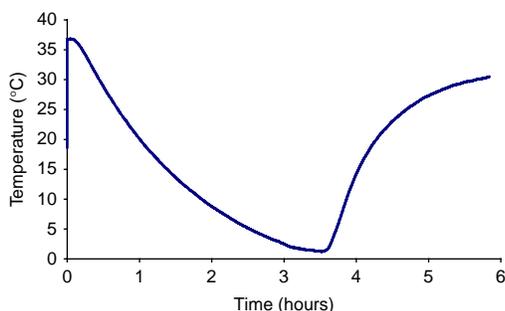
Figure 5 | Variation of pipe temperature with time during a typical thermal cycle.

To begin a typical thermal cycle the system was set to heat the circulating water to 45°C and the pipe wall temperature allowed to reach slightly above 35°C. The chiller system was then used to cool the water over a three-hour period until the outer wall of the pipe had reached 5°C. The water was then heated slowly until the pipe had reached a temperature slightly in excess of 30°C at which point the cycle was either stopped or repeated. [Figure 5](#) shows a typical plot of pipe temperature as a function of time for the normal temperature cycle used during the measurement of thermal strains and thermally induced loads.

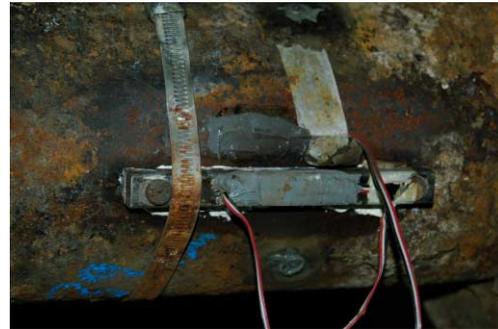
Figure 6 | Invar bar, with its surface mounted strain gauge, attached to the pipe adjacent to the measurement gauge.

The Invar bar, with its surface mounted strain gauge, was clamped to the wall of the pipe next to the other strain gauge ([Figure 6](#)). A layer of heat-sink compound was used between the Invar bar and the pipe wall in order to minimise the thermal gradient between the two materials. The temperature of the pipe was measured using a thermocouple placed between the pipe wall and the Invar bar. Using the measuring system developed in conjunction with the controlled temperature cycle it was possible to

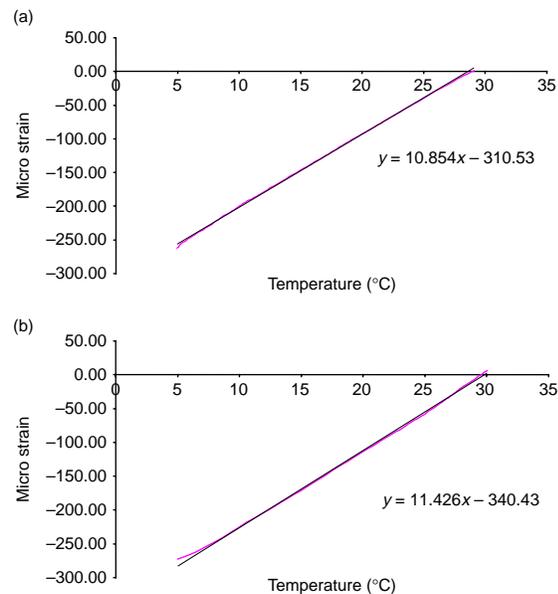
Figure 7 | Pipe surface strain as a function of temperature during the first thermal cycle of sample A1, (a) cooling and (b) heating.

Figure 7 shows data for the thermal strain measured on the pipe wall (relative to the Invar bar reference sample) as a function of temperature during the first experiment investigating the response of pipe A1 under conditions of cooling and heating. There is a high degree of linearity to the data. The coefficient of thermal expansion (CTE) for the pipe material was determined from the slope of the line, with the addition of the CTE value for the Invar reference. Proceeding in this way, the data for all the samples investigated are summarised in Table 2. There is very good consistency of the data between the heating and cooling regimes, as well as reproducibility and consistency between the different pipes, with the exception of pipe D1. The measured values of CTE are in the range $11\text{--}13 \times 10^{-6}/\text{K}$ and as such are consistent with published values for grey cast irons (White 1990). Pipe D1, which showed a much lower CTE, is believed to be another (iron-based) material rather than a grey cast iron. The physical appearance and wall thickness of pipe D1 were different from the other pipes tested, consistent with the different CTE value.

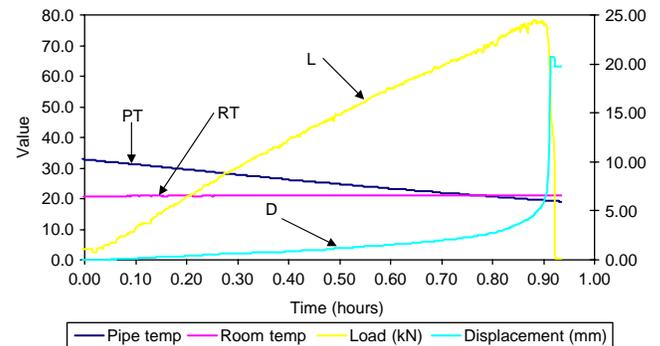
**Figure 8** | Data from thermal cycle on fully restrained jointed pipe section E1.

Pipe E1 was used to investigate the thermal cooling of a fully restrained jointed pipe. With the bonded adaptors in place, this pipe was placed into the reaction frame of the Instron 8805 and, once heated to slightly above 35°C, the ends were restrained. The pipe was then cooled at around 10°C/hour following the normal cooling profile. As the pipe was cooled, an increasing load was applied to maintain the required restraint (Figure 8). At a load of around 65 kN it was observed that the joint itself was being pulled apart. As the test continued a limited amount of water leakage occurred at the lead-run joint. When 20 mm of pipe had been pulled out from the joint the test was stopped to prevent complete separation of the joint. The maximum load recorded during the test was 78 kN.

At the end of the thermal loading experiment the overall movement at the joint in pipe E1 was approximately 20 mm, with the majority of the displacement occurring around the peak load (Figure 8). After the thermal cycle test had been completed (and the pipe restraint removed) a continual leakage of water was observed at the joint. While below the limit detectable using commercially available flow meters, it was possible to collect the water that leaked from the pipe over time and record its volume. Using this method a stable, and reproducible, leakage rate of 2–3 cm³ per minute was determined (Figure 10).

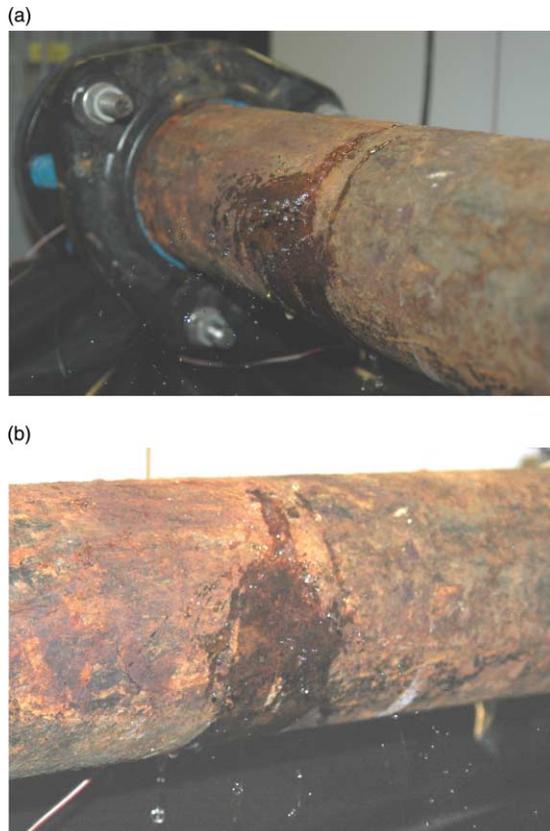
Figure 9 | Leak from a plain section of pipe E.

As well as large-scale, through wall-thickness graphitisation, a section of plain pipe (taken from location E) was found to have a hairline crack, less than 50 mm in length, present on its surface. When this pipe section was pressurised to 4 bar the leak took the form of a high pressure stream (Figure 9(a)). The resulting leakage rate, measured using a flow meter, was found to vary between 100 and 150 cm³ min⁻¹. Careful observation of the pipe suggested that the ‘wet’ area around the crack seemed larger than could be accounted for simply from associated spray, splash-back, or lower pressure fluid at the edge of the crack. There was also a localised wet patch, away from the main stream (Figure 9(b)).
