## Hydraulic considerations in restoring boreal streams

Juha Järvelä and Terhi Helmiö

**Abstract** The physical habitat that controls ecosystem functioning is determined by local hydraulics and channel morphology. Hydraulic field studies were conducted in a boreal stream (1) to test the hypothesis that the local hydraulic conditions are determined by cross-sectional geometry and flow resistance in boreal conditions by analysing the relationship between flow velocities, cross-sectional geometry and flow resistance, and (2) to suggest success criteria for the restoration of local hydraulic conditions. Results suggest that, in the case of small channels, cross-sectional geometry and flow resistance are weakly interconnected and influenced by factors such as local roughness elements and channel forms. The study showed that both flow resistance and cross-sectional geometry are vital factors in determining local hydraulics. In stream restoration, a design based on consideration of only one of these two factors is inadequate and may result in a failure to replicate natural hydraulic conditions. Simple success criteria for the restoration of local hydraulics are developed.

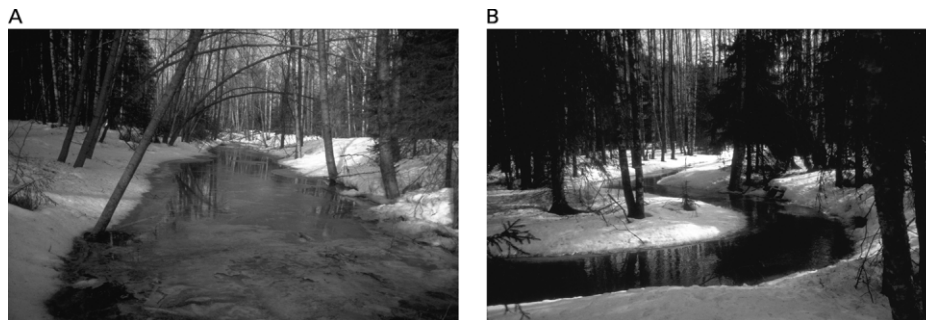
**Figure 1** Before and after the restoration: the brook was restored to its historical meandering channel (right) from the channelized reach, which was dredged in the 1960s (left)

The restoration project included design challenges, such as the reconstruction of meanders, cohesive sediments, mild slopes, diverse vegetation and harsh climatic conditions (Figure 1).

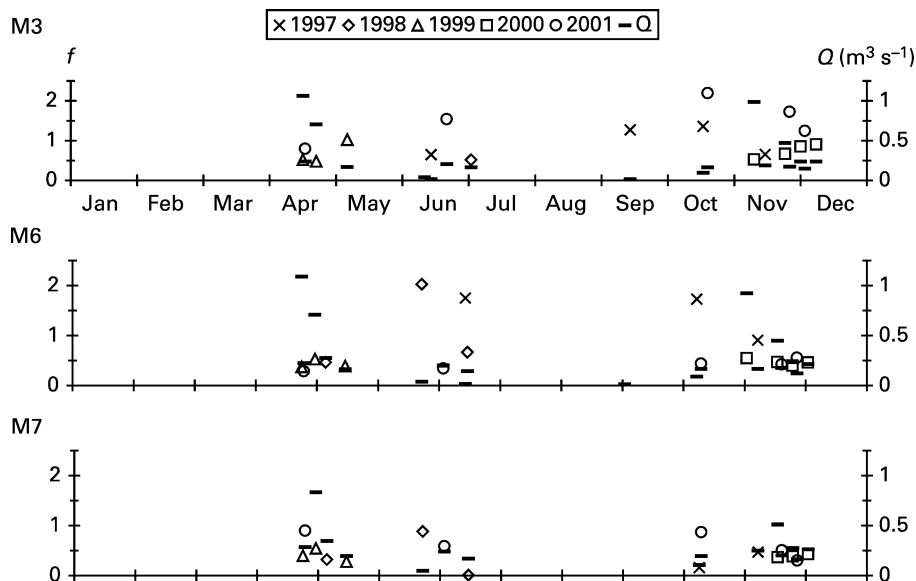
**Figure 2** Variation of friction factor and discharge in different years and seasons in reaches M3, M6 and M7

Vegetation can be a major source of temporal variation in flow resistance. Dense vegetation can also alter the effective area of a cross section that conveys the flow. Considerable seasonal variation caused by the growth of vegetation has been reported by several authors including Bakry *et al.* (1992), Fisher (1995), Sellin and van Beesten (2002) and Maione *et al.* (2000). Vegetative characteristics in boreal streams can be expected to be different compared to warmer climates. In the present study, temporal variation in flow resistance was investigated in reaches with the greatest number of measurements: M3, M6 and M7. Data available for the analysis covered the years 1997–2001, but measurements were taken mostly in April–June and October–December. The temporal variation of the observed friction factors with corresponding discharges is presented in Figure 2. In the figure, the friction factors for discharges of the same magnitude can be compared. It appears

The friction factors of reach M7 were close to the values of the pristine reference, despite differences in cross-sectional geometry. Five years after restoration no considerable changes in flow resistance were observed (Figure 2). Field observations suggest that stream–floodplain interaction, with frequent flooding typical for the reference reach, was not gained. For the later restored reach M8, smaller cross sections were designed and woody debris was later introduced into the stream to retard the flow and to increase the substrate diversity. The adjusted design proved to be successful as both flow resistance and cross-sectional geometry were close to the values of the pristine reference. Field observations show flooding was more frequent in reach M8 than in reach M7 and thus closer to the reference.

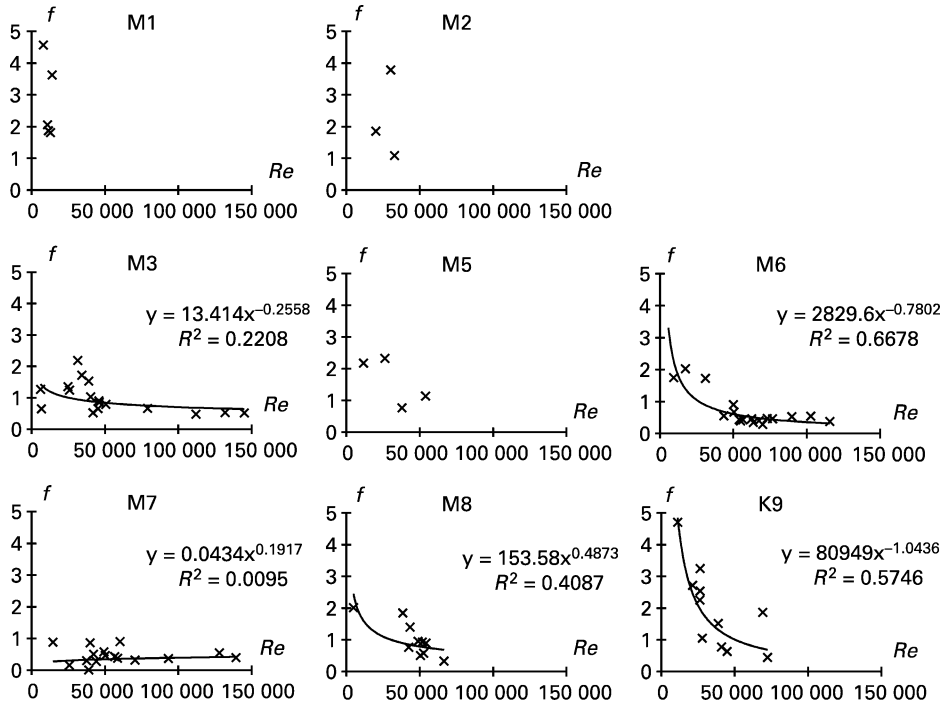
**Figure 3** Reach-averaged friction factor,  $f$ , as a function of the corresponding Reynolds number. Because of the scaling,  $f$  values greater than five are not shown

In Figure 3, reach-averaged friction factors are presented as functions of the corresponding Reynolds numbers. Power functions were fitted to the data with  $R^2$  values presented in Figure 3. The fitting was not carried out for reaches M1, M2 and M5 because of the limited number of measurement points. The friction factors decreased with increasing Reynolds numbers for reaches M6 and M8. The friction factor decreased with increasing flow velocity, but there was substantial variation between the reaches.

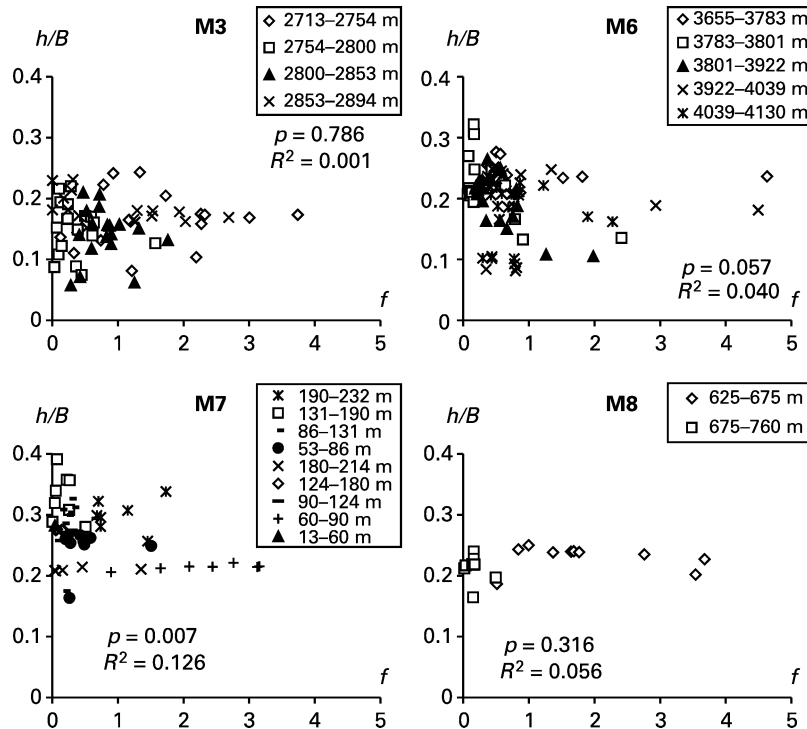
**Figure 4** Depth-width ratio vs friction factor for sub-reaches of M3, M6, M7 and M8. See the text for the statistical parameters  $R^2$  and  $p$

The friction factor was plotted against the hydraulic radius and depth–width ratio. Because of the similarity of the plots, only the friction factor vs the depth–width ratio is

presented (Figure 4). In this figure, the sub-reaches are referred to by their start and end points as a distance along the centre line of the channel from a selected zero point downstream. A linear regression analysis was carried out using the least-squares method.  $R^2$  values and  $p$  values determined using the  $t$ -test with a 95% confidence level are shown in Figure 4. Based on the statistical analysis, both  $R^2$  and  $p$  values were small and therefore no clear dependence between the parameters was found either at reach or sub-reach scale. The effects of individual roughness elements, e.g. logs and boulders, overlaid the effects of the cross-sectional geometry. Therefore, the length of reach analysed can strongly affect the magnitude of the flow resistance coefficient. When investigating the relationship between the flow velocities and cross-sectional geometry, the statistical analysis showed no clear dependence between the parameters (Figure 5). However, clear differences were detected between the reaches. With equal values of  $v$ , the depth–width ratio was clearly higher in reach M7 than in reaches M6 and M8.

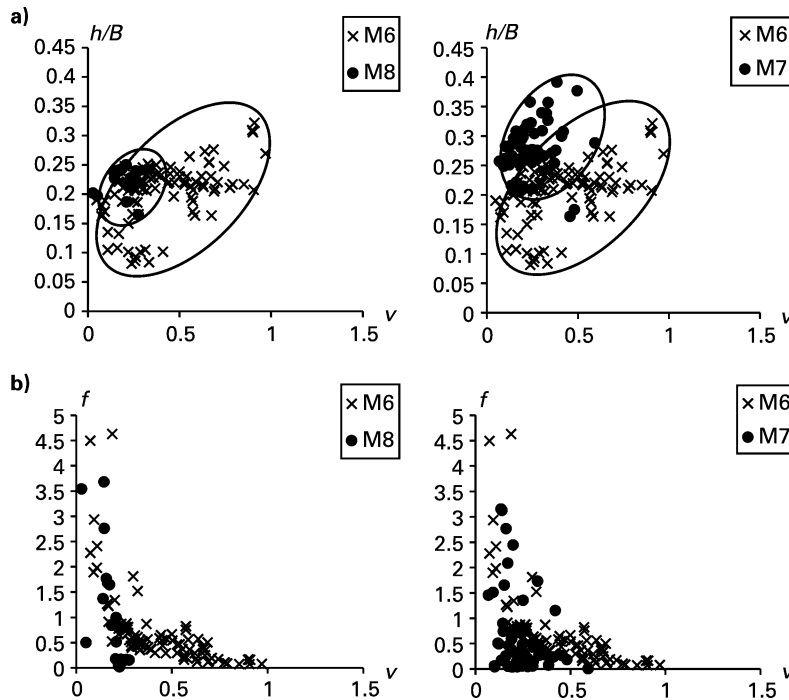
**Figure 7** An example application of the procedure. (a) Depth–width ratio vs flow velocity differs in reach M7 from reference reach M6. (b) Friction factors vs flow velocities match relatively well

These criteria can be used as an assessment tool in post-project evaluation. Application of this procedure is presented in Figure 6. For both the reference reach and the restored reach, the flow velocity is plotted against (1) the friction factor and (2) the parameter(s) of cross-sectional geometry. The plots are compared to investigate if the relationships are similar for the reference reach and the restored reach. An example of applying the procedure is shown in Figure 7.
