Hydraulic considerations in restoring boreal streams

Juha Järvelä and Terhi Helmiö

Helsinki University of Technology, Espoo, PO Box 5300, FI-02015 HUT, Finland

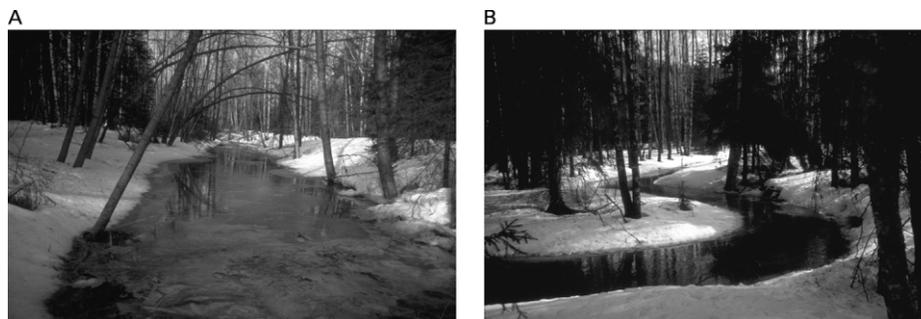
Figure 1 Before and after the restoration: the brook was restored to its historical meandering channel (right) from the channelized reach, which was dredged in the 1960s (left)

The restoration project included design challenges, such as the reconstruction of meanders, cohesive sediments, mild slopes, diverse vegetation and harsh climatic conditions (Figure 1).

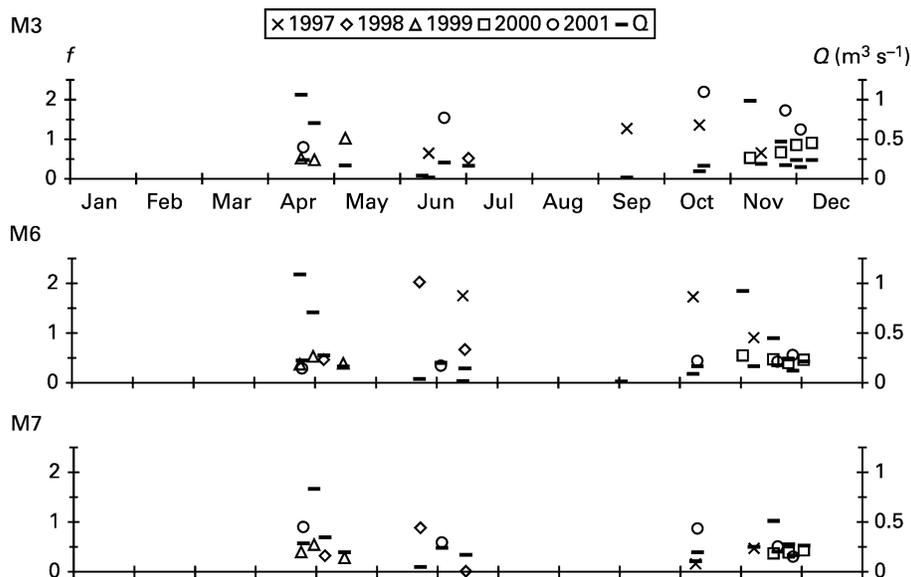
Figure 2 Variation of friction factor and discharge in different years and seasons in reaches M3, M6 and M7

The friction factors of reach M7 were close to the values of the pristine reference, despite differences in cross-sectional geometry. Five years after restoration no considerable changes in flow resistance were observed (Figure 2). Field observations suggest that stream–floodplain interaction, with frequent flooding typical for the reference reach, was not gained. For the later restored reach M8, smaller cross sections were designed and woody debris was later introduced into the stream to retard the flow and to increase the substrate diversity. The adjusted design proved to be successful as both flow resistance and cross-sectional geometry were close to the values of the pristine reference. Field observations show flooding was more frequent in reach M8 than in reach M7 and thus closer to the reference.

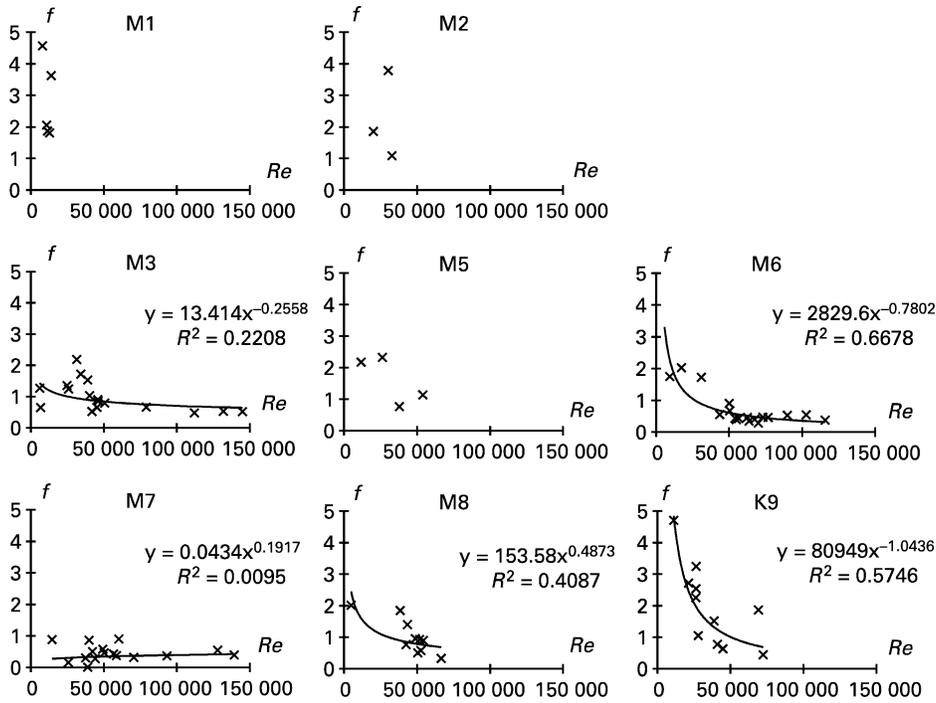
Figure 3 Reach-averaged friction factor, f , as a function of the corresponding Reynolds number. Because of the scaling, f values greater than five are not shown

In Figure 3, reach-averaged friction factors are presented as functions of the corresponding Reynolds numbers. Power functions were fitted to the data with R^2 values presented in Figure 3. The fitting was not carried out for reaches M1, M2 and M5 because of the limited number of measurement points. The friction factors decreased with increasing Reynolds numbers for reaches M6 and M8. The friction factor decreased with increasing flow velocity, but there was substantial variation between the reaches.

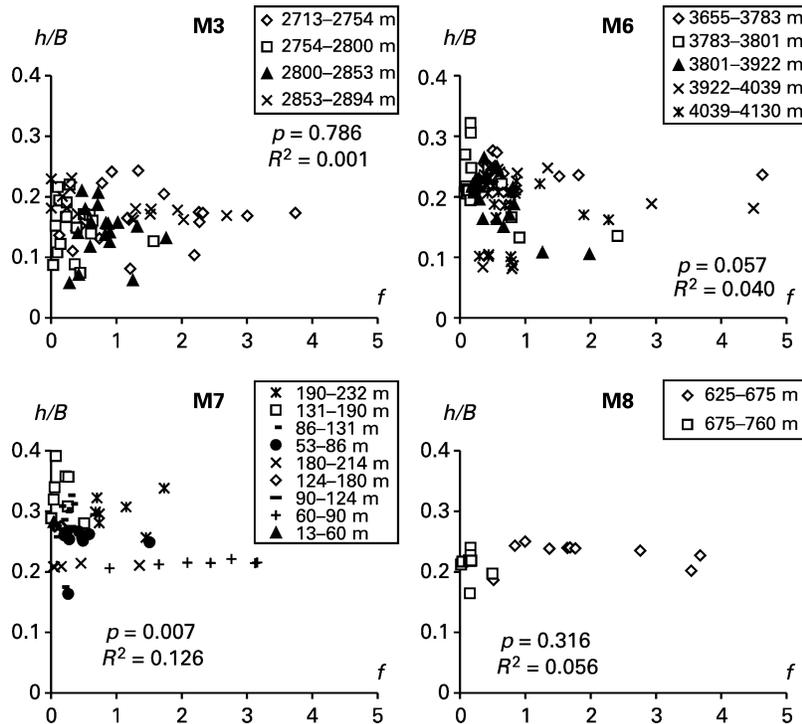
Figure 4 Depth-width ratio vs friction factor for sub-reaches of M3, M6, M7 and M8. See the text for the statistical parameters R^2 and p

The friction factor was plotted against the hydraulic radius and depth–width ratio. Because of the similarity of the plots, only the friction factor vs the depth–width ratio is

presented (Figure 4). In this figure, the sub-reaches are referred to by their start and end points as a distance along the centre line of the channel from a selected zero point downstream. A linear regression analysis was carried out using the least-squares method. R^2 values and p values determined using the t -test with a 95% confidence level are shown in Figure 4. Based on the statistical analysis, both R^2 and p values were small and therefore no clear dependence between the parameters was found either at reach or sub-reach scale. The effects of individual roughness elements, e.g. logs and boulders, overlaid the effects of the cross-sectional geometry. Therefore, the length of reach analysed can strongly affect the magnitude of the flow resistance coefficient. When investigating the relationship between the flow velocities and cross-sectional geometry, the statistical analysis showed no clear dependence between the parameters (Figure 5). However, clear differences were detected between the reaches. With equal values of v , the depth–width ratio was clearly higher in reach M7 than in reaches M6 and M8.

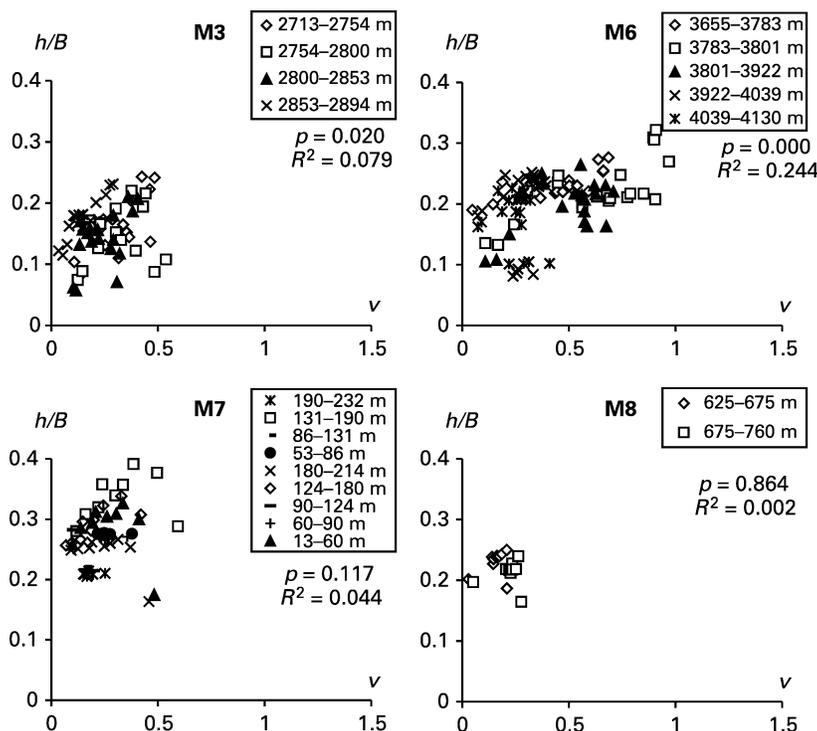
Figure 5 Depth–width ratio vs average velocity for sub-reaches of M3, M6, M7 and M8. See the text for the statistical parameters R^2 and p

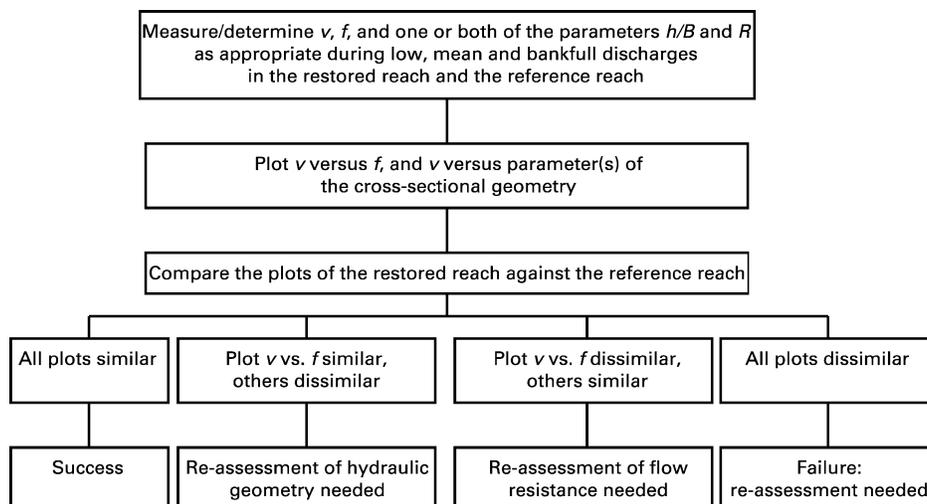
Figure 6 Procedure for applying the success criteria in post-project evaluation of local hydraulics

These criteria can be used as an assessment tool in post-project evaluation. Application of this procedure is presented in Figure 6. For both the reference reach and the restored reach, the flow velocity is plotted against (1) the friction factor and (2) the parameter(s) of cross-sectional geometry. The plots are compared to investigate if the relationships are similar for the reference reach and the restored reach. An example of applying the procedure is shown in Figure 7.

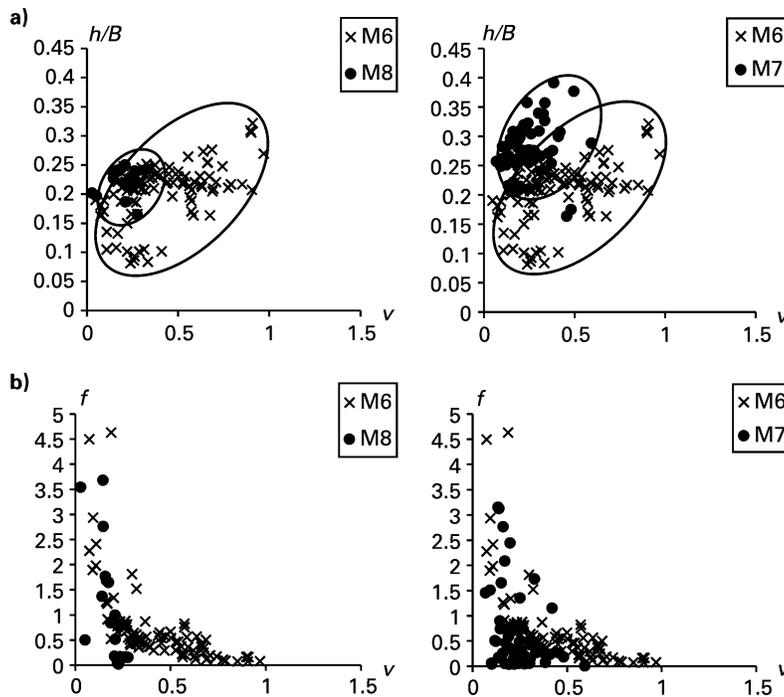
Figure 7 An example application of the procedure. (a) Depth–width ratio vs flow velocity differs in reach M7 from reference reach M6. (b) Friction factors vs flow velocities match relatively well
