Hydraulic considerations in restoring boreal streams

Juha Järvelä and Terhi Helmiö

Helsinki University of Technology, Espoo, PO Box 5300, FI-02015 HUT, Finland

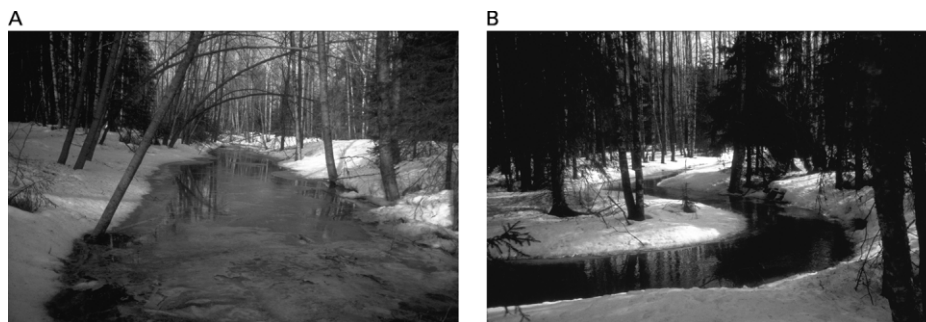
Figure 1 Before and after the restoration: the brook was restored to its historical meandering channel (right) from the channelized reach, which was dredged in the 1960s (left)

The restoration project included design challenges, such as the reconstruction of meanders, cohesive sediments, mild slopes, diverse vegetation and harsh climatic conditions (Figure 1).

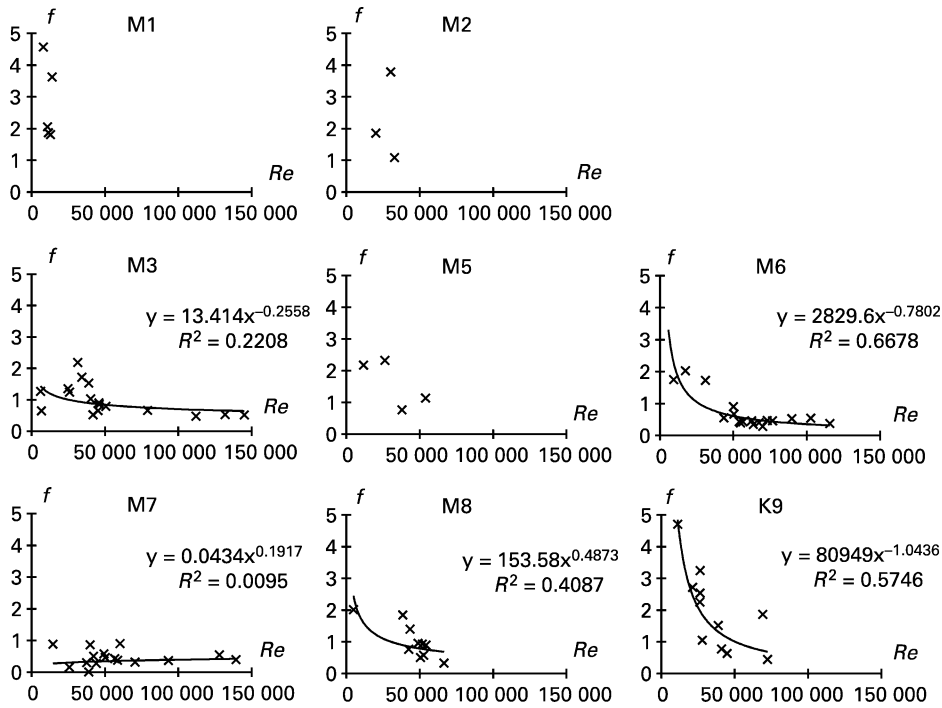
Figure 3 Reach-averaged friction factor, f , as a function of the corresponding Reynolds number. Because of the scaling, f values greater than five are not shown

In Figure 3, reach-averaged friction factors are presented as functions of the corresponding Reynolds numbers. Power functions were fitted to the data with R^2 values presented in Figure 3. The fitting was not carried out for reaches M1, M2 and M5 because of the limited number of measurement points. The friction factors decreased with increasing Reynolds numbers for reaches M6 and M8. The friction factor decreased with increasing flow velocity, but there was substantial variation between the reaches.

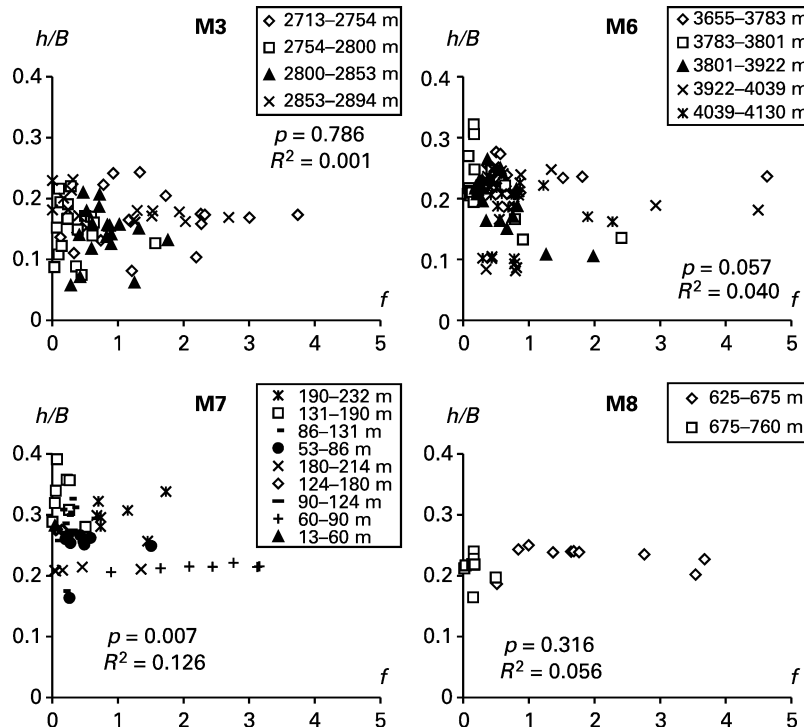
Figure 4 Depth-width ratio vs friction factor for sub-reaches of M3, M6, M7 and M8. See the text for the statistical parameters R^2 and p

The friction factor was plotted against the hydraulic radius and depth–width ratio. Because of the similarity of the plots, only the friction factor vs the depth–width ratio is

presented (Figure 4). In this figure, the sub-reaches are referred to by their start and end points as a distance along the centre line of the channel from a selected zero point downstream. A linear regression analysis was carried out using the least-squares method. R^2 values and p values determined using the t -test with a 95% confidence level are shown in Figure 4. Based on the statistical analysis, both R^2 and p values were small and therefore no clear dependence between the parameters was found either at reach or sub-reach scale. The effects of individual roughness elements, e.g. logs and boulders, overlaid the effects of the cross-sectional geometry. Therefore, the length of reach analysed can strongly affect the magnitude of the flow resistance coefficient. When investigating the relationship between the flow velocities and cross-sectional geometry, the statistical analysis showed no clear dependence between the parameters (Figure 5). However, clear differences were detected between the reaches. With equal values of v , the depth–width ratio was clearly higher in reach M7 than in reaches M6 and M8.

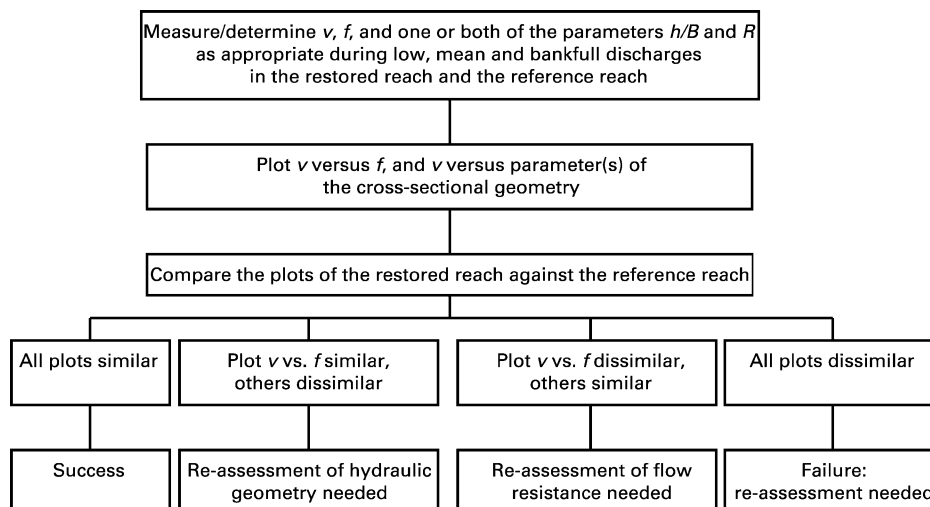
Figure 6 Procedure for applying the success criteria in post-project evaluation of local hydraulics

These criteria can be used as an assessment tool in post-project evaluation. Application of this procedure is presented in Figure 6. For both the reference reach and the restored reach, the flow velocity is plotted against (1) the friction factor and (2) the parameter(s) of cross-sectional geometry. The plots are compared to investigate if the relationships are similar for the reference reach and the restored reach. An example of applying the procedure is shown in Figure 7.

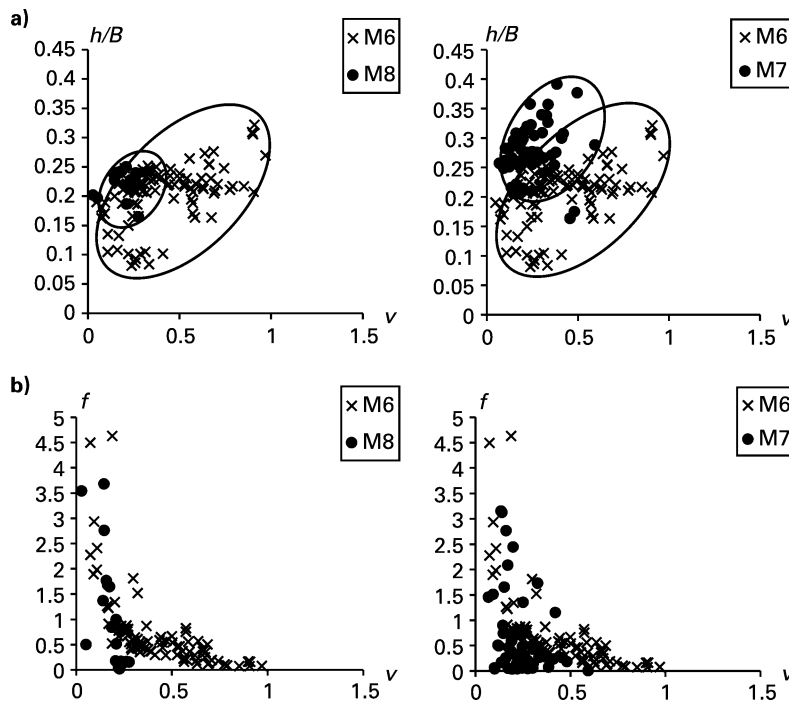
Figure 7 An example application of the procedure. (a) Depth–width ratio vs flow velocity differs in reach M7 from reference reach M6. (b) Friction factors vs flow velocities match relatively well
