## Research on buried pipe corrosion assessment using corrosion sensors

Hidefumi Itaya, Kazuyuki Midorikawa, Takaaki Nagai and Shukuji Asakura

This research aims to establish a water pipeline replacement plan that employs soil-corrosion evaluation technology and utilizes easy-to-use corrosion sensors by assessing the performances and validating operation methods based on verification experiments. Since 2005, we have assessed the performances of two different types of sensor, and have confirmed that bar-type sensors can detect soil corrosion effects, including macrocell corrosion. To verify the sensors' practicality, beginning in 2007 we have performed tests on corrosion sensors buried underground for two pipelines with nominal diameters 400 mm or more. In 2008, we collected and analysed the data from some of the sensors, which were buried for about a year. This paper discusses the results of the corrosion sensor performance assessment to date and the practicality of sensors based on data analyses of the test sensors collected in 2008.

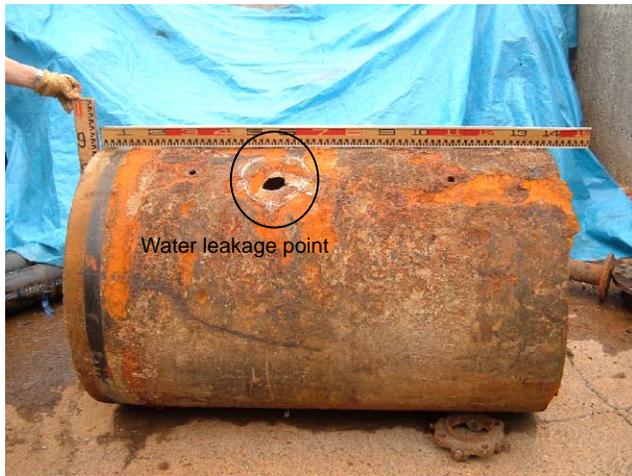
Figure 1 | Tomioka line pipe.

On 16 June 2005, a hole with a 5 cm diameter was found in the bottom of a ductile cast iron pipe with a nominal diameter of 800 mm (Tomioka Line; [Figure 1](#)), even though the pipe was still within the legally defined life period. The pipeline, built in 1970, was not covered with a polyethylene sleeve, and 950 households in Yokohama city suffered interruption of water supply for eight hours. This led to the convening of the Yokohama Yokodai water pipe leakage investigation committee, which included outside specialists, to discuss the cause of the accident as well as preventive measures. Upon examining the pipe and soil corrosiveness, it was revealed that although the pipe maintained the same material quality standard as when it was initially installed, the bottom of the pipe, in particular, was badly corroded.

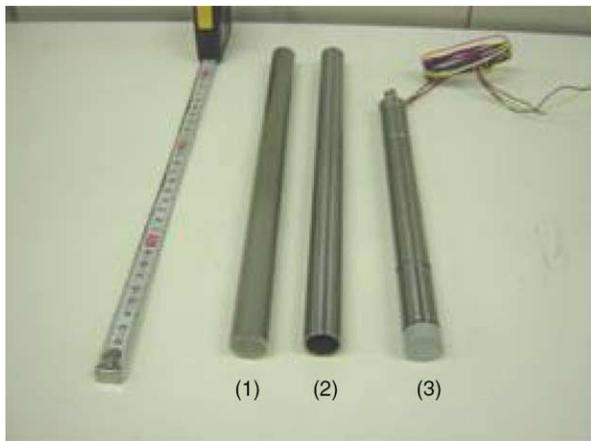
Figure 6 shows the three types of test sensor, a round bar, pipe and segmented electrode, which are described below and in Table 3.

**Figure 6** | Round bar test sensors.

The 30 cm polished round bar was made from normal steel (SGD 400: diameter 2 cm).

The pipe sensor was made from a black pipe (SGP, 15A: O.D. 21.7 mm, thickness 2.8 mm) using the following procedure. First the outer circumference was machined by a lathe to obtain a 2 cm diameter. Then the mill scale on the pipe surface was removed to obtain O.D. 2 cm. Finally the pipe was cut to a length of 30 cm to be used as the test sensor.

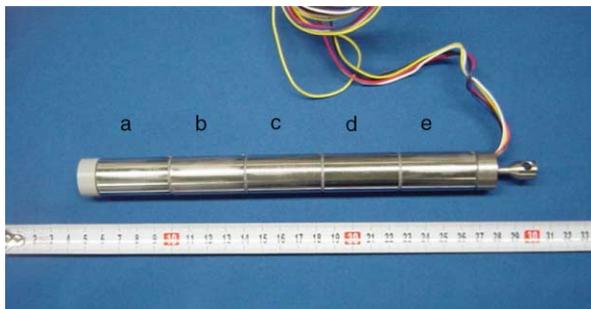
Figure 7 shows the segmented electrode test sensor, which consisted of five steel pipes (O.D. 2 cm, length 4 cm, each) cut out of black pipe (SGP, 15A). We used a PVC pipe to put the five steel pipes through the axle to fix with acryl discs (thickness 1 mm) inserted between the steel pipes for insulation. The conducting wires from the steel pipes were pulled and connected so they could serve as a piece of steel pipe. By measuring the electrical current using the segmented electrode, we could confirm whether macrocell corrosion occurred.

**Figure 7** | Segmented electrode.

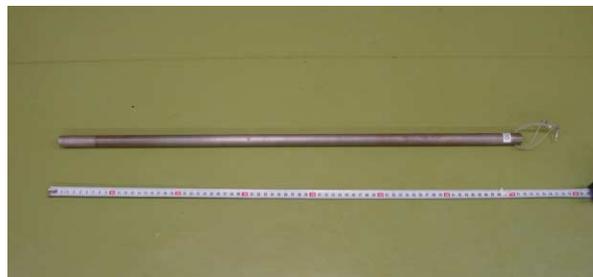
The test sensor for scrutiny was made by cutting a round bar (FCD400, diameter 18 mm; Figure 10) to fit the nominal diameter of the target pipeline. Instead of normal steel, which was used in the verification test, ductile cast iron was used for the sensor because ductile cast iron is more adaptable to the environment where the water pipes were buried. To provide a more accurate measurement using a precision balance, the test sensor, which is an improved form of the round bar type test sensor used in the verification test, was devised to allow only the tip of the sensor where corrosion tends to concentrate to be removed.

Figure 10 | Test sensor for scrutiny.
