Pipeline management in Tokyo - measures for leakage prevention

Kazuhiko Fujimura

Key words | lead pipe, leakage prevention, leakage prevention statistics data, planned work, preventive measures, stainless steel pipe

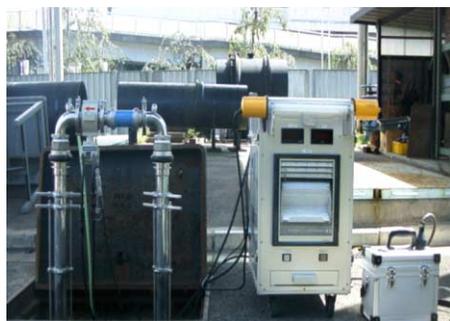
Figure 8 | Portable minimum flow meter.

We established an Office of Leakage Prevention in 1974 to cope with the prevention of leakage machinery and to the study and development of leakage prevention technology. Environment leakage searches by acoustic methods became extremely difficult due to the increase of city noise, traffic density, and congestion of buried structures. Therefore, development of new leakage search technology which was not influenced by the difficult work environment (i.e. was easy to operate) and that made work more efficient, was necessary. We established a “Training and Technical Development Center” to plan the reinforcement of the development system and the general improvement of waterworks technology and to carry out the technology development that could cope with a change of on-site needs immediately (Figure 8).

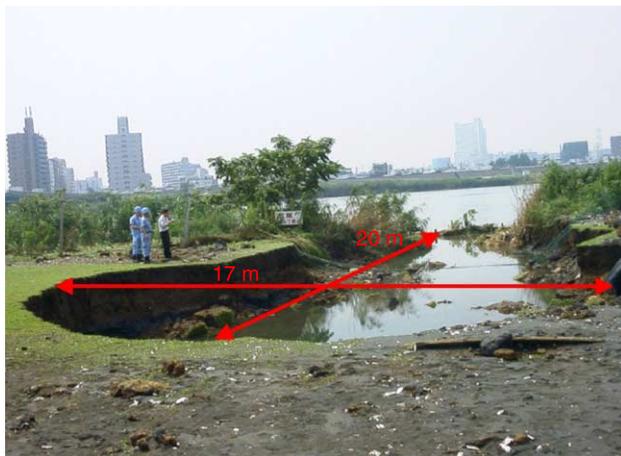
Figure 9 | The leakage accident.

In August, 2003, a large-scale leakage accident occurred on the riverside land of Arakawa and caused turbid water in 400,000 houses. In this accident, the riverside land sank by an area of 20 m by 17 m and 5 m deep (Figure 9), and the quantity of the leakage amounted to 8,000 m³. In addition, in the accident which occurred in March, 2005, an arterial road sank, and serious consequences occurred such as flooding above and under ground as well as an outflow of water to a basement parking area.

These accidents were caused by “aging deterioration of a pipe”. In these cases, it is possible to reduce leakage by
