IN SITU MEASUREMENT OF PARTICULATE EROSION DAMAGE ON ADDITIVELY MANUFACTURED IN718

A. T. Fry, J. Nunn, M. G. Gee, L. Orkney
National Physical Laboratory, Teddington, Middlesex, UK

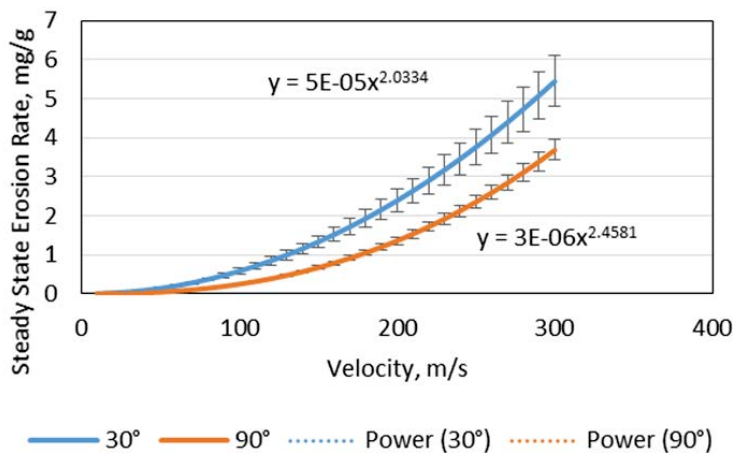
Figure 1 Erosion rate as a function of incident angle for all data collected by project partners for Nimonic 80A at 600 °C [6].

80A [5] which focussed on the influence of the apparatus design and the test method on the erosion measurements [6]. This work demonstrated the use of *in situ* mass measurement to determine the erosion rate, comparing these *in situ* measurements with *ex situ* measurements conducted by project partners, an example of the results is shown in Figure 1.

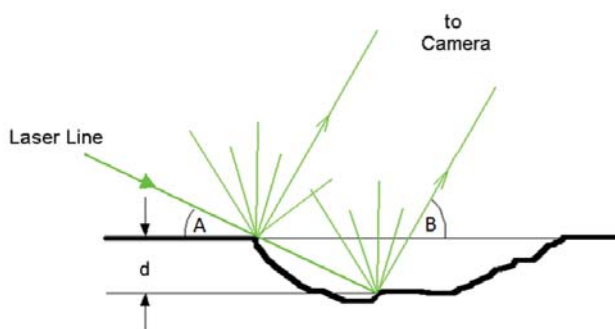
Figure 3 Detail of how a change in vertical surface height affects the position at which the line laser will strike the surface, and hence where the scattered light will originate from.

A change in surface height affects where the scattered light is seen to be coming from, as shown in Figure 3. It should be noted that of all the light scattered from the surface of the scar, only the light scattered in the direction of the camera (marked with arrows towards the camera) will be collected to form the image.

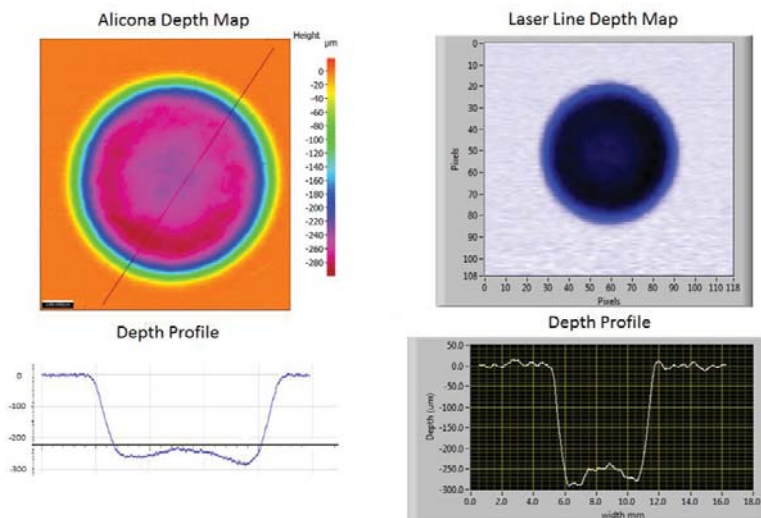
Figure 7 Typical results on the nominally 0.3mm specimen: Alicona 3D Optical Microscope (left) and Laser Line Method (right).

Bench top validation of the process was conducted using an aluminium reference sample which had dimples machined into it, and on aluminium samples which had been eroded, a full description of these tests is discussed in [7]. To summarise, the measurements showed that *ex situ* the measurement system had good agreement with other optical microscope measurement systems, such as the Alicona 3D optical microscope, of less than 4%, with the level of agreement in depth measurement being is typically $\pm 10 \mu\text{m}$. Figure 7 shows a typical Alicona height map and profile on the left-hand side, and corresponding Laser Line results on the right-hand side.

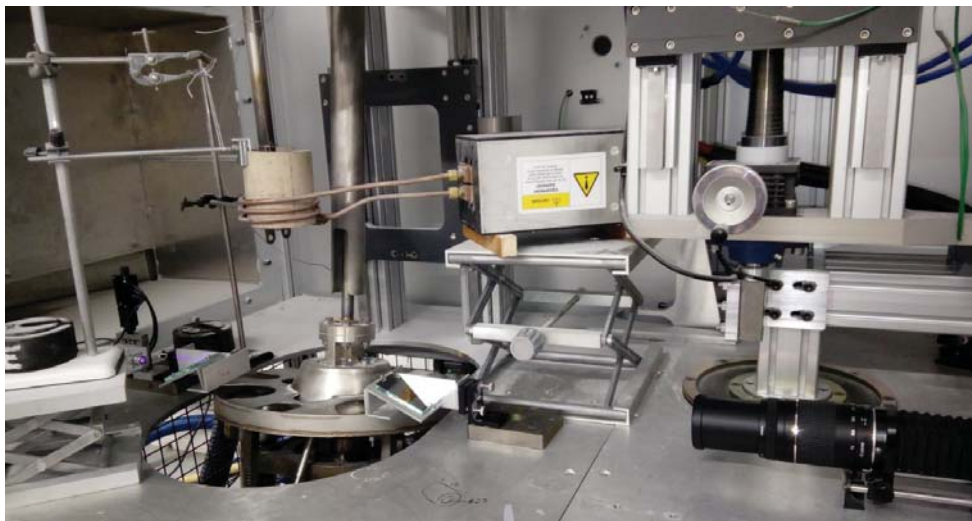
Figure 8 Internal view of the HTSPE apparatus showing the induction heater, sample hang down and laser optics.

The HTSPE tests were conducted using the modified NPL HTSPE apparatus, shown in Figure 8. Originally the apparatus used a furnace to maintain the sample at the test temperature. Whilst this was found to work, the furnace lining did experience issues of erosion itself and the furnace did obstruct line of sight for the laser optics. Consequently, the apparatus was modified to incorporate an induction heater which surrounds the sample. The induction coils are protected from damage using a ceramic sheath as shown in Figure 8. All other features of the original design [5] remain unchanged with the rig consisting of an air pump which delivers air at a flow rate of $400\text{m}^3\text{h}^{-1}$ (235cuft.min^{-1}), which is delivered at a pressure of 1 bar. The air passes through a heater cartridge located under the nozzle, where it is heated to the test temperature, with an upper limit of $900\text{ }^\circ\text{C}$. The hot gas then passes through the nozzle where a reduction in cross section occurs, thereby accelerating the gas further. The velocity of the gas is governed by the flow rate from the air pump. The erodent powder is introduced into the gas stream after the ‘throat’ [4] section of the nozzle, where it accelerates along the nozzle length (200 mm) before exiting and impinging on the specimen surface, in this case at 90° to the flow direction. The stand-off distance between the sample and the nozzle can be varied, for the work presented here it was set to 40 mm.

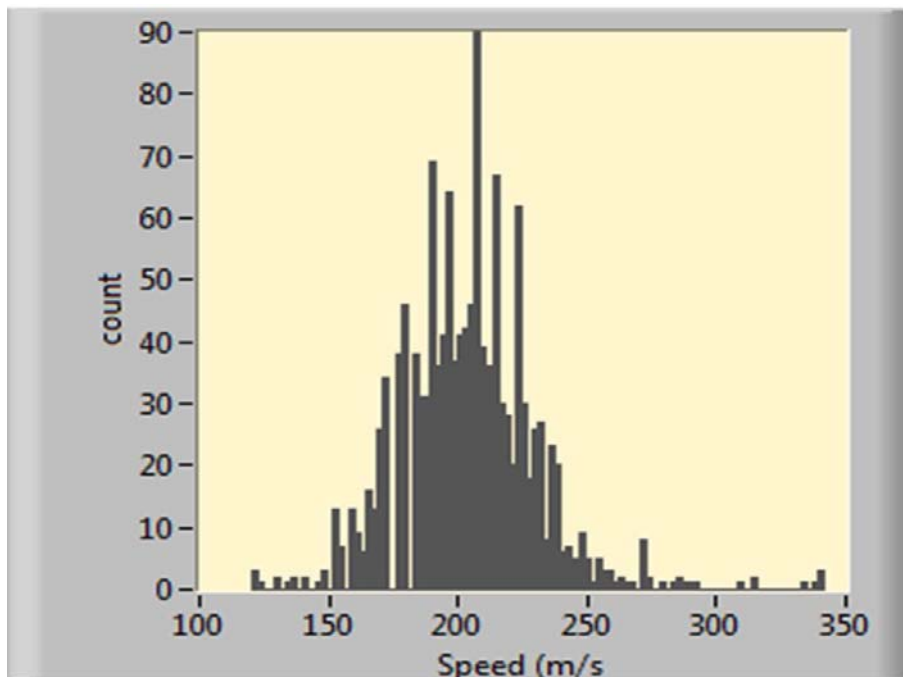
Figure 9 Velocity distribution for the Saftgrit White230-mesh alumina at a temperature of 700 °C within the NPL HTSPE test apparatus.

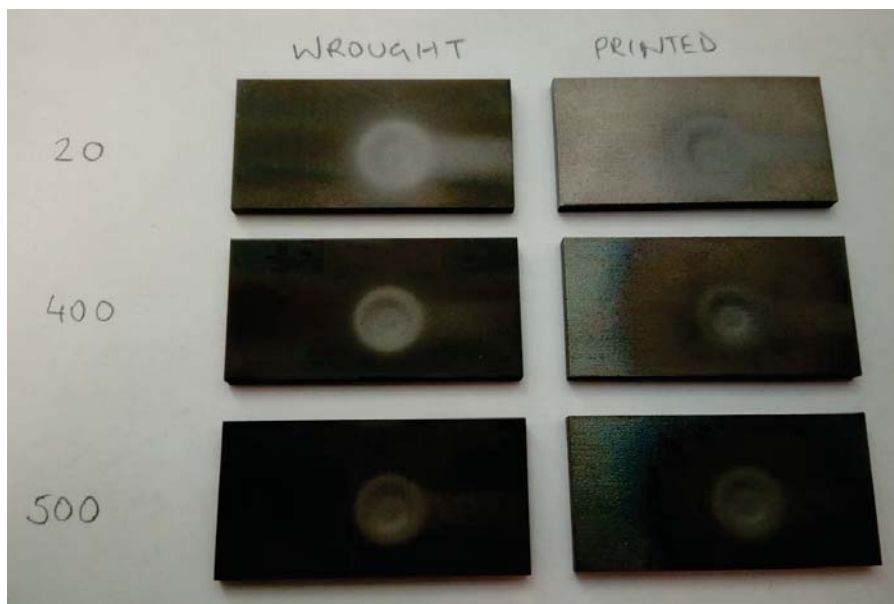
Figure 10 Photo of the six samples HTSPE tested.

Figure 10 shows an image of the eroded samples tested at 20, 400 and 500 °C, the erosion scar can be clearly observed with a track extending on the right-hand side of the scar. This track is caused by the ‘parking’ of the

nozzle during the erosion test which was performed with the powder flowing to ensure a consistent feed rate during the exposure.

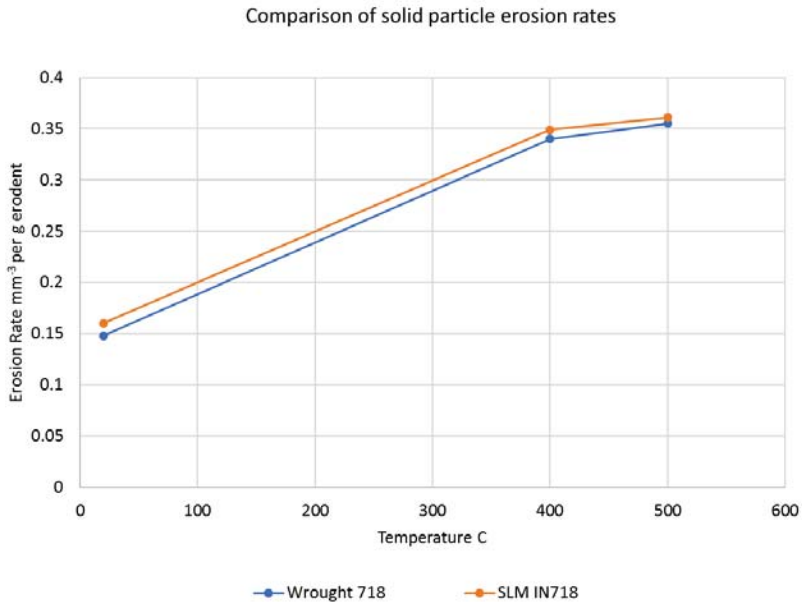
Figure 15 Comparison of the erosion rate for the wrought and SLM IN718 as a function of temperature.

- The HTSPE erosion rate of wrought and SLM IN718 has been measured at room temperature and at 400 and 500 °C. In all cases the erosion rate was found to be the same, within the realms of experimental error, between the two material batches. This suggests that the as produced additively manufactured material has comparative erosion resistant (under these conditions) to the conventionally cast, forged and heat treated IN718.
