# Application of A Drone Camera in Detecting Road Surface Cracks: A UAE Testing Case Study

*This research aims to introduce DJI Phantom 4 Pro, and its process of calibration and image processing. To get accurate aerial photos, a camera calibration process has been applied to find the true parameters (e.g., focal length, format size, principal point, and lens distortion) of the camera that took the photographs. Results from the point of view of variance factor confirmed the reliability of this camera for photogrammetric work. This study also calculates the 3D coordinates of unknown points on the ground and added Photogrammetric Derivatives DEM and accurate Digital Orthophotos to check the road condition. It is difficult to precisely identify them using publicly accessible standard satellite imagery (including the three multispectral bands (G, R, NIR) with resolutions of 20 meters). Agisoft software has been used for image analysis and for accuracy checking to detect street cracks to provide recommendations and guidance to the related planning entity for maintenance. Captured aerial crack images were processed using Agisoft software, from which orthophotos were produced and potentia

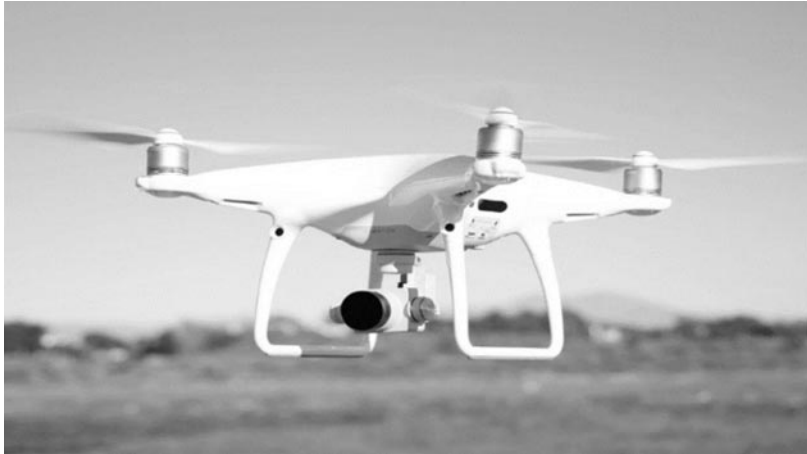
FIGURE 2

DJI Phantom 4 Pro equipped with high-definition camera used for visual inspection in this research

It takes several steps from selection to testing if all its specifications are working correctly. The DJI Phantom 4 Pro (Figure 2) is the drone type used in this study. It is equipped with a 1-inch 20 MP camera; the Phantom 4 Pro is capable of shooting 4K 60fps video and 14fps Burst Mode stills. The battery has a max flight time of 30 minutes, and a maximum transmission range of 7 km. This drone was first upgraded before testing. The firmware of the drone was downloaded from the website, placed in a memory card and inserted into the drone to update its system. The upgrading process was performed in the lab, and the flight test took place at the surveying network field. This was to test if the drone specifications like image quality/resolution, flight altitude (10m to 15m above ground level), motion directions (left, right, backward, forward etc.) were all functioning well and are up to standard.

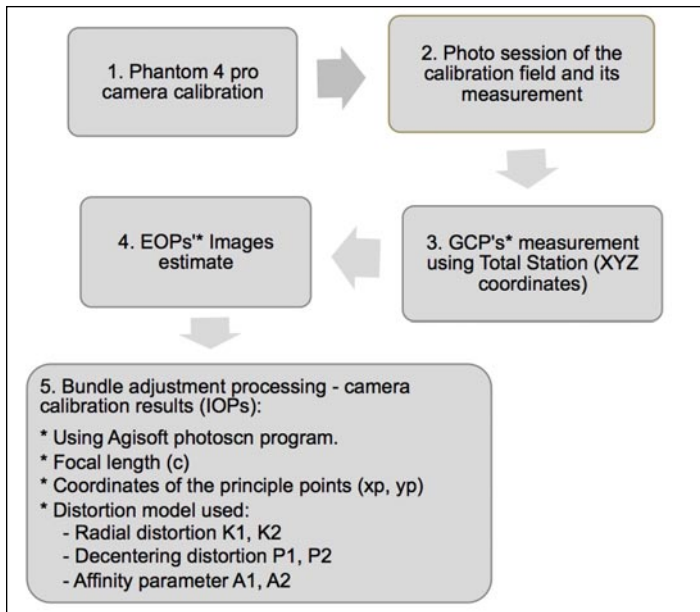
FIGURE 4

- 1 Start dataset acquisition for the camera calibration phase. This includes field measurements on the test field in addition to multiple photographs in predesigned configurations necessary for successful calibration (Figure 5).
- 2 Start the semi-automatic and manual data measurement from the acquired images for each dataset utilizing AgisoftPhotoScan software.

- 3 Prepare calibration data input files for processing using Bundle Adjustment software.
- 4 Analyze and present the results of camera calibration.

Camera calibration steps

The existing wide-format calibration field was used to calibrate the new drone camera. The Calibration process was conducted in the following steps as illustrated in Figure 4:

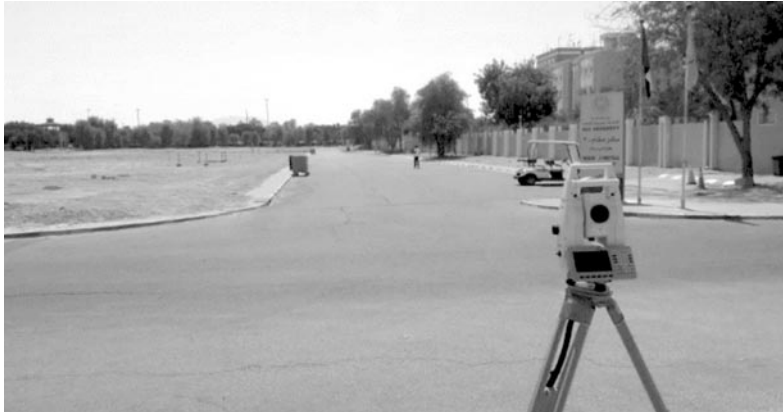
FIGURE 6

Total Station TS16i for the ground support of GCPs

- 2 Field measurement of GCPs using a precise total station: The measurement was performed to determine and calculate the accuracy of the positions/coordinates of the aerial crack photos to be collected in the coordinate system. GCPs were well positioned and marked to make them easily visible on aerial images. Due to the nature of the survey area, a few GCPs (about 5) were used to obtain the desired precision (Figure 6).

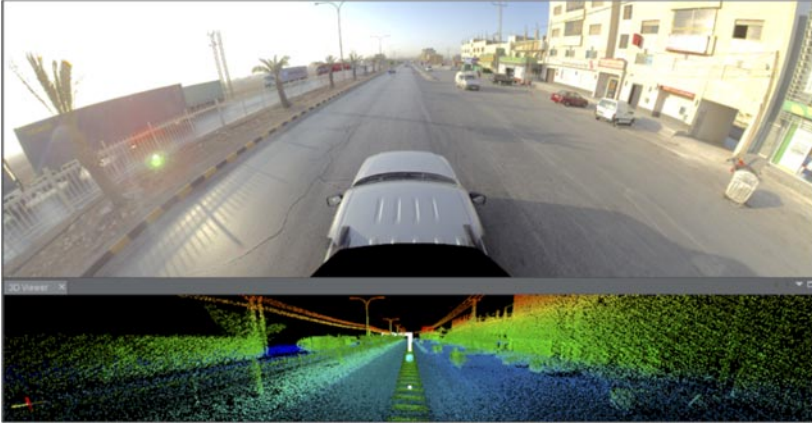
FIGURE 9

Crack Detection from Mobile Laser Scanning Point Clouds and images

The case study is a part of the Highway (Amman-Aqaba Desert Highway) road project of reconstruction and rehabilitation at the end of 2017. The project involves a complete reconstruction of 220km of that road. Road surface damage analysis is indicated in Figure 9, which presents the damage on the road surface.

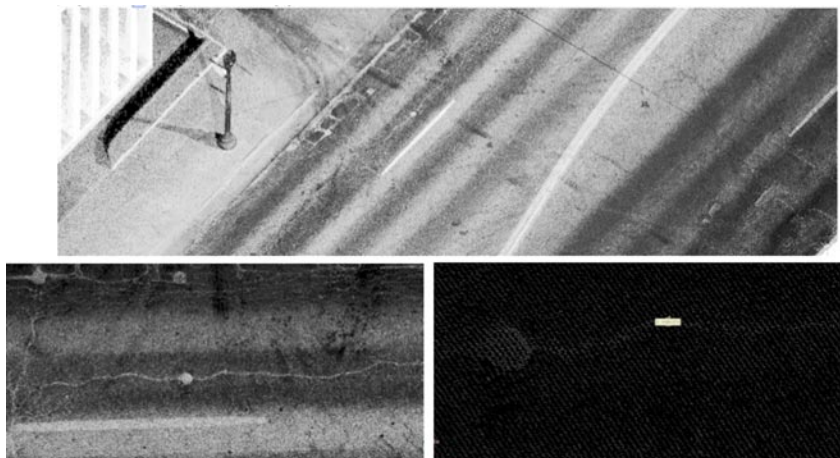
FIGURE 11

Location2: crack1 detection using point cloud

As we can see in the following Figures 10 and 11, we can detect the cracks in the road more accurately by using the dense point cloud taken from the Faro laser scanning device.

Crack Dimension	Location 1 - Crack1	Location 2 - Crack1
Depth	2 cm	1 cm
Cross Length	8.9 cm	7.3 cm

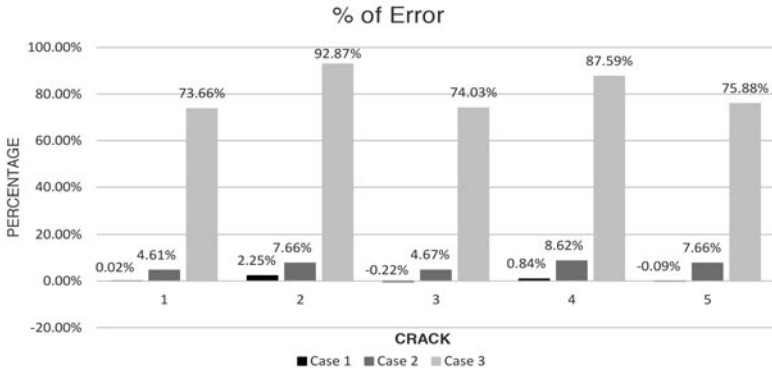
FIGURE 12  
Error percentage in three cases

The results showed that Case 1 has the least amount error of 0.56%, followed by Case 2 (6.65%) and Case 3 with an error of 80.81%. These results showed that it is better to use Ground Control Points with Camera Calibration for obtaining results with the least errors.
