MOTOR-TANKER COIMBRA - THE MILLION GALLON GAMBLE

ABSTRACT

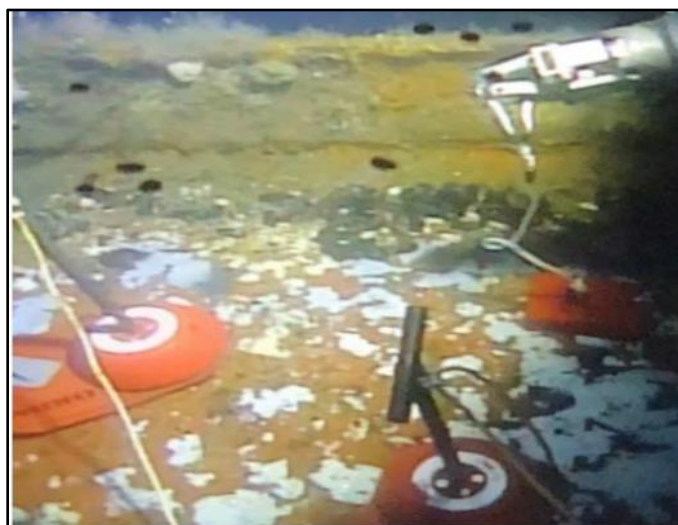
Figure 5. Oil globules captured by the ROV's camera

Additionally, this period is when migratory bird season is at its peak. Periodically, migrating birds would land on what appeared to be an oasis, the SHELIA BORDELON which was 30 nautical miles offshore. The migrating birds would expire due to dehydration, exhaustion, or starvation. A safety plan had to be generated to address the carcasses, which were removed safely and discarded humanely and to protect the crew from sickness. Once at the wreck, Phase 1 – Mobilization was complete and Phase 2 – Survey, could begin. The ROV was splashed and commenced a comprehensive scan of COIMBRA for hazards. Once deemed safe for work, the ROV identified pinhole oil seeps (visible in Figure 5) in the mid-section of the ship, which lay nearly fully inverted. Oil was positively identified by the ROV, some of which oiled the ROV itself and was recovered using cotton swabs on the surface. The oil tested positive as lube oil, matching the surface sheen results obtained in 2017. Magnetic patches were sometimes deployed from the ROV over these small seeps. During survey, there were many small leaks discovered. Plugging each leak would have prolonged the survey, therefore, each leak was documented and prioritized for the third phase. After scanning the ship visually, wire brush and cavitation cleaners were used to clear the ship's surface of growth so that magnets could be attached to identify sections of the ship for Phase 3 - Removal. Occasionally when a wire brush on the ROV made a pass over a rivet, oil began leaking from the tanks at a faster rate. The rivets that joined sections of hull plating began rotating and created small pathways for oil to escape the wreck. The movement of the rivets in the hull plating highlighted the fragility of the wreck and increased the urgency of the response.
