Using In situ Capacitance Measurements to Monitor the Stability of Thermal Interface Materials in Complex PCB Assemblies

Michael Gaynes, Timothy Chainer and Edward Yarmchuk
 IBM T. J. Watson Research Center
 1101 Kitchawan Road
 914 945 1838
 gaynesma@us.ibm.com
 Yorktown Heights, NY 10598

John Torok, David Edwards, David Olson and Katie Pizzolato
 IBM Corporation
 Poughkeepsie, NY 12601

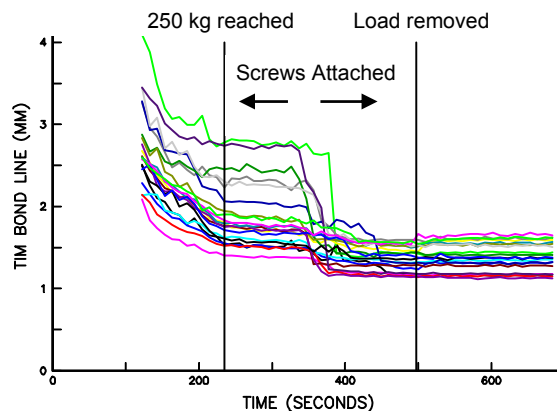
Figure 1: TIM bond line response to load, time and fastening.

Capacitance, temperature and time were logged continuously. The mating force applied to the heat spreader was limited to 250 kg which was determined by assuming a uniform loading of all 37 modules to 90% of the compressive limit. Figure 1 is a plot of the TIM bond line vs. time and mechanical loading. The ultimate bond lines were not achieved with 250 kg mating force and time alone. Only after engaging the screws and securing to the standoffs were stable bond lines achieved: 1.2 to 1.7 mm.

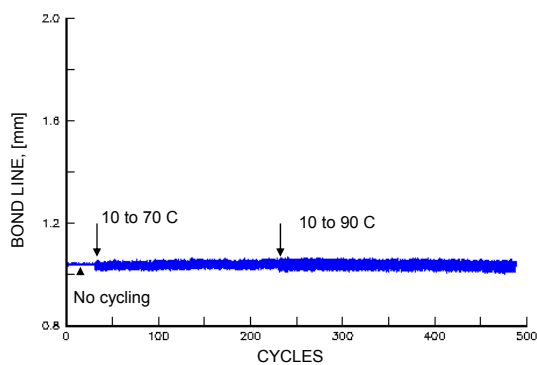
Figure 3: Bond line response of a module to thermal cycling with peak to valley motion < 0.05 mm.

cycles for a module that had a peak to valley change of < 0.05 mm. The bond line is very stable and the amplitude of motion is not changing with increasing thermal cycles. When the thermal cycle changed from 10 - 70 C to 10 - 90 C, bondline compression increases from 70 to 90 C as shown in the plot in Figure 3. Photographs of the heat spreader site and the module after disassembly are shown in Figure 4. The fissures that appear in the TIM on the heat spreader side are an indicator of structure weakness.

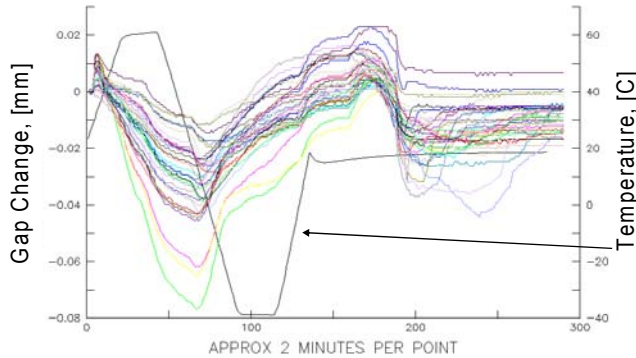
Figure 7: Absolute air gap motion vs. thermal cycle from -40 to 60 C, +20 um and -80 um respectively.

Figure 7 shows the air gap changes for all modules during a ship shock thermal cycle between -40 C and 60 C. Consistent with the trend in the first test, at the cold temperature, the air gap increases as much as 20 um, and at the hot temperature, it decreases as much as 80 um. The air gap motion was converted to strain for correlation to changes in capacitive bond line of the TIM during thermal cycling and evidence of pumping. The nominal air gap strain was 6%: Figure 8.

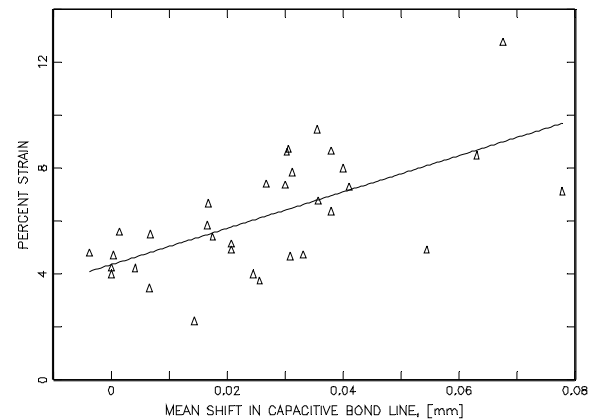
Figure 11: Correlation between strain and mean shift in capacitive bond line: $R^2 = 0.4$.

The plot in Figure 11 shows that there is a

mild correlation between the air gap strain and the mean shift in capacitive bond line for the 32 modules that were tested.
