## Early detection of dens evaginatus appearing on the premolars and clinical management: histological study

T. Kawata\* / K. Tanne\*\*

J Clin Pediatr Dent 26(2): 199-201, 2002

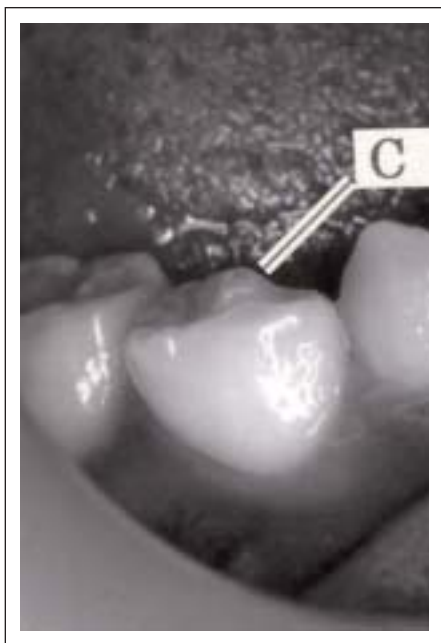
**Figure 1.** The appearance of the central cusp on initial presentation. C: central cusp.

On examination, the tooth had a large central cusp to the upper second premolar (Figure 1). A Radiograph of the central cusp showed a pulpal horn (Figure 2). The central cusp was protected by the application of a self-curing acrylic resin at early detection. Acrylic resin was attached on the occlusal surface for about one year (Figure 3). At one year acrylic resin was observed to the bottom surface and showed good

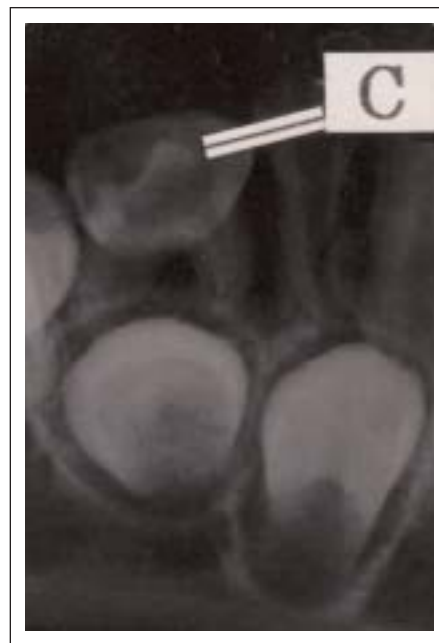
**Figure 2.** Radiographic appearance on presentation. C: central cusp.

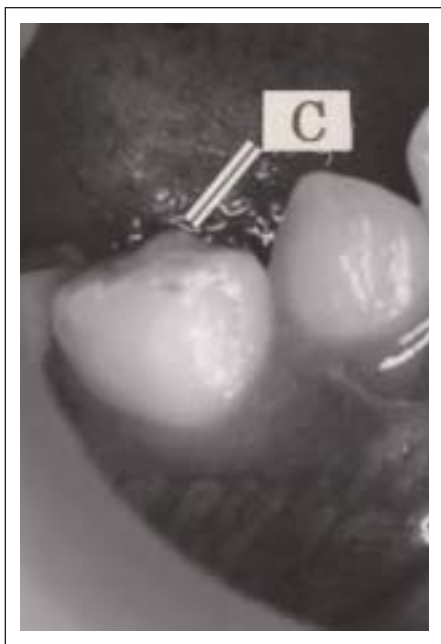
**Figure 3.** The appearance of the cusp when protected by self-curing acrylic resin at early detection. C: central cusp.

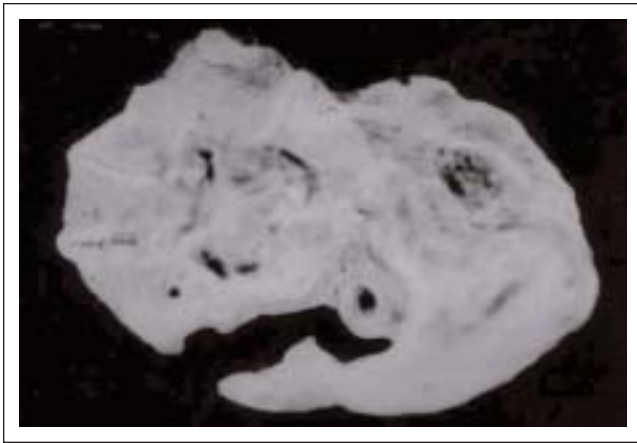
**Figure 4.** The bottom surface of the cusp after the application of the self-curing acrylic resin.

adhesive properties (Figure 4). Histological examination showed a large pulpal cavity and a wide radicular canal extending from the pulp horns through the root apex (Figure 5).

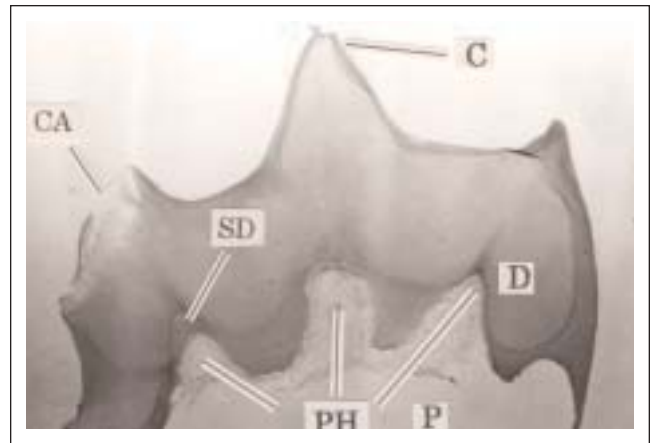
**Figure 5.** A photomicrograph of the upper second premolar. P: pulp. C: central cusp. CA: caries. D: dentin. PH: pulp horn. SD: secondary dentin.

Histological examination showed that, the pulp did not penetrate deeply into the central cusp. We suggest that closure of the horn of pulp can be accomplished by early detection and a useful treatment for central cusp fractures of premolars.
