# POINT CLOUD APPLICATIONS FOR DISASTER REMEDIATION: A CASE STUDY

Glenda Mayo<sup>1\*</sup>

<sup>1</sup>Univeristy of North Carolina at Charlotte, 9201 University City Blvd., Smith 236, Charlotte, NC 28223, United States

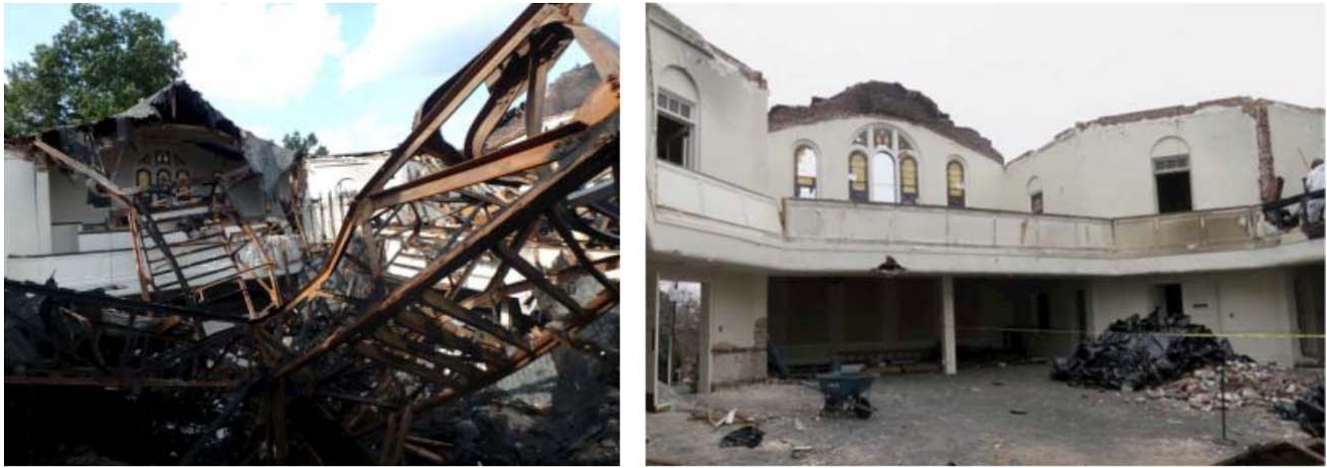
FIGURE 1.—Site photos of initial damage scan and after demolition scan areas.

compare the binary image of the scanned data with the binary image of a filter (or simplified geometries of the steel shapes). The research indicated progress in automating the process of steel identification with the results of the procedure (analyzing 9 structural members) showing the capability to predict two of the members correctly and the remaining seven members had errors of between 15% to overestimate and 41% to underestimate the sizes. However, the difficulty in the areas of disaster recovery exists in the reality that many of the steel members are difficult to capture due to the overall effects of the disaster (See Limitations and Figure 1) and the overlap of the steel members.

tion. For both the traditional method of collecting measurements as well as the scan method, some of the areas were inaccessible at the time of the first visit and required a second visit to confirm and gather additional dimensions. Once demolition was completed, a second scan was conducted to create a new starting point for redesign and determine any changes that may have occurred to the structure during the demolition phase. This duplication of scanning efforts also contributed to a larger time commitment, but also added to quality assurance measures since the exterior walls had already been documented in the first scan and were then be verified. Figure 1 provides photos of both the areas for the initial scan and post-demolition scan.

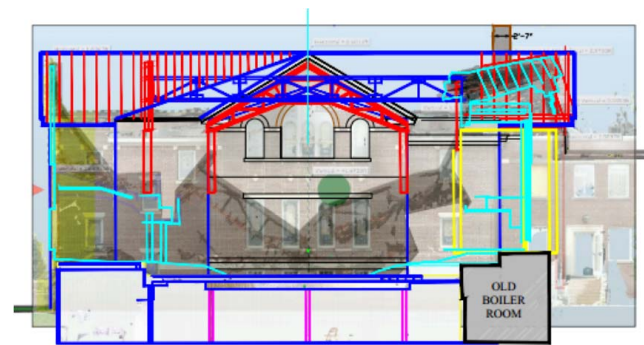
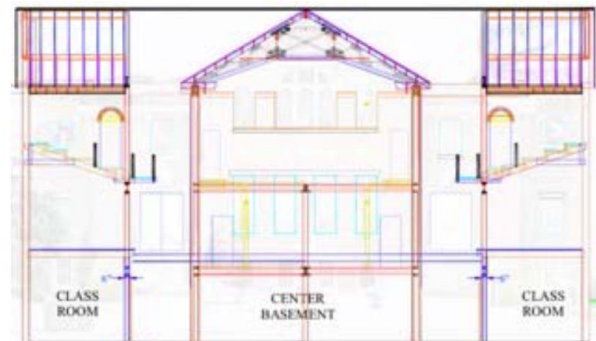
Initial Overlay of Point Cloud

Design Process

**FIGURE 2.**—Overlay of cloud data to assess structural damage and for redesign. (Provided by Crump Engineering Works, PLLC.)

**Analysis** - The results of the scan project (the point cloud scan data) was used to create an overlay in AutoCAD to determine the configuration of existing structure. The CAD files were created based on the initial scans, and verification of the dimensions in the newly created CAD file were also checked to the second scan files (Figure 2). By using this combined method of traditional CAD development with the scan overlays, the project team could use an
