# POINT CLOUD APPLICATIONS FOR DISASTER REMEDIATION: A CASE STUDY

Glenda Mayo<sup>1\*</sup>

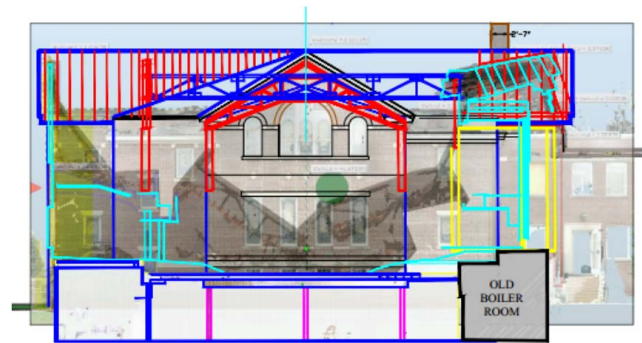
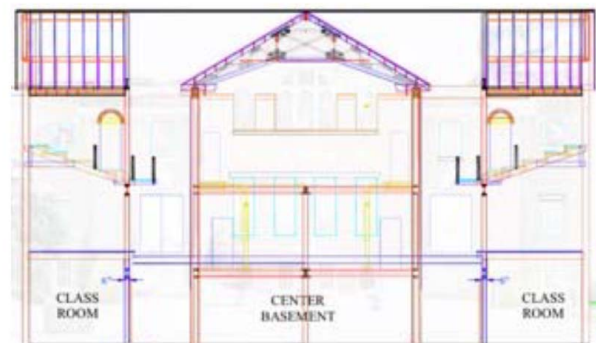
Initial Overlay of Point Cloud

Design Process

**FIGURE 2.**—Overlay of cloud data to assess structural damage and for redesign. (Provided by Crump Engineering Works, PLLC.)

**Analysis** - The results of the scan project (the point cloud scan data) was used to create an overlay in AutoCAD to determine the configuration of existing structure. The CAD files were created based on the initial scans, and verification of the dimensions in the newly created CAD file were also checked to the second scan files (Figure 2). By using this combined method of traditional CAD development with the scan overlays, the project team could use an

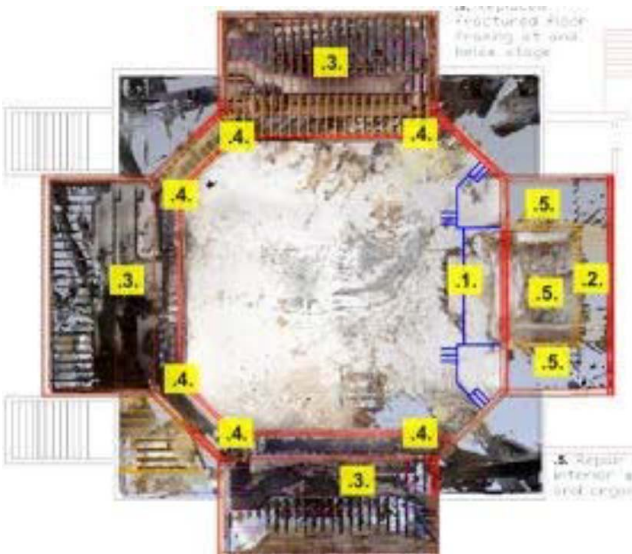
FIGURE 4.—Review of structural components for redesign. (Provided by Crump Engineering Works, PLLC.)

wood members, cross sections were analyzed to determine the physical properties and layouts of existing structural components (framing member cross sections for example, as shown in Figure 4). Attempting to re-create the existing structural design allowed the engineer to remain true to the original design while ensuring the integrity of a new design.
